# Collapse of the Quebec Bridge, 1907

Pearson, C., and Delatte, N. (2006). "Collapse of the Quebec Bridge, 1907." *J.Perform.Constr.Facil.*, 20(1), 84-91.

**Abstract:** In the late 19th century, the transportation needs of Quebec led to proposals for bridging the St. Lawrence River. The Quebec Bridge was the longest cantilever structure attempted until that time. In its final design, the clear span was 548.6 m (1,800 ft) long. The bridge project was financially troubled from the beginning. This caused many setbacks in the design and construction. Construction finally began in October 1900. In August 1907, the bridge collapsed suddenly. Seventy five workers were killed in the accident, and there were only 11 survivors from the workers on the span. A distinguished panel was assembled to investigate the disaster. The panel's report found that the main cause of the bridge's failure was improper design of the latticing on the compression chords. The collapse was initiated by the buckling failure of Chord A9L, on the anchor arm near the pier, immediately followed by Chord A9R. Theodore Cooper had been the consulting engineer for the Quebec Bridge project, and most of the blame for the

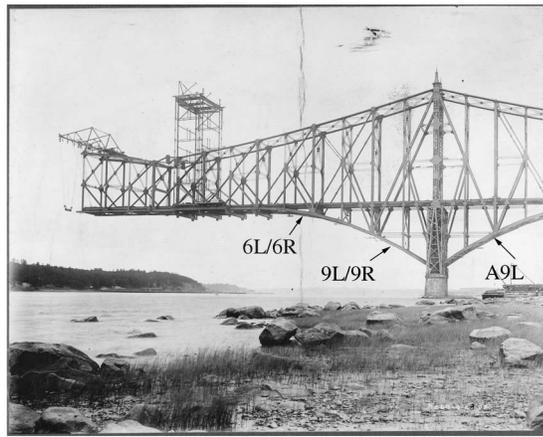
**Fig. 2.** Quebec Bridge just before collapse (Modjeski et al. 1919 used by permission of Library and Archives Canada, PA 029229)

The last photograph taken of the bridge before the collapse is shown in Fig. 2. The panels were numbered from 1, at the outer ends of the cantilever arms, through 10, at the piers. The anchor arm panels added the notation “A.” The A9L notation, therefore, refers to the chord located in the anchor arm, within the ninth panel, and on the left or west side of the bridge. Some of the major chords with their corresponding deflections, with the dates of measurement, are presented in Table 2.

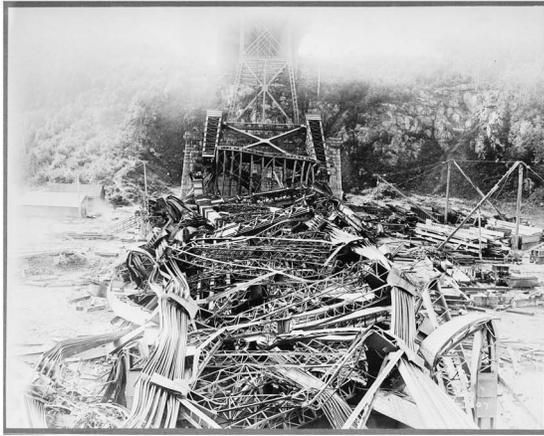
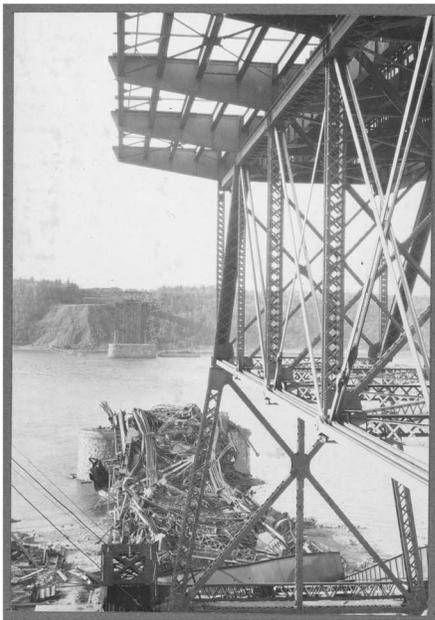
**Fig. 3.** Wreckage (Modjeski et al. 1919 used by permission of Library and Archives Canada, C009766 and PA020614)

The A9L bottom compression chord, which was already bent, gave way under the increasing weight of the bridge. The load transferred to the opposite A9R chord that also buckled. The piers were the only part of the structure that survived. The wreckage is shown in Fig. 3, looking from the south bank toward the pier. Of 38 Caughnawaga Mohawk ironworkers who had left their village to work on the bridge, 33 were killed and two were injured (Middleton 2001, p. 84).

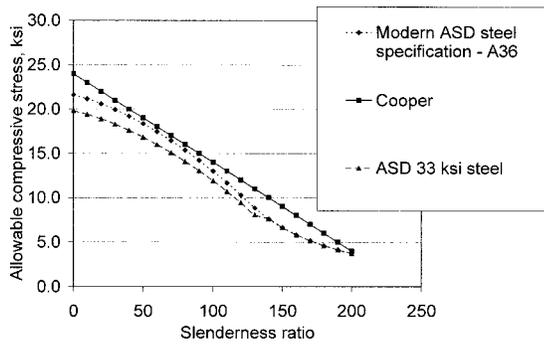
**Fig. 4.** Cooper’s allowable compressive stresses for Quebec bridge (1 ksi=6.89 Mpa)

Cooper’s formula is compared to contemporary allowable stresses from the American Institute of Steel Construction (AISC 1989) as well as the 96.5 MPa (14 ksi) compressive allowable stress adopted for the second bridge (Middleton 2001, p. 107) in Fig. 4. AISC curves are shown for both 230 MPa (33 ksi) and 250 MPa (36 ksi) steel. Cooper’s allowable stresses are higher than those in use today by 3.3–8.7% over a range of slenderness ratios from 10 to 100. Given the lower and uncertain quality of the materials available to Cooper, along with the less developed state

of knowledge of compression members at that time and the lack of testing of compression members, Cooper’s formula represents an unsafe practice.

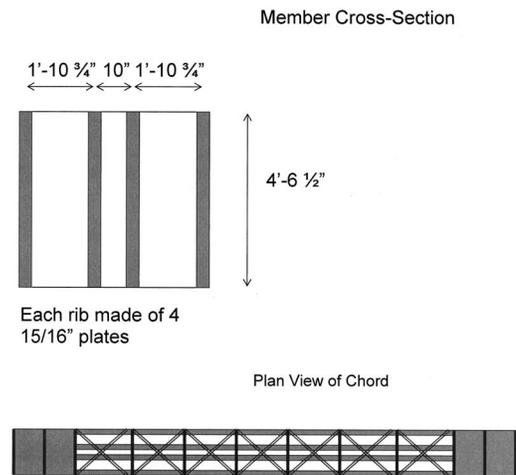
The commission had suspected that the A9L compression chord failed due to improper latticing. Compression tests were performed on one-third scale models of the compression chords in November 1907 and January 1908 to verify this theory. The compression chord members for the Quebec Bridge consisted of four multilayered ribs (Fig. 5). They were stiffened by the use of diagonal latticing to make them act as one unit. During testing, the lattice system failed explosively due to shearing of its rivets, immediately followed by buckling of the chord. This confirmed the commission's findings that the chords were inadequately designed. In Schneider's opinion, "These members consist of four separate ribs, not particularly well developed as compression members, and their connections to each other are not of sufficient strength to make them act as a unit" (Middleton 2001, p. 97).

Fig. 5. Builtup compression members

Schneider wrote in his report, which was published as an appendix to the Royal Commission Report, "If a column is made up of several shapes or parts, they have to be connected in such a manner that they will act as a unit. In an ideal column each part would take its share of the load and no connection would be required. In practice, however, as stated before, bending will occur before the buckling load is reached, causing shearing strains which have to be transferred through the connections, as latticing, tie plates, or cover plates. These connection parts have, therefore, to perform the same function as the web of a girder or the web system of a truss" (Holgate et al. 1908).
