Ronan Point Apartment Tower Collapse and its Effect on Building Codes

Cynthia Pearson
Cleveland State University

Norbert Delatte
Cleveland State University, n.delatte@csuohio.edu

Pearson, C., and Delatte, N. (2005). "Ronan Point Apartment Tower Collapse and its Effect on Building Codes." *J.Perform.Constr.Facil.*, 19(2), 172-177.

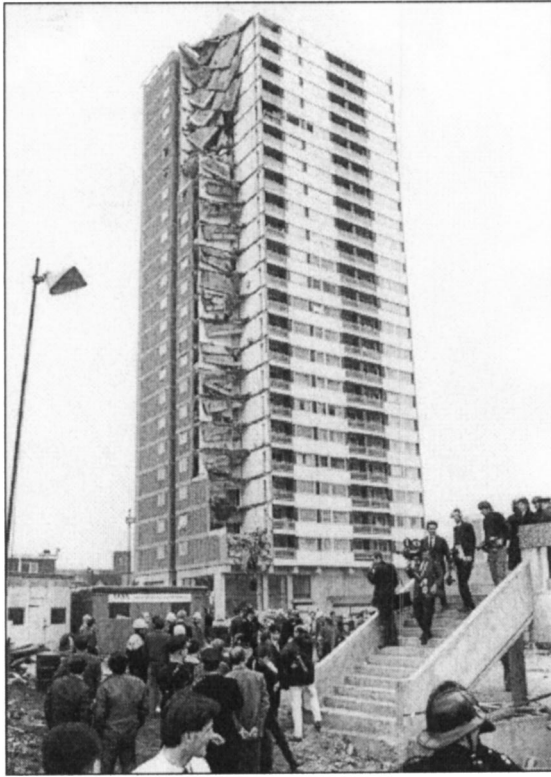
The pressure of the small gas explosion blew out the walls of her apartment, and initiated a partial collapse of the structure that killed four people and injured 17. One of the injured, an 82-year-old woman, subsequently died, but possibly not due to the collapse (Griffiths et al. 1968). The partially collapsed structure is shown in Fig. 1. The floor plan for apartment 90 is provided in Fig. 2.

Fig. 1. Ronan Point after collapse

The collapse was initiated by a gas-stove leak on the 18th floor in apartment 90. The resident struck a match and was knocked unconscious by the resulting explosion. The force of the explosion knocked out the opposite corner walls of the apartment. These walls were the sole support for the walls directly above. This created a chain reaction in which floor 19 collapsed, then floor 20, and so on, propagating upward. The four floors fell onto level 18, which initiated a second phase of the collapse. This

sudden-impact loading on floor 18 caused it to give way, smashing floor 17 and progressing until it reached the ground.

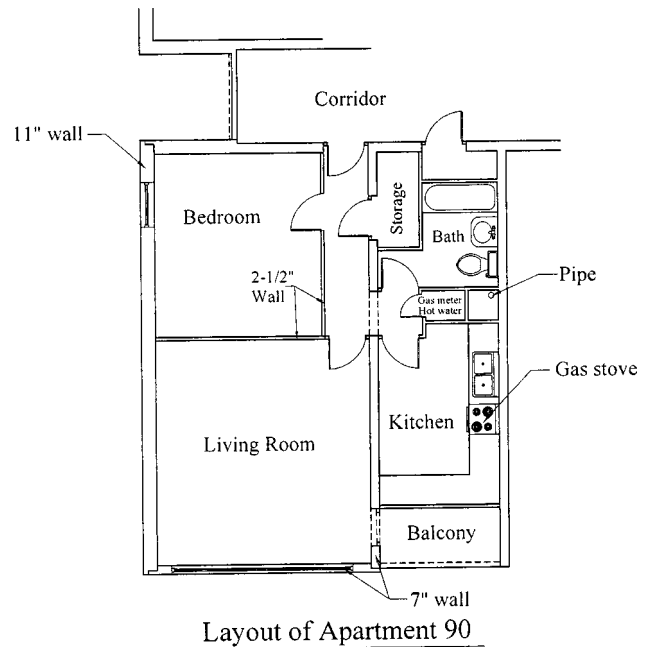
Fig. 2. Floor plan of apartment (based on Bignell [1977] and Levy and Salvadori [1992])

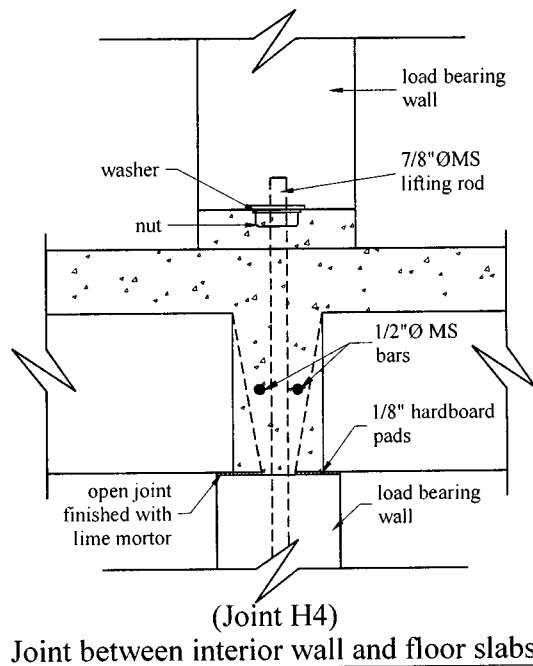
Ronan Point was one of many identical high-rise precast concrete flat-plate structures constructed during this time. In this type of structural system, each floor was supported by the load-bearing walls directly beneath it. Gravity load transfer occurred only through these load-bearing walls. The wall and floor panels fitted together in slots. These joints were then bolted together and filled

with dry-pack mortar to secure the connection. The connections are shown in Figs. 3 and 4.

Fig. 3. Interior joint (based on Wearne [2000], Bignell [1997], and Levy and Salvadori [1992])

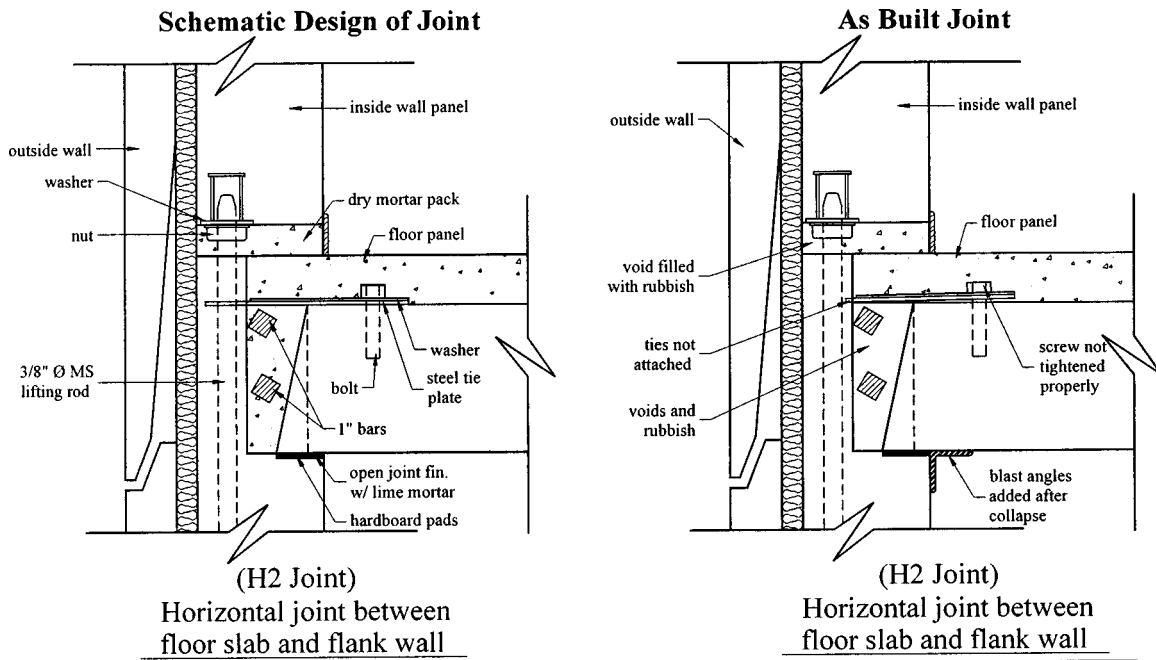
Fig. 4. Exterior joints (based on Wearne [2000], Bignell [1997], and Levy and Salvadori [1992])

The southeast corner of Ronan Point was rebuilt as a separate section of apartments and then joined to the existing building by means of walkways. Ronan Point was reinforced with blast angles as part of the reconstruction. The blast angles added are shown in Fig. 4, on the right side. Gas was also banned from Ronan Point.
