Ronan Point Apartment Tower Collapse and its Effect on Building Codes

Cynthia Pearson¹ and Norbert Delatte, M.ASCE²

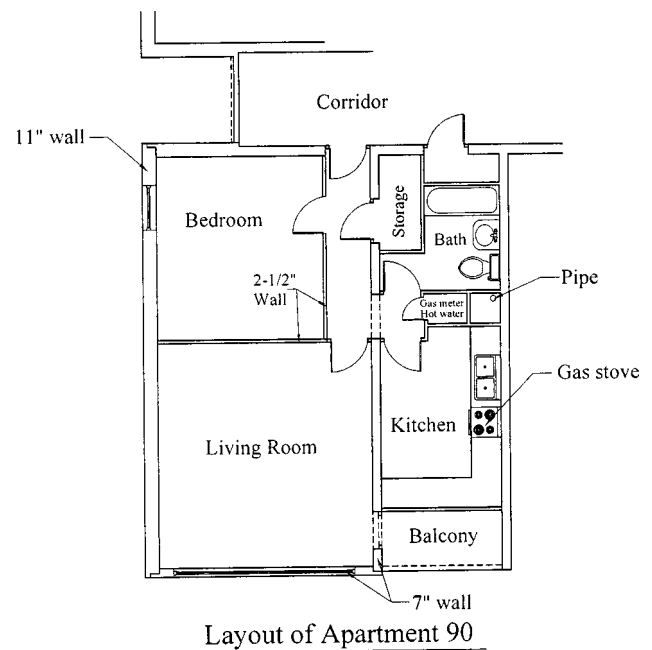
The collapse was initiated by a gas-stove leak on the 18th floor in apartment 90. The resident struck a match and was knocked unconscious by the resulting explosion. The force of the explosion knocked out the opposite corner walls of the apartment. These walls were the sole support for the walls directly above. This created a chain reaction in which floor 19 collapsed, then floor 20, and so on, propagating upward. The four floors fell onto level 18, which initiated a second phase of the collapse. This

Fig. 2. Floor plan of apartment (based on Bignell [1977] and Levy and Salvadori [1992])

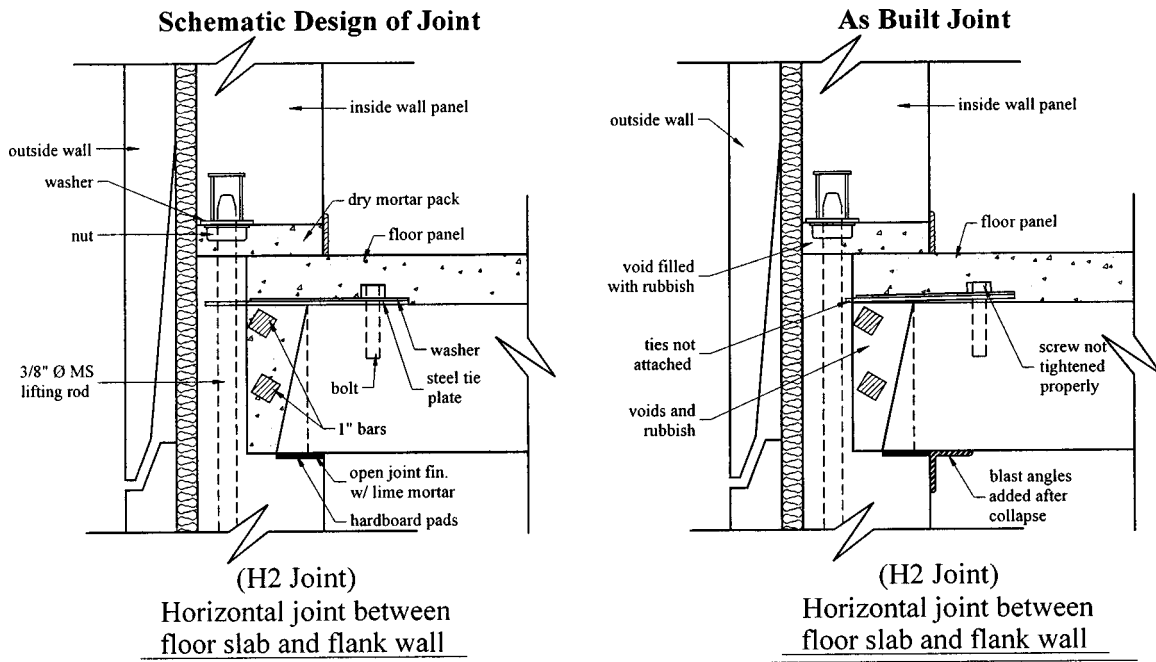
with dry-pack mortar to secure the connection. The connections are shown in Figs. 3 and 4.

Fig. 4. Exterior joints (based on Wearne [2000], Bignell [1997], and Levy and Salvadori [1992])

The southeast corner of Ronan Point was rebuilt as a separate section of apartments and then joined to the existing building by means of walkways. Ronan Point was reinforced with blast angles as part of the reconstruction. The blast angles added are shown in Fig. 4, on the right side. Gas was also banned from Ronan Point.
