Failure of Cold-Formed Steel Beams during Concrete Placement

Norbert Delatte

Delatte, N. (2005). "Failure of Cold-Formed Steel Beams during Concrete Placement."
J.Perform.Constr.Facil., 19(2), 178-181.

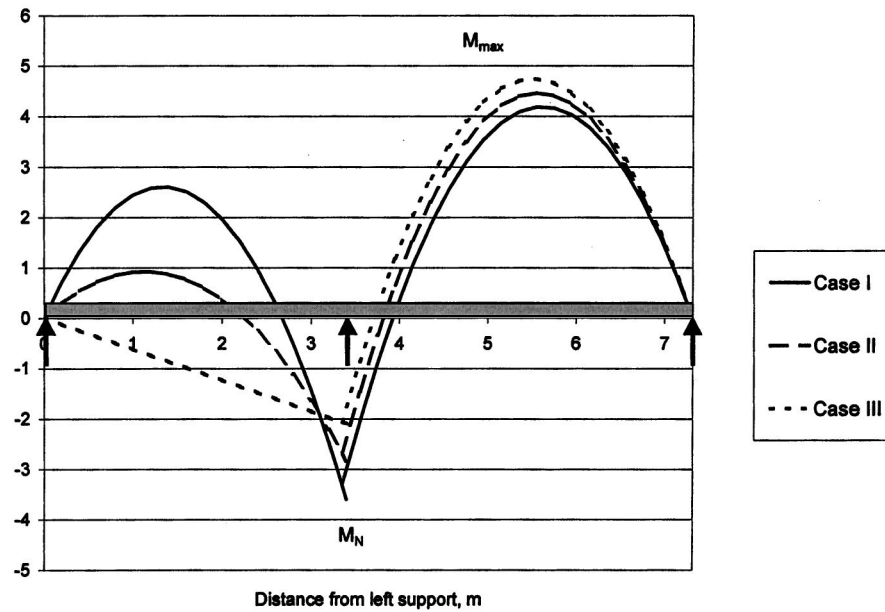
Bending moments for these three load cases are shown in Table 1, and moment diagrams are shown in Fig. 1. The greatest absolute value of the moment is always the positive moment near the midspan of the longer beam, for the load cases considered.

Therefore, the bending failure in the beams would occur near the center of the 3.96 m (13 ft) span, and at the support between the 3.96 and 3.35 m (13 and 11 ft) spans. This agrees with the damage shown in the photographs that accompanied the various depositions.

Fig. 1. Moment diagrams for cold-formed steel support beams
