Another Look at the Collapse of Skyline Plaza at Bailey's Crossroads, Virginia

Jeffrey Schellhammer¹; Norbert J. Delatte, F.ASCE²; and Paul A. Bosela, F.ASCE³

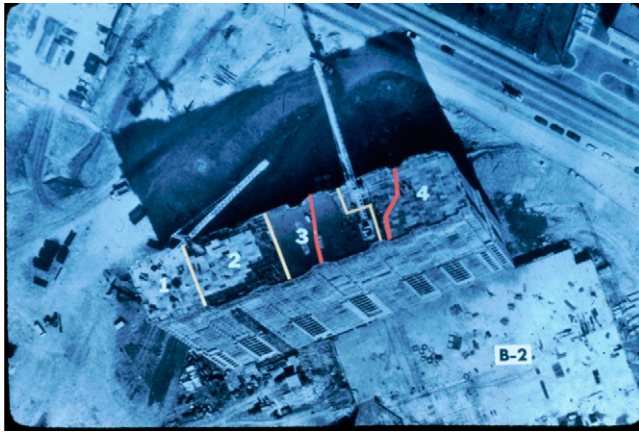
Fig. 1. Aerial photograph of the structure shortly before the collapse (courtesy of NIST)

The collapse killed 14 workers and injured 34 (Carino et al. 1983, p. 35). The area that collapsed is designated as area 3 in Fig. 1. This area also contained a crane; as a result, there was a question as to whether the crane fell and initiated the collapse, or if it just came down with the rest of the building. Once the section of the apartment building collapsed, the failure propagated horizontally through the attached parking garage. Of the workers killed, 10 were in the tower and four in the garage (Leyendecker and Fattal 1977, p. 2).

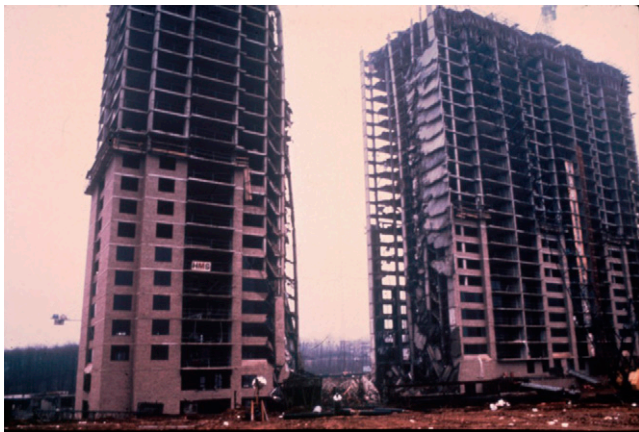
On March 2, 1973, the Skyline Plaza apartment building in Bailey's Crossroads, Virginia collapsed while under construction. The collapse extended vertically through the building, from the 24th floor to the ground, leaving an appearance of the structure as two different high-rise buildings with a gap between them. The collapse tore a 18-m (60-ft) wide gap through the building all the way to the ground. At the time of the collapse, two practically identical RC towers had already been built (Kaminetzky 1991, p. 64). Fig. 1 shows an aerial photograph of the structure taken shortly before the collapse, at about 11 a.m. on the same day. The collapse occurred at about 2:30 p.m. (Leyendecker and Fattal 1977, p. 2). The collapsed structure is shown in Figs. 2–4.

Fig. 2. The collapsed structure (courtesy of NIST)

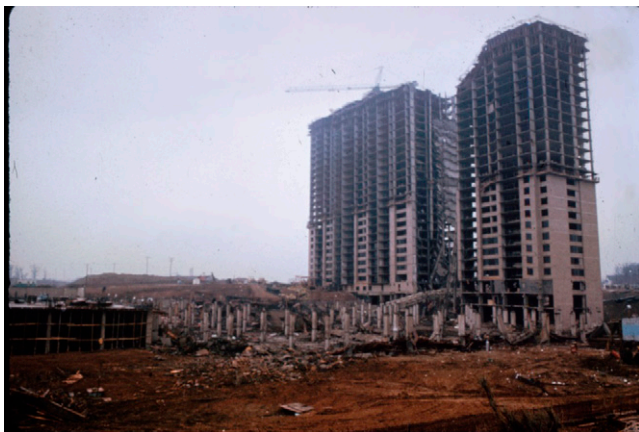
Fig. 3. Another view of the collapsed structure (courtesy of NIST)

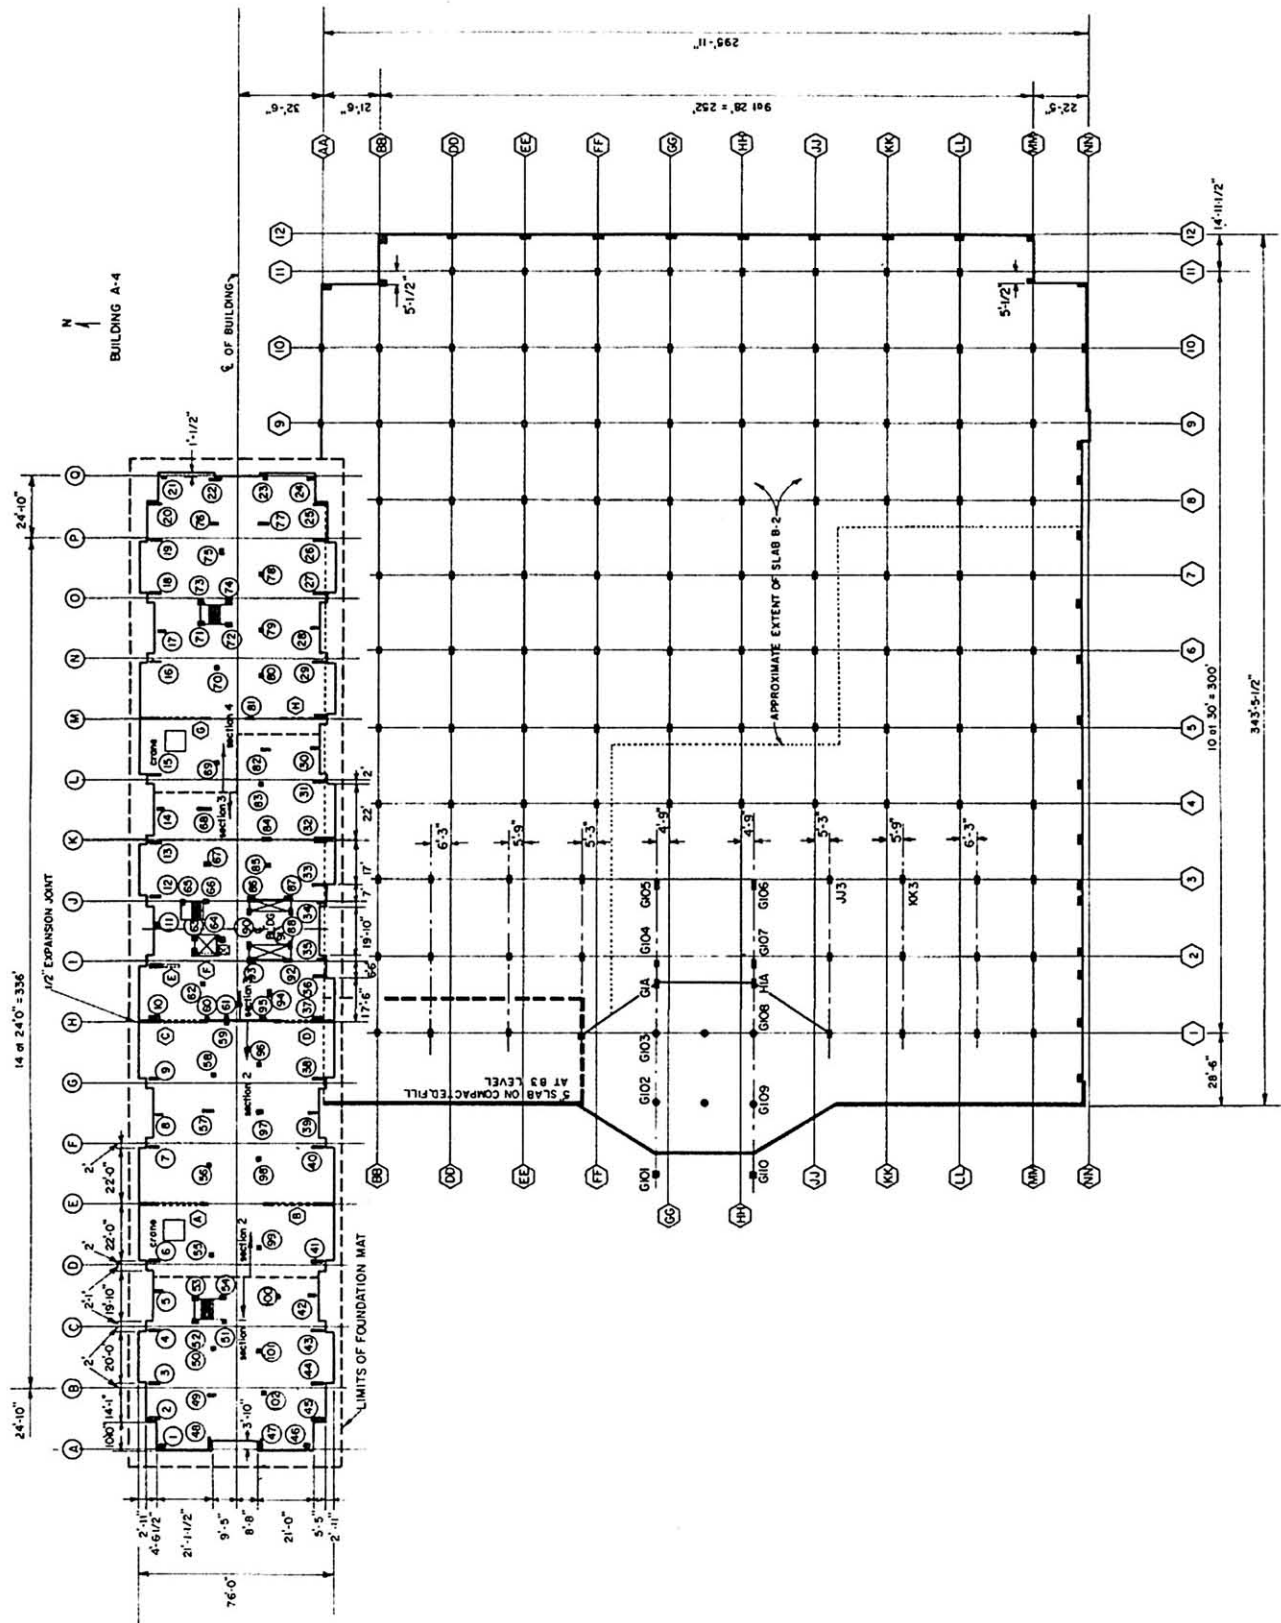
The 26-story apartment building was part of a \$200 million residential project (Carper 1997, p. 243). The floor plan is shown in Fig. 5. The building that collapsed is on the left side of Fig. 5, with a parking garage extending to the right. The 118- by 23-m (386- by 76-ft) building was to be built at a pace of one floor per week (Delatte 2009, p. 145). Each floor was to be placed in four separate sections with a construction joint in the middle, between sections two and three.

Fig. 5. Plan view of the Skyline Plaza Apartment Building and parking garage (Leyendecker and Fattal 1977, p. 6)

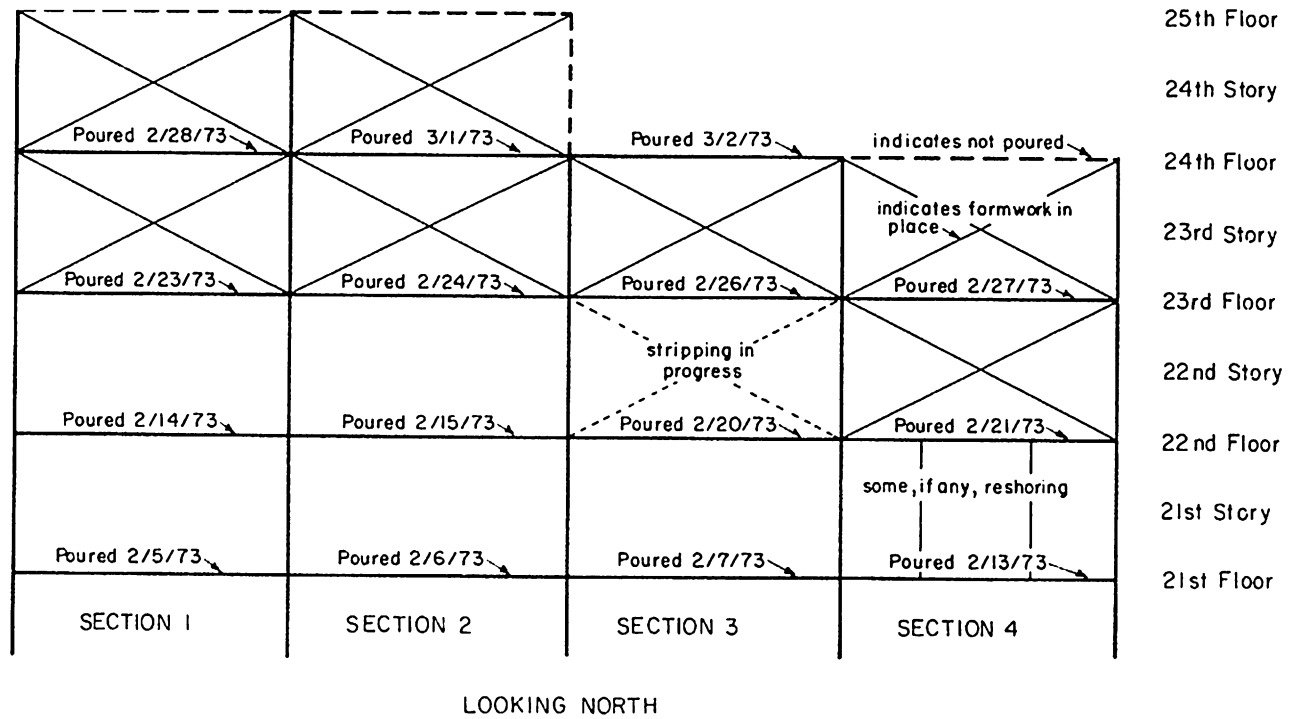
To determine whether premature removal of shoring or failure to install reshoring had caused the collapse, it was necessary to determine what formwork was in place at that time. This proved difficult. Between the March 2nd collapse and the arrival of the NBS team on site, additional reshoring was placed to stabilize some parts of the building. Some of the workers’ statements about the status of the shoring conflicted with each other. One worker who was installing reshores on the 21st floor claimed to have heard formwork and shoring removal on the 22nd floor at about 2 p.m. Careful analysis of photographs taken right after the collapse showed that while full shoring remained on the 23rd and 24th stories, it had nearly all been removed from the 22nd story in sections 1 and 2, but remained in section 4. The condition of the formwork in section 3 could not be observed because nearly all of this section had collapsed. The engineer’s structural drawings required 2 full stories of shoring and 1 story of reshoring while a concrete slab was being cast. The NBS team concluded that the estimated location of forms, shores, and reshores at the time of the collapse was as shown in Fig. 6, with all formwork removed on sections 1–3 of the 22nd floor and little if any reshoring on that floor (Leyendecker and Fattal 1977, pp. 18–31).

Some workers said that all of the shoring was removed on both floors, some said that only some was removed, and others believed that all was still in place at the time of collapse (Leyendecker and Fattal 1977, p. 18). However, the statements of one worker gave the investigators a good idea of the state of the forms at the time of the collapse. Leyendecker and Fattal (1977, p. 31) reported “One workman indicated that, at the time of the incident, he was placing reshores in section 3 of the 21st story and that some reshores were present when he started working. Prior to the incident, all the reshores fell out (except those in the balcony areas). This is consistent with what would be likely to occur if the forms had been removed in the story above.” If the shoring had been removed in the 22nd floor, the 22nd floor slab would have been relieved of its previous loads. With less loading, the deflection would have decreased in the slab, causing the reshores on the 21st floor to fall out.

Fig. 6. Estimated location of forms and reshores at the time of the collapse (Leyendecker and Fattal 1977, p. 30)

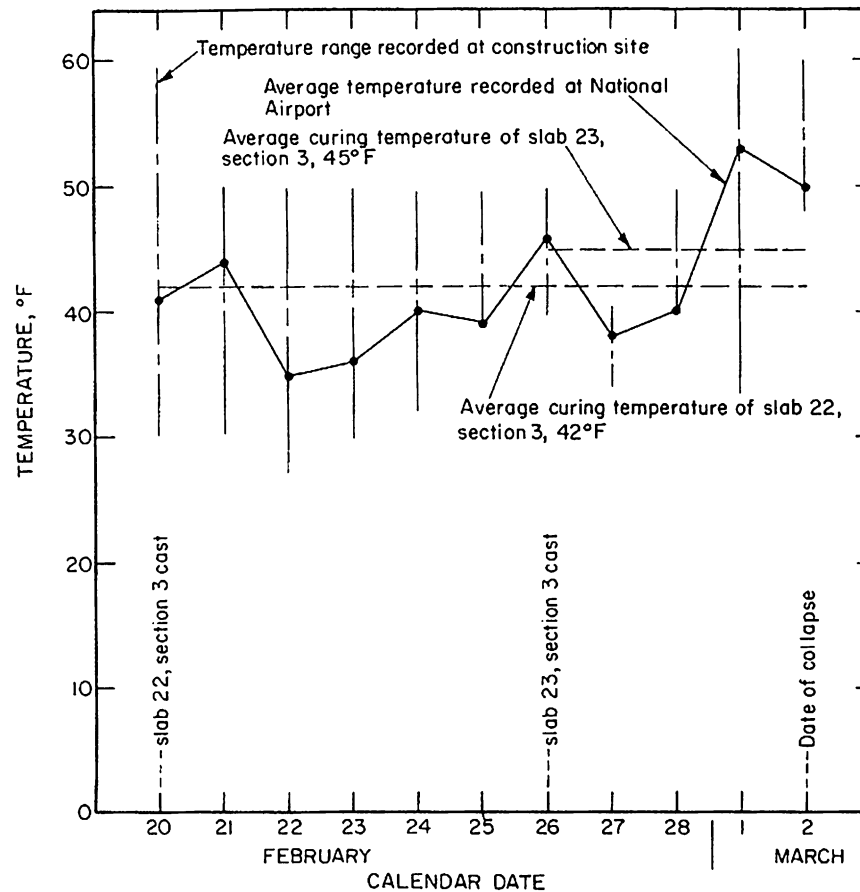
floor and 7°C for the 23rd floor (42 and 45°F , respectively) (Leyendecker and Fattal 1977, p. 60). The temperature history is shown in Fig. 7. Concrete cured at (5.6°C) (42°F) for 1 week would have a $\text{TTF} = (5.6 + 10) \times 7 = 109^\circ\text{C} - \text{days}$ [$(42 - 14) \times 7 = 196^\circ\text{F} - \text{days}$]. In contrast, concrete cured at the standard laboratory temperature of 23°C (73°F) would have a $\text{TTF} = (23 + 10) \times 7 = 231^\circ\text{C} - \text{days}$ [$(73 - 14) \times 7 = 392^\circ\text{F} - \text{days}$]. In other words, at 5.6°C (42°F), concrete takes about twice as long to gain strength as at standard laboratory temperature.

Fig. 7. Temperature history (scale 0°F = -18°C and 60°F = 15.6°C) (Leyendecker and Fattal 1977, p. 63)
