## Collapse of 2000 Commonwealth Avenue: Punching Shear Case Study

King, S., and Delatte, N. (2004). "Collapse of 2000 Commonwealth Avenue: Punching Shear Case Study." *J.Perform.Constr.Facil.*, 18(1), 54-61.

**Abstract:** On January 25, 1971, two thirds of a 16-story apartment building collapsed while under construction at 2000 Commonwealth Avenue, Boston, Massachusetts. Four workers died after a failure on the roof instigated a progressive collapse all the way to the basement, where the men were found. Fortunately, the collapse occurred slowly enough for most of the other workers to run to safety. An investigation, conducted by a commission assembled by the Mayor of Boston, painted a picture of a troubled project, with considerable confusion about responsibility for structural safety. The surviving workers' descriptions of the failure provide a textbook definition of punching shear. Low concrete strength due to inadequate protection against cold weather contributed to low punching shear strength of the flat slab. Inspection, quality control, planning, and supervision were for all practical purposes absent from the project. This paper investigates the numerous causes and lessons

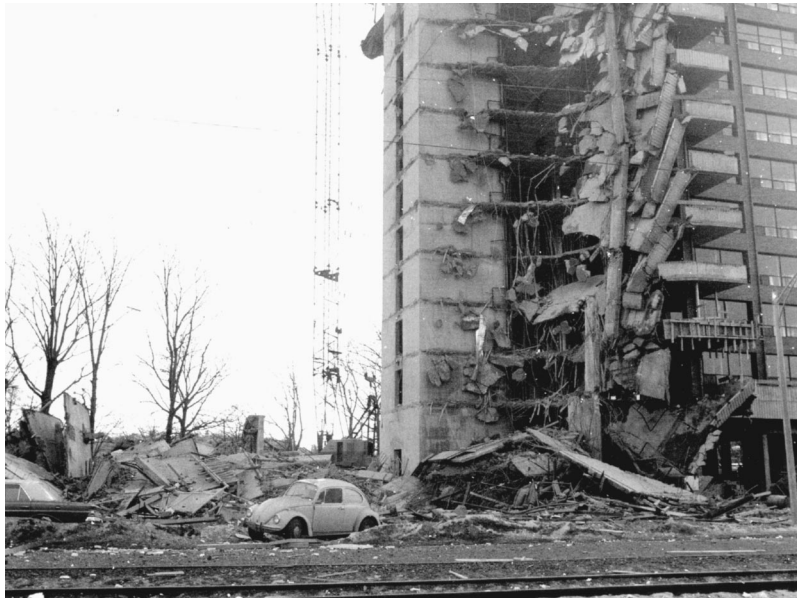
**Fig. 1.** Chunks of concrete and wood were strewn across MBTA track (in foreground) by building collapse [from *Boston Globe*, January 26, 1971; republished with permission]

At the time of failure, the structural subcontractor was placing reinforcing steel for the stairs on the fourteenth and fifteenth floors on the east side of the building. When the workers were making their way from the roof and floors above, most of them crossed over to the west side of the building when they reached the fifteenth floor (Granger et al. 1971). Thus, the portion of the building that remained standing, shown on the right side of Fig. 1, provided an escape for many of the workers that survived.

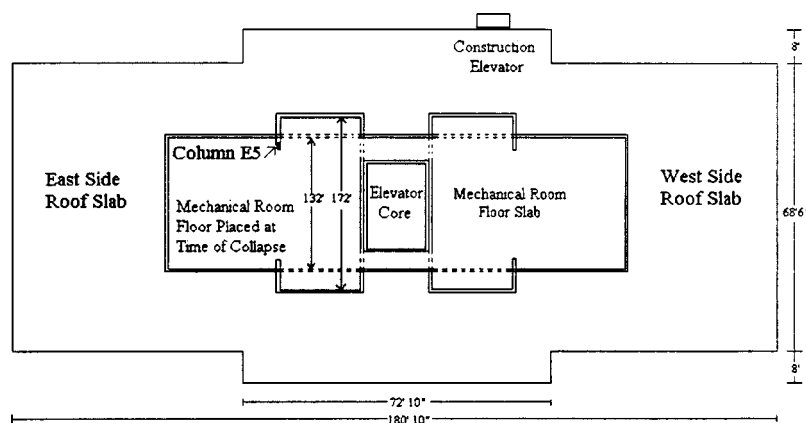
The carpenter foreman, Mr. A. F., was also in the area and immediately yelled a warning to the men working on the sixteenth floor and roof of a possible roof collapse. The slab had dropped 125–150 mm (5 or 6 in.) around the column, and there was a crack in the bottom of the slab extending from column E5 toward column D8. Column E5 is located directly below where the concrete was being placed for the mechanical room floor slab on the east side of the building, as shown in Fig. 3 (Granger et al. 1971).

**Fig. 3.** Floor plan and location of column E5 [after Granger et al. (1971)] (1 ft=0.3 m)

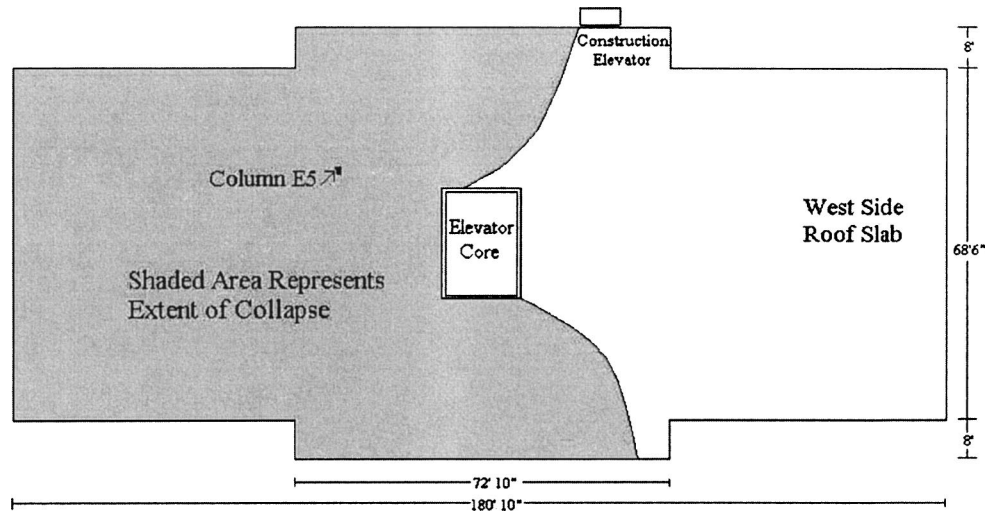
At first the different floors were distinguishable, but later dust and debris made it difficult to tell them apart. When the dust finally settled, two-thirds of the building had collapsed. The east side and areas on either side of the elevator shaft were gone. Four workers were killed during the collapse, and 30 workers suffered injuries (Granger et al. 1971). The extent of damage is shown in Fig. 4. The elevator core probably prevented the collapse from propagating to the other half of the structure.

Fig. 4. Extent of collapse [after Granger et al. (1971)] (1 ft=0.3 m)

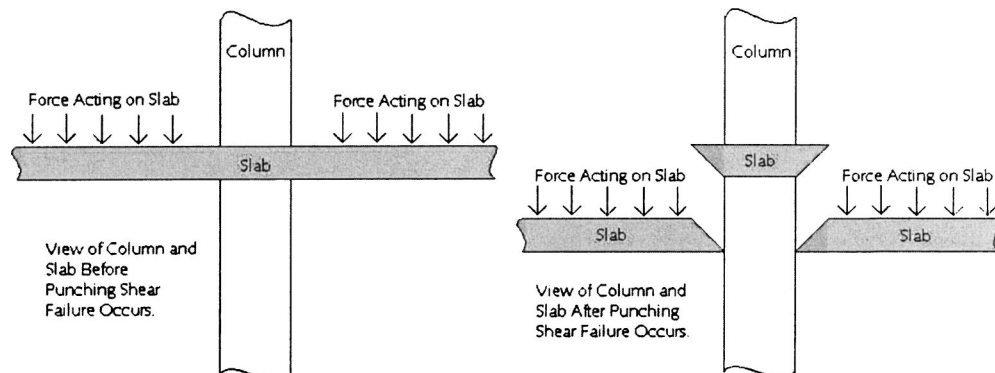
Punching shear is usually the critical failure mechanism for flat slab reinforced concrete structures. This mechanism is illustrated in Fig. 5. With this type of failure, the column and part of the slab punch through the slab as it moves downward.

Fig. 5. Punching shear mechanism
