Agricultural Product Loads and Warehouse Failures

Abstract: Two manufactured metal building warehouses loaded with agricultural products failed in service. Inspection revealed considerable damage to the structure and the foundation. The building owner filed suit against the building supplier, the building erector, and the soils testing laboratory whose engineer had designed the foundation. The agricultural product imposed substantial outward lateral pressures on the walls of the structures. Review of the available design documents indicated that these loads had not been accounted for in design. A structural analysis revealed that elements of the structure were underdesigned for the agricultural product loads. In addition, the foundation did not have any slab reinforcement to resist the loads. To prevent similar failures, these loads must be accounted for in design. The steel structure design and foundation design were both deficient. A contributing factor was the lack of communication between the designer of the structure and the designer of the foundation, due to the lack of a single engineer of record to take responsibility for the buildings.

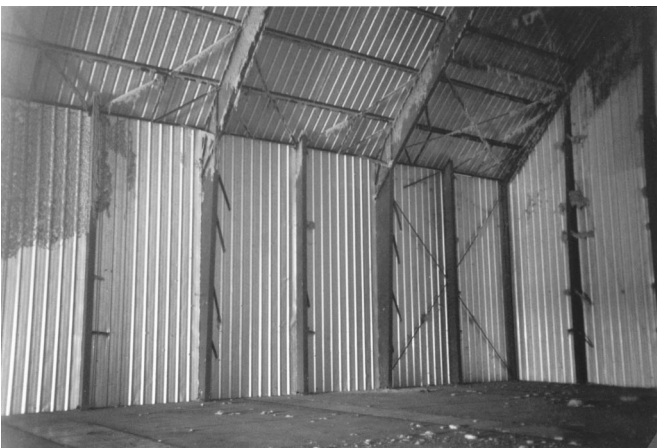
The structural configuration of both warehouses was identical. The interior framing of one of the warehouses is shown in Fig. 2. Six gable frames are spaced at 6.1 m (20 ft) intervals. Between the gable frames are interior soldier columns. The tops of the interior soldier columns are restrained by steel angle bracing leading back to the gable frames. Each of the pair of braces at the top of each column has two parts, with bolts attaching them to other parts of the structural secondary framing. The first and last bays have x-bracing for longitudinal stability of the structure. Each end wall had seven columns.

Fig. 2. Warehouse interior framing

Once the foundation was prepared, a construction firm was hired to erect the building. Adjustments had to be made during construction because the building was purchased with an interior liner, which was not shown on the plans supplied by the metal building manufacturer. The liner may be seen in Figs. 2 and 4.

Therefore, the pattern of damage to the flange braces shown in Figs. 2 and 4 was most probably due the outward force of the cottonseed. Other damage mechanisms were suggested, such as downward drag of the cottonseed or impact by forklifts. The former would have imposed much smaller forces than the outward cottonseed pressure, and the latter seemed unlikely in view of the extent and pattern of the damage.

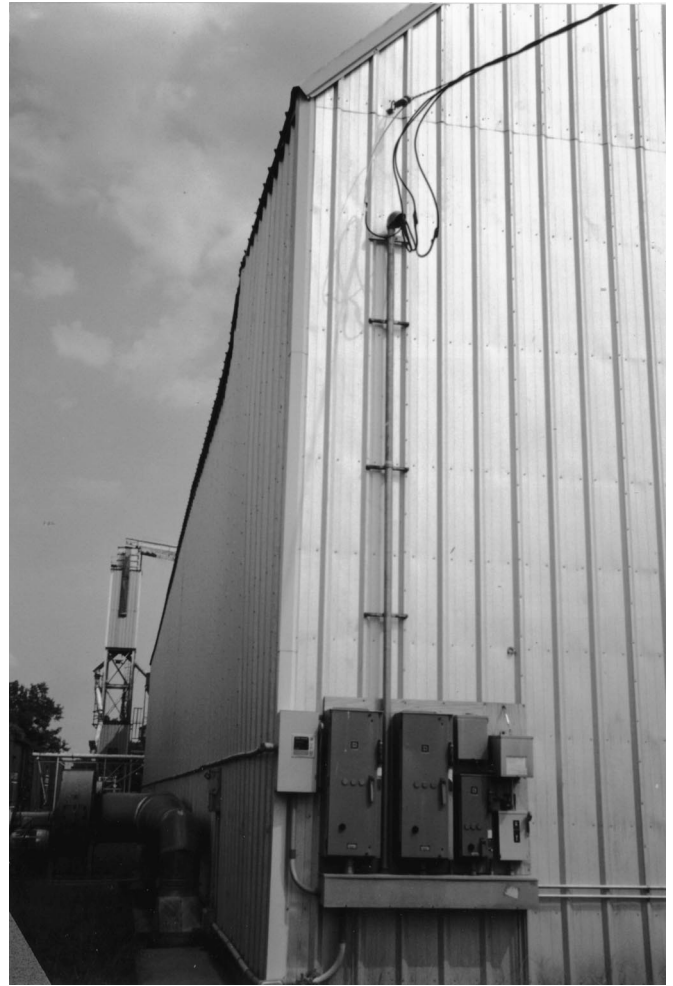
1. On the right side of the far end of the warehouse (loading end), the top of the wall had been torn outward. This is shown in Fig. 3. From inside the warehouse, the sky was visible through the gap.
2. The interior liner of the wall at the far end of the warehouse showed signs of permanent distortion (wrinkling) due to outward bulging.
3. A large number of the flange braces on the end walls had been torn away from the interior liner and were hanging down. This is illustrated in Fig. 4. The cotton lint pattern in this figure also provided an indication of how high the seed was piled at the end wall. Some flange braces along the side walls were also torn away, as shown in Fig. 2. More flange braces were torn away lower on the walls than higher up.

Fig. 3. Damage at eave line

In each warehouse, one of the interior columns nearest the end wall showed damage at the top. In warehouse 1, the top of a column was shown outward, as shown in Fig. 3. In warehouse 2, one of the braces holding in the top of a column was torn away (Fig. 6). Analysis using both the Allowable Stress Design (ASD)

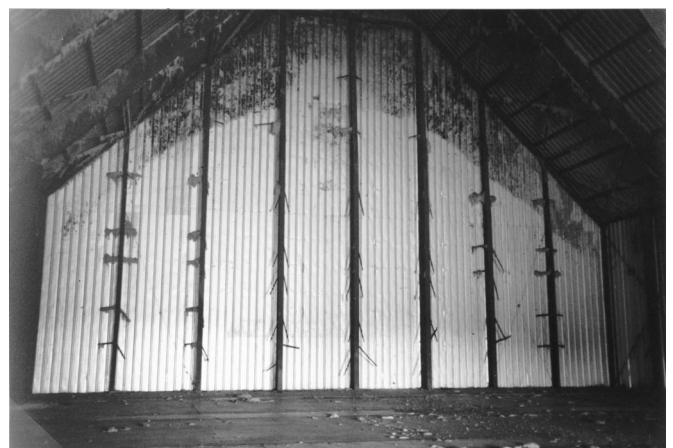
Fig. 4. Column flange braces torn away at end wall

Review of the structural design documents indicated that the flange braces were intended to prevent lateral-torsional buckling of the columns. The analysis of the load path, discussed above, noted that the cottonseed forces were transferred to the columns through these braces as well as through the girt clips. The flange braces were more than twice as stiff as the girt clips, so they would take carry about 2/3 of the tensile forces as the walls were pushed outward by the cottonseed.

The tensile forces in the lateral braces increased linearly from the top to the bottom of each column. The bottom flange attachments on the side walls and end walls were considerably overstressed. The lowest brace had an axial force of 24.5 kN (5,500 lbs) and transmitted shear and tensile forces to the screw of 17.3 kN (3,890 lbs) each. Both pullout tension and shear capacities are exceeded, without considering interaction. Use of lower strength screws would make this deficiency worse.

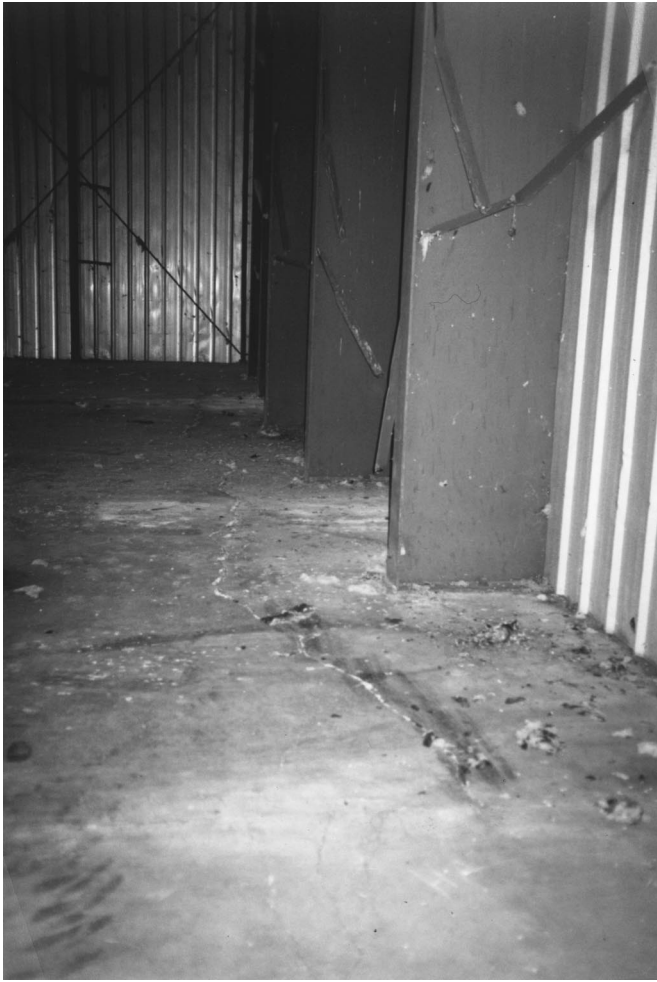
4. The concrete slab foundation was badly cracked. Cracks ran near the bases of the side wall columns nearest to the end wall. Cracks on the right-hand side near the end wall are shown in Fig. 5. Cracks also ran parallel to the end wall. Cracks were approximately 3–6 mm (1/8 to 1/4 in.) wide. Some cracks ran about 100 mm (4 in.) from the inner column flange, and some were about 1 m (3 ft) from the inner column flange.
5. Overall, the greatest damage was closest to the end wall. The door ends had almost no damage.

Fig. 5. Cracking near side wall columns

However, the pattern of damage suggested a prying action at the base of the most heavily loaded columns. The D-shaped cracks around some of the column bases, with cracks propagating through the edge turndown beam, provided strong evidence of this behavior. The column base plate detail, with bolts 305 mm (12 in.) apart, was sufficient to provide a fixed base connection. An expert witness for the metal building manufacturer suggested that the base plate connection was a hybrid hinge, but admitted that some moment would nevertheless be transmitted to the slab. Also, this witness did not perform an analysis of the structure, but had been asked only to evaluate the foundation. Therefore, he did not attempt to calculate the magnitude of the moments.

Moreover, the critical stresses imposed on the foundation were tension imposed by column base forces and moments, not compression. No reinforcement was shown in the interior of the slab to resist these forces. The ACI building code states in section 10.2.5 that the tensile strength of concrete shall be neglected in axial and flexural calculations, and thus requires steel reinforcement to resist tensile forces (ACI 1995). The design clearly vio-

As the last step in the analysis of the slab, the concrete tensile and flexural stresses imposed at the column bases were considered. For the 27.6 MPa (4,000 psi) compressive strength specified, tensile and flexural strength would be approximately 4,500 kPa (650 psi) (Mindess and Young 1981). Using the lowest column force and moment reactions determined earlier, the concrete slab stress would be 7,500 kPa (1,090 psi), well in excess of concrete strength. Therefore, the unreinforced concrete slab was cracked by the forces and moments imposed by the steel structure, bending outward from the pressure of the cottonseed.

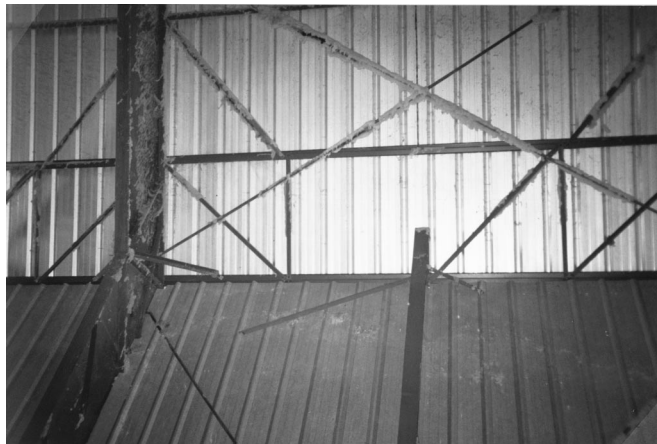
1. On the left side of the far end of the warehouse (loading end), a brace holding back the top of an interior soldier column had been torn away. This is shown in Fig. 6.
2. The wall at the far end of the warehouse showed signs of permanent distortion, similar to warehouse 1.
3. Some flange braces on the end wall and along the side walls had been torn away, similar to warehouse 1.
4. The concrete slab foundation cracking in warehouse 2 was worse than in warehouse 1. A large crack about 25 mm (1 in.) wide, shown in Fig. 7, ran parallel to the end wall. The height differential across the crack was approximately 3 mm (1/8 in.), with the side next to the wall lower. On the left side wall, the three columns closest to the end wall had D-shaped cracks around them, and a large crack ran parallel to the wall just over 1 m (3 ft) from the wall.

Fig. 6. Interior column brace torn, warehouse 2

and Load and Resistance Factor Design (LRFD) provisions of the American Institute of Steel Construction (AISC 1986, 1989) indicated that the connections for the braces were inadequate. Each brace had a maximum force of 20.5 kN (4,600 lbs), but the capacity at the slotted hole was only 9.3 kN (2,090 lbs). In the metal building manufacturer's job file, a document entitled "Correction Warranty" was found for replacing the two-part brace with a single continuous member, with a larger steel cross section. This document suggested that at some point, the metal building manufacturer realized that this detail was deficient.

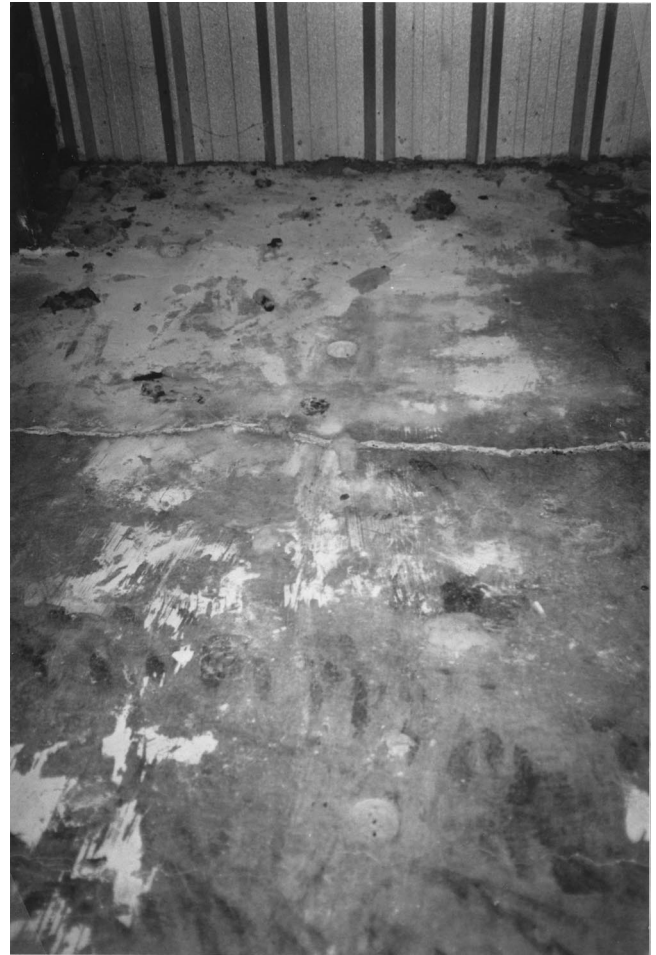
5. As in warehouse 1, the greatest damage was closest to the end wall.

Fig. 7. Cracking near end wall, warehouse 2
