## Another Look at the L'Ambiance Plaza Collapse

Martin, R., and Delatte, N. (2000). "Another Look at the L'Ambiance Plaza Collapse."  
J.Perform.Constr.Facil., 14(4), 160-165.

# ANOTHER LOOK AT THE L'AMBIANCE PLAZA COLLAPSE

By Rachel Martin<sup>1</sup> and Norbert J. Delatte,<sup>2</sup> Member, ASCE

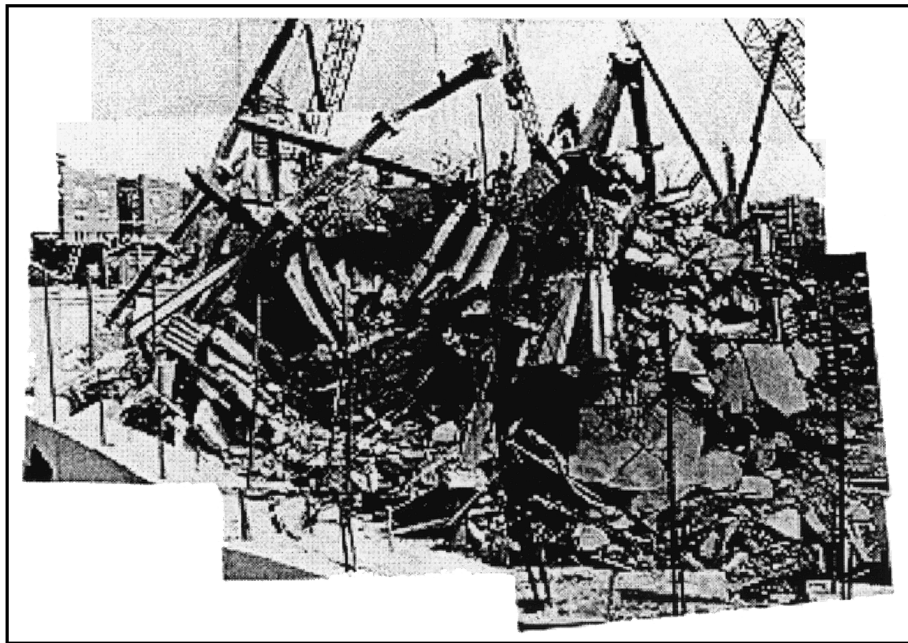
FIG. 2. Ruins of L'Ambiance Plaza (Image from Internet at <http://www.sgh.com/aplaza.htm>)

At the time of collapse, the building was a little more than halfway completed (Fig. 2). In the west tower, the 9th, 10th, and 11th floor slab package was parked in Stage IV directly under the 12th floor and roof package (Fig. 3). The shear walls were about five levels below the lifted slabs (Cuoco et al. 1992).

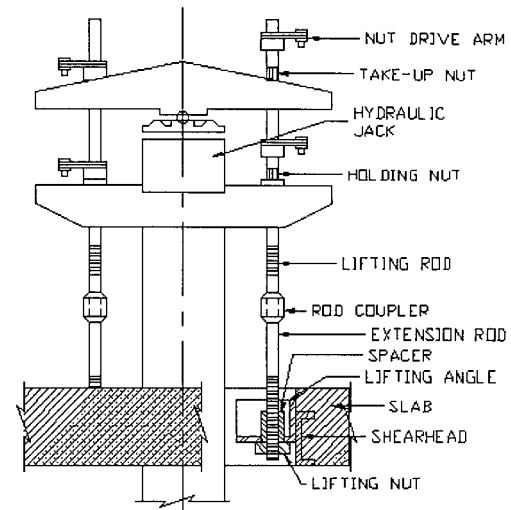
FIG. 4. Lifting Assembly

The NBS investigation concluded that the failure occurred at the building's most heavily loaded column, E4.8, or the adjacent column, E3.8, as a result of a lifting assembly failure (Fig. 4). The shearhead reinforces the concrete slab at each column, transfers vertical loads from the slabs to the columns, and provides a place of attachment for the lifting assembly. It consists of steel channels cast in the concrete slab, leaving a space for the lifting angle. The lifting angle has holes to pass the lifting rods through. These rods are raised by the hydraulic jacks on the columns above them (Levy and Salvadori 1992).

Shortly before the collapse, the workers lifted the 9th, 10th, and 11th floor package to its final position and began tack welding the steel wedges into place. They used a jack on top of the column, E4.8 or E3.8, to slightly adjust the position of the slab overloading the lifting angles. When the shearheads and lifting angles had lifted the package of three 3.13-MN (320-ton) slabs, they were dangerously close to their maximum capacity, so adding even the smallest of loads could strain them.

One of the reasons was that the lifting capacities of the two types of jacks used were too small for the 9.38-MN (960-ton) package being lifted. The regular jacks have a maximum load of 869 kN (89 tons), and the superjacks have a maximum load of 1.47 MN (150 tons). The NBS also tested the shearhead and lifting angle and found that they tended to twist as the loads approached 781 kN (80 tons) because, although strong enough, they were not stiff enough. The excess force deformed the lifting angle, allowing the jack rod and lifting nut to slip out of the lifting angle and hit the column with 333 kN (75,000 lb) of force. This accounts for the loud noise that Kenneth

Shepard heard and the indentation found in that column. After this initial slip, the jack rods and lifting nuts in the entire E line progressively slipped, causing the ninth floor slab to collapse, which initiated the collapse of the entire building (Korman 1987). This theory was later abandoned by NBS in favor of Theory 4 (Culver and Marshall 1994).

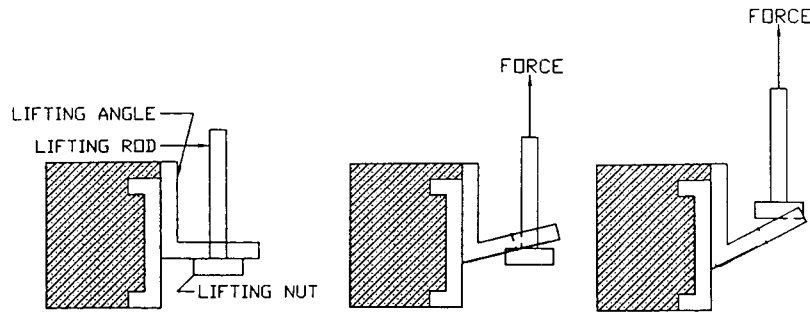
FIG. 5. Failure Sequence

On the day of collapse, the lateral load from the hydraulic jack exerted on the heavily loaded wedges caused the west wedge to roll. Then the local adjustments to slab elevations caused the remaining wedge to roll out, which initiated the collapse of the 11th floor and roof package and the west tower (Fig. 5). Forces transmitted through the pour strips or the horizontal jack, or the impact of the debris from the west tower triggered the east tower's collapse (Cuoco et al. 1992).

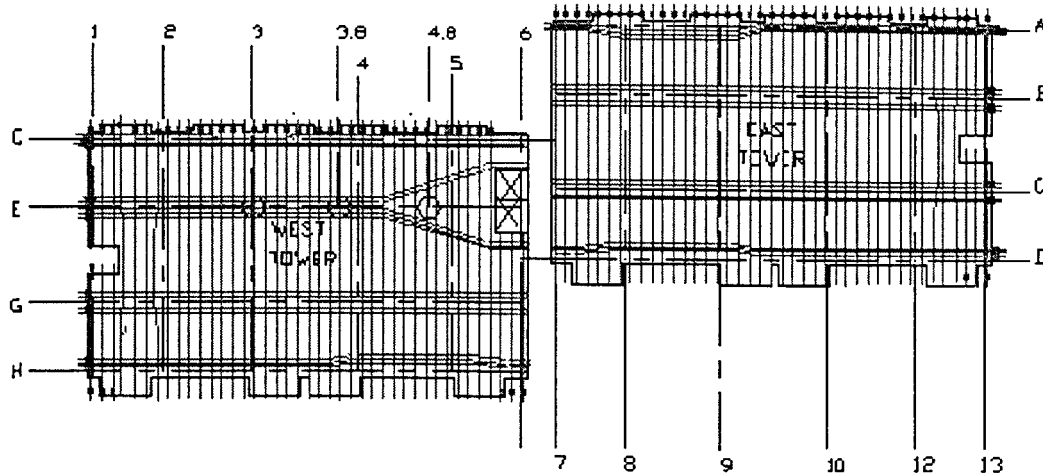
FIG. 6. General Layout of Posttensioning Tendons (Each Line Represents 1–5 Monostrand Tendons)

unusual layout of the posttensioning tendons (Fig. 6). The tendons in the east tower follow a typical two-way banded posttensioning tendon layout. In this layout the vertical tendons distribute the weight of the slab to the east-west column lines, which in turn distribute the weight to the columns. The west tower, however, deviates from this pattern. At Column 4.8E the tendons split in two, both diverging from the column line. In the west tower, the vertical tendons still distribute the slab's weight to the column line. In Line E, however, there are no tendons to carry this weight. This setup violates the building code of the American Concrete Institute, Detroit. Kaminetzky pointed out that the code stipulates "a minimum of two tendons shall be provided in each direction through the critical shear section over columns" (Kaminetzky 1991, p. 84).

Furthermore, the design details of the posttensioned floor slabs do not show the location of the shear walls or the openings for the walls at Columns 11A, 8A, and 2H. The design did not take these openings into account. Detailed finite-element analysis showed that tensile stresses along Column Line E, east of Column 4.8E, exceeded the cracking strength of the concrete. Therefore once a crack began, it would immediately spread to Column 4.8E. In addition, under ideal lifting conditions, the analysis demonstrated that column 2H would have unsuitably high compressive and punching shear stresses (Poston et al. 1991).

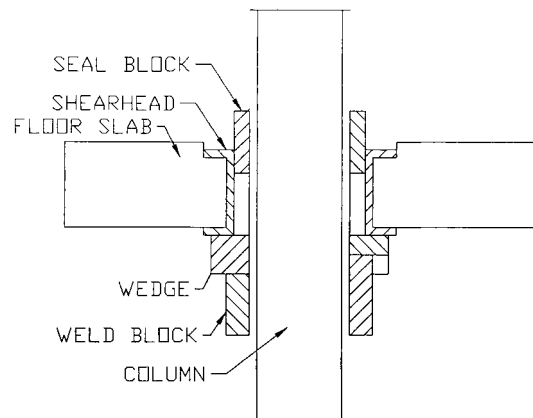
FIG. 7. Wedged Slab-to-Column Connection

OSHA found that the header bar-to-channel welds on one side of the ninth-floor shearhead, at Column E3.8, had failed (Fig. 7). The use of one-sided square-groove welds for the header bar-to-channel connection was criticized because they were not prequalified joints, according to the American Welding Society. Because their penetration was not known, their strength could not be determined. OSHA hired Neal S. More-

ton and Associates to examine 30 welds around the shearheads at Column E3.8 at the 7th, 8th, and 10th floors. They found only 13 of the 30 welds acceptable; the other 17 were substandard. The questionable weld details and substandard welding, coupled with drawings that indicated that the welds would undoubtedly experience forces that they could not resist, all point to weld failure as the trigger of the collapse (McGuire 1992).
