## Investigating Performance of Bonded Concrete Overlays

# INVESTIGATING PERFORMANCE OF BONDED CONCRETE OVERLAYS

By Norbert J. Delatte Jr.,<sup>1</sup> Member, ASCE, David W. Fowler,<sup>2</sup> Fellow, ASCE,  
B. Frank McCullough,<sup>3</sup> Member, ASCE, and Stefan F. Gräter<sup>4</sup>

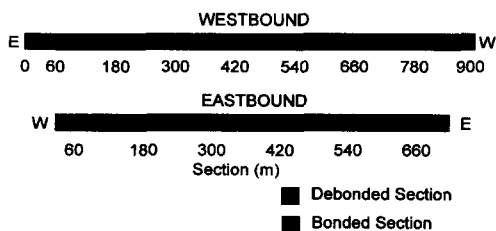
FIG. 8. Plan View of BCO Showing Overlay Bonding Condition

one westbound section was also delaminated. Fig. 8 shows a plan view of the project section, illustrating bonded and unbonded segments in both directions.

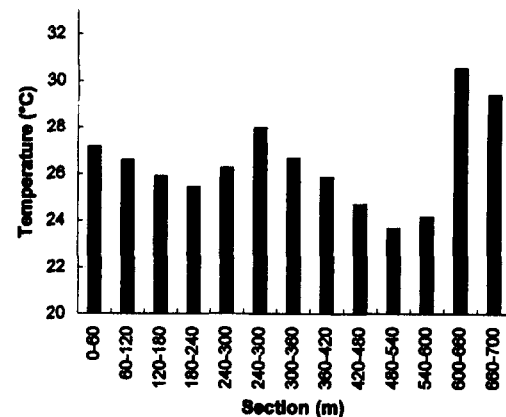
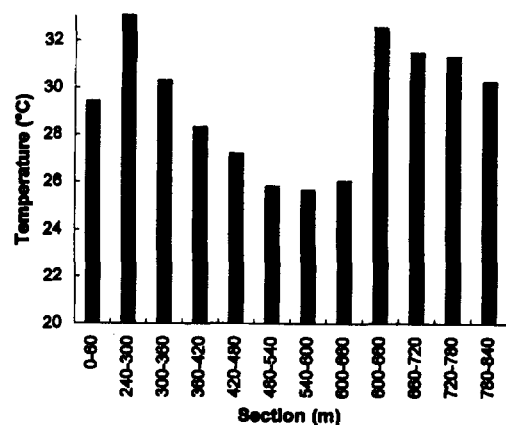
In order to find possible causes for the delamination, the weather station data gathered during the placement of the overlays were analyzed, as well as the concrete mix moisture content. Ambient temperatures and water evaporation rates were studied for the periods that concrete was placed. Information was provided by correlating the time of placement and the section placed. Figs. 9 and 10 present the average temperatures during the construction period for the eastbound and westbound lanes, respectively. The most critical temperatures occurred while the westbound lanes were overlaid, especially the 240–400 m section, which includes the only unbonded section in that direction, where the average temperature was 33°C. In the eastbound direction, the temperatures were not as high, but the two sections with highest temperature recordings (between 600 and 700 m) had unbonded segments.

FIG. 9. Average Ambient Temperatures during Eastbound Lane Construction

FIG. 10. Average Ambient Temperatures during Westbound Lane Construction

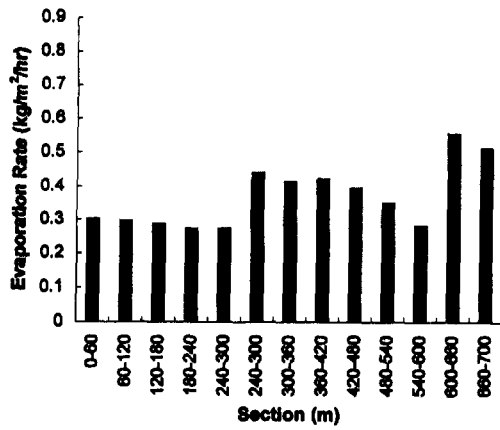
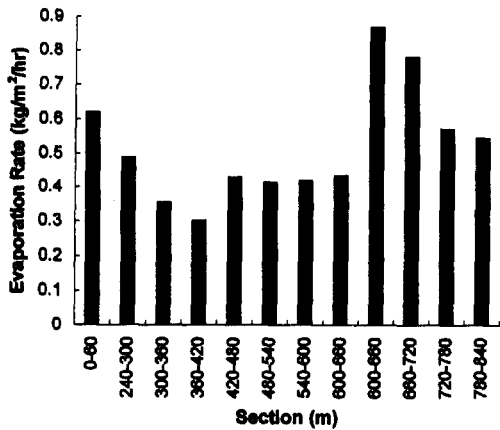
Figs. 11 and 12 show the average evaporation rates during overlay placement for the eastbound and westbound lanes, respectively. Water evaporation rate from freshly placed concrete is a function of the wind speed, air and concrete temperatures, and relative humidity. Evaporation rates of 1 kg/m<sup>2</sup>/h or greater are considered critical during overlay placement. In this case, none of the average values surpassed that standard, but there were higher evaporation rates associated with delaminated areas. The highest evaporation rate (0.88 kg/m<sup>2</sup>/h) occurred on the 600–660 m westbound section, which includes the unbonded part of the overlay.

Evaporation rates, in combination with the time elapsed between the overlay placement and the application of the curing compound, may have been a cause of the delamination. A mix

FIG. 11. Average Evaporation Rates during Eastbound Lane Construction

FIG. 12. Average Evaporation Rates during Westbound Lane Construction

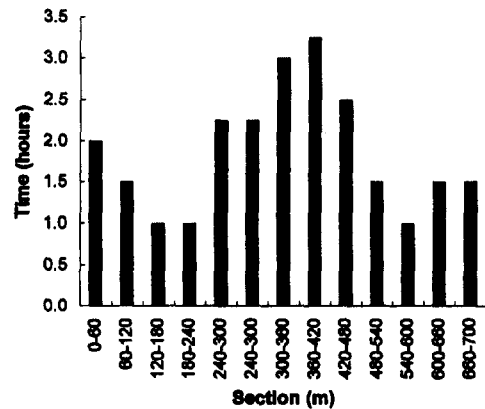
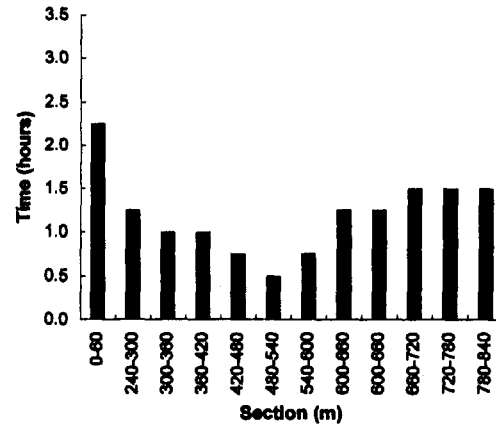
FIG. 13. Time between Concrete Placement and Application of Curing Compound on Eastbound Lane

that was dry to start with in order to satisfy the strength requirement may have lost critical water required for adequate adhesion. Figs. 13 and 14 illustrate the time after overlay construction until curing, for the eastbound and westbound lanes, respectively. In some cases, the surface of the overlay for the eastbound lanes lost moisture for about three hours before the curing process started. Limiting water loss to evaporation is an important construction aspect that should be carefully followed up to avoid delaminations in the future.

FIG. 14. Time between Concrete Placement and Application of Curing Compound on Westbound Lane

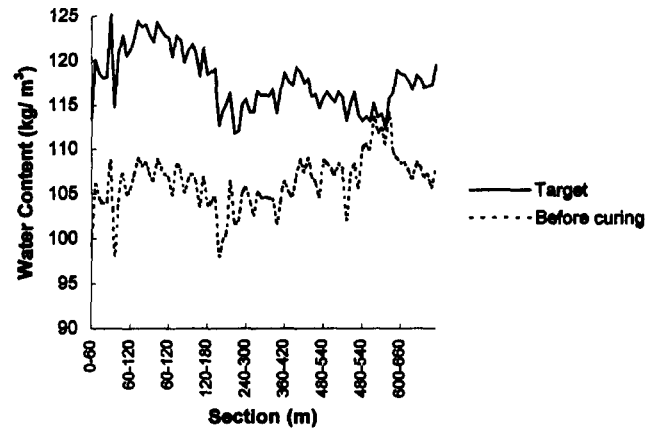
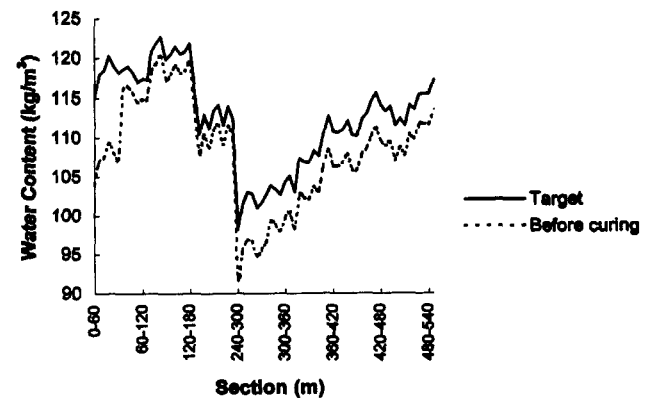
Water losses that occurred after the overlay was placed and before the curing compound was sprayed on are illustrated in Figs. 15 and 16. The mix design called for a water content of 138 kg/m<sup>3</sup>. The water content indicated in the figures as "target" is the water content for the mix after corrections for aggregate moisture content were made. An additional adjustment to the design water content was made by withholding water at the batch plant. The withheld water content varied from 13 kg/m<sup>3</sup> on the eastbound lane and 2 kg/m<sup>3</sup> on the westbound lane. The line in figures indicated by the legend "before curing" was calculated by subtracting the water withheld and the water that evaporated from the pavement before curing compound was applied, from the target value. The difference between the "target" and "before curing" water contents in the figures, therefore, indicate the amount of water absent from the mix at the time of curing as was specified by the mix design. This water deficiency resulted in a stiff mix that was not workable and had low adhesion.

FIG. 15. Design Water Content, Corrected for Aggregate Moisture Content (Target) and Actual Water Content at Time of Curing Compound Placement (before Curing) for Eastbound Lane

FIG. 16. Design Water Content, Corrected for Aggregate Moisture Content (Target) and Actual Water Content at Time of Curing Compound Placement (before Curing) for Westbound Lane

The data presented imply that the delamination of the overlay was due mainly to inadequate paste adhesion caused by deficiencies in surface preparation, materials, and curing. The loss in adhesion was caused by the low initial water content of the concrete mix compounded by the loss of available water to evaporation and by adsorption into the dry existing pavement, and to the action of withholding water from the mix at batching.
