INSTALLATION AND FIELD TESTING OF HIGH PERFORMANCE REPAIR
MATERIALS FOR PAVEMENTS AND BRIDGE DECKS

ANDREW LESAK

This study was sponsored by the Ohio Department of Transportation (ODOT), under a research contract titled “Evaluation of High Performance Pavement and Bridge Deck Wearing Surface Repair Materials”, State Job number 124816, Agreement number 25969. The research was also supported by Civil and Environmental Engineering Department, Washkewicz College of Engineering, and the College of Graduate Studies at Cleveland State University.

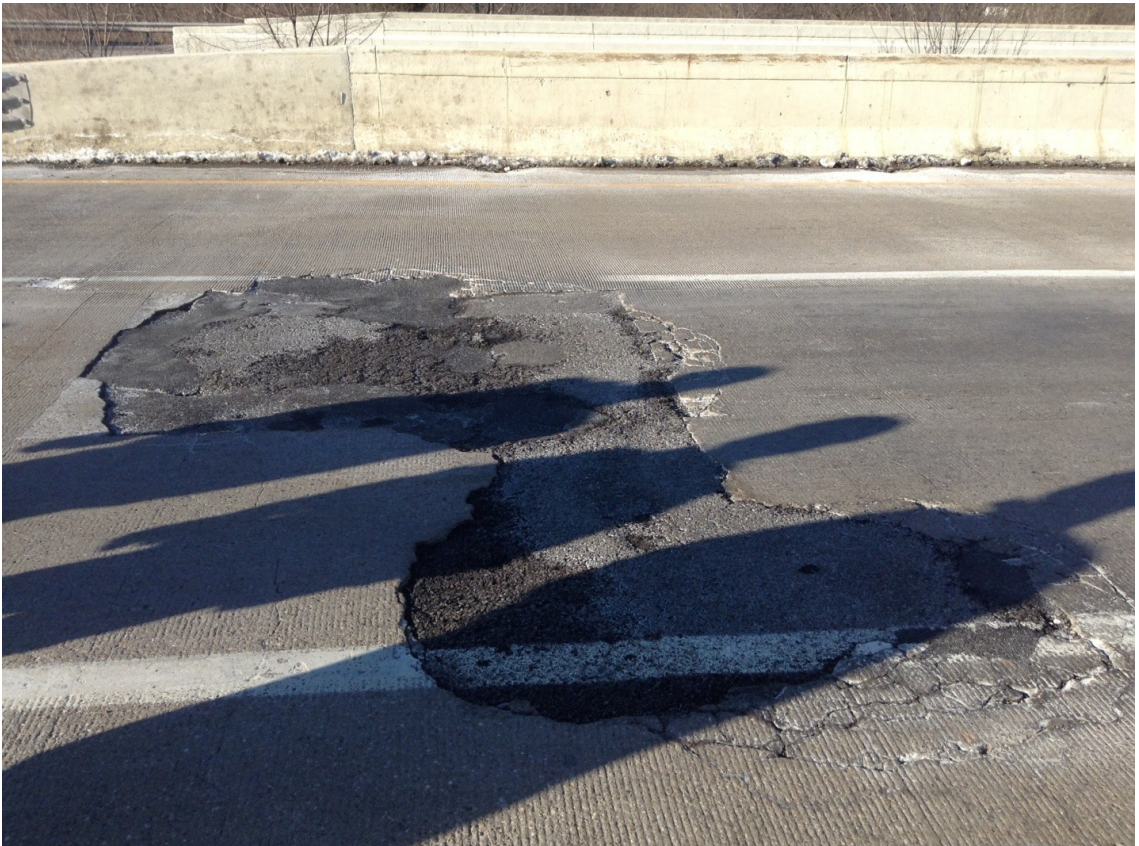
For the majority of the sections proposed for repair, shallow spalling failures of the concrete pavement are present. Where present, this failure was primarily in the right lane. At the bottom of the spalls, reinforcement can be seen in the concrete pavement. These shallow spalls were caused due to an error in placing the reinforcement too high, and not leaving sufficient cover between the reinforcement and the top of the pavement. A bridge deck was proposed to be repaired as well, due to the failure of a previously installed patch, seen in Figure 3.

Figure 3: Failing patch on bridge deck, before installation of new patches.

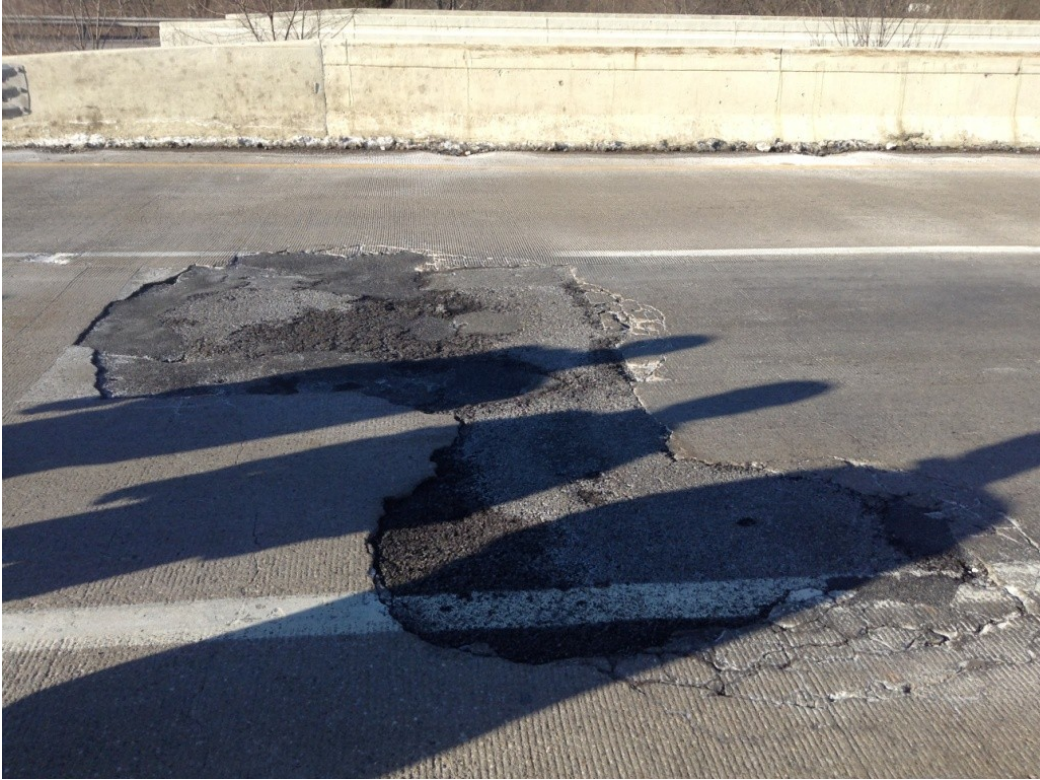
Figure 6: Previous patch deterioration, at location of patches #2 and #3.

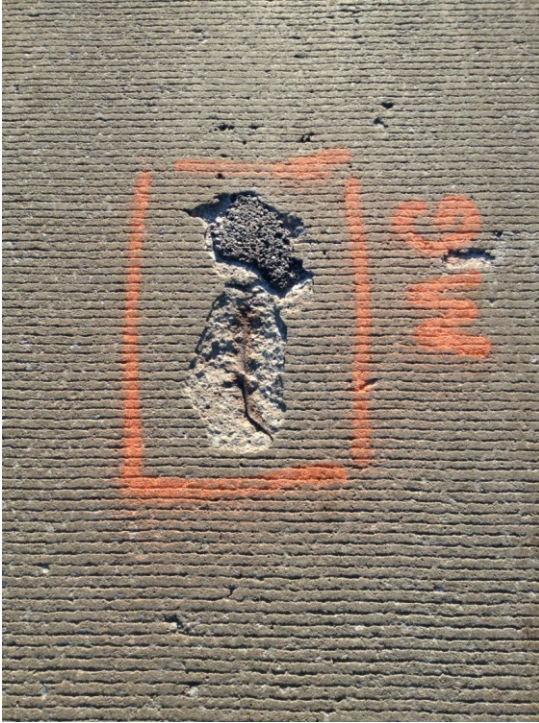
Figure 7: Spalling, at location of patch #6.

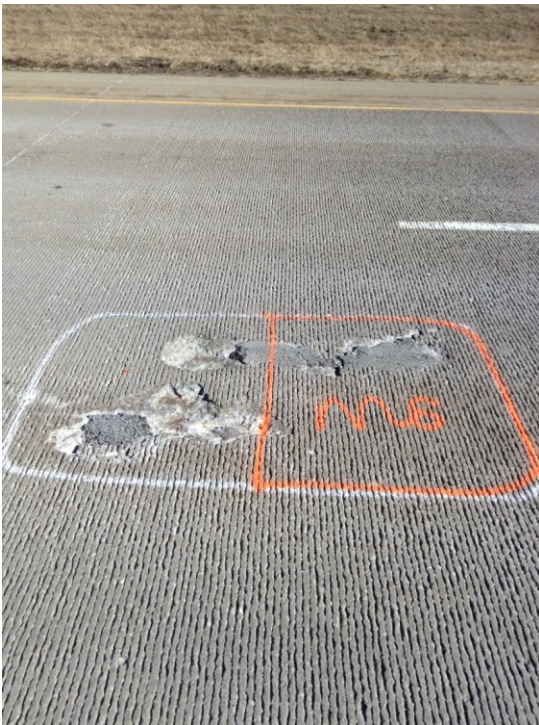
Figure 8: Spalling and potholes at location of patches #9 and #10.

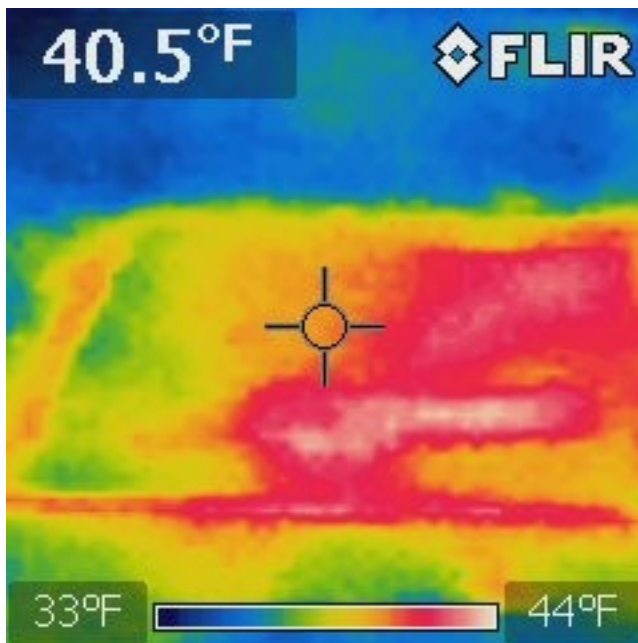
Figure 17 shows a picture from the infrared camera of patch #7, containing MG Krete. The heat distribution for this product tended to be uneven, with the focus of the heat towards the middle of the patch. The Quikrete and RepCon 928 products had similar heat distributions, likely due to all three of these products being similar cementitious materials. The difference in the heat from the middle to the outside of the patches for all three products was small, and likely will not affect the durability of the patches.

Figure 17: Infrared camera picture of patch #7, containing MG Krete, showing the temperature variation throughout the patch.

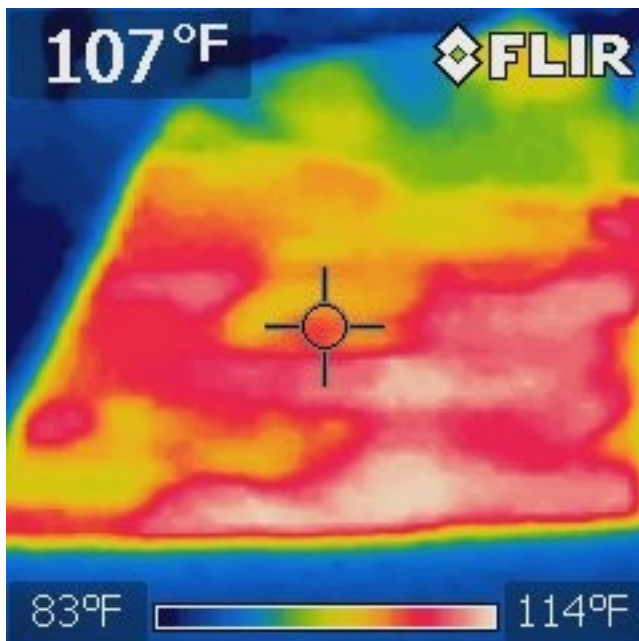
Similar to the FlexSet patches, the SR-2000 product had an even heat distribution throughout the patches, as seen in Figure 18. Figure 19 shows patch #34, containing the Delpatch product, with a fairly even heat distribution throughout the patch. This patch was nearly 7 feet (2.1 m) long, which would make the installation of the product take

longer than the smaller patches, which is likely why half of the patch shows higher heat than the other half.

Figure 19: Infrared camera picture of patch #34, containing Delpatch, showing the temperature variation throughout the patch.

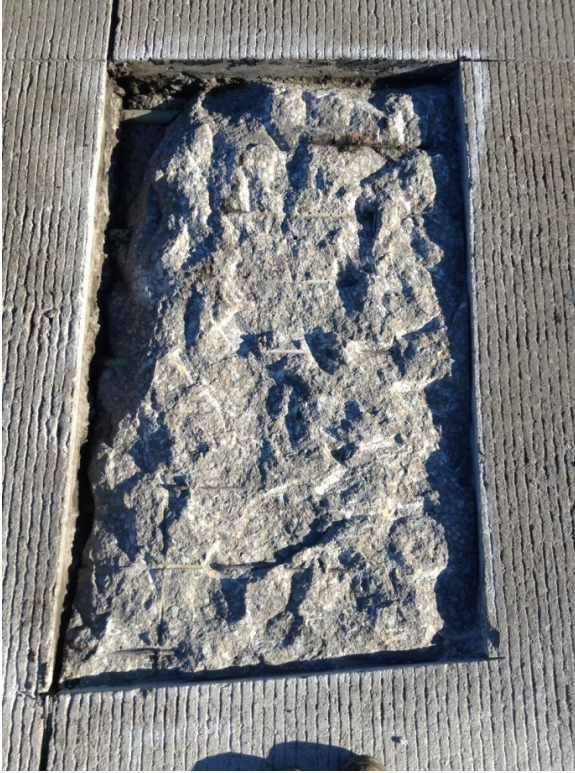
Five of the patches for this project were installed on original expansion joints. Two of these patches were at the corner of concrete pavement slabs, as seen in Figure 20 and Figure 21. The material used for patch #5, on the first expansion joint, was chosen to be Flex Set due to its promoted flexibility. The material used for patch #75 was RepCon 928, which is a polymer modified material. Patch #75 is on an expansion joint, in Figure 21, and it can be seen that there is a tie-bar and dowel that seems to be located too close together to the expansion joint. With the obvious future expansion of the expansion joints, it will be interesting to see the performance of these patches over the course of this project. It can also be seen in Figure 20 that the upper left corner of the patch hole, at the expansion joint, is visibly damp. This was not flame dried, and should be monitored throughout the project.

Figure 20: Patch #5, placed at an expansion joint, visibly damp at upper-left corner.

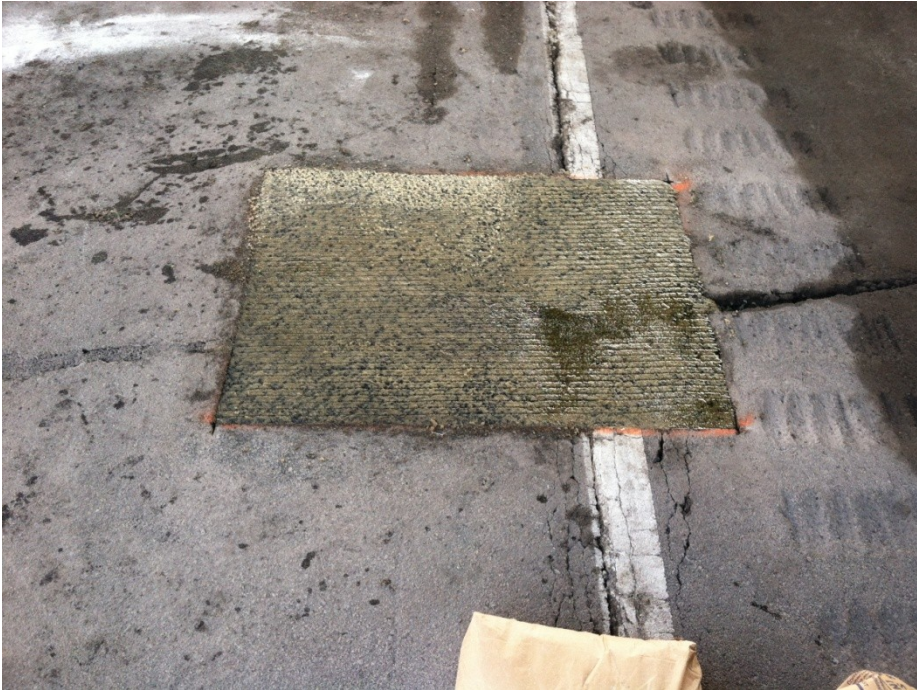
The other three patches installed over expansion joints were installed on asphalt pavement, with the SR-2000 product. These patches were placed over the joints, as seen in Figure 22, rather than along them. These patches will need to be closely monitored, especially throughout the winter.

Figure 22: Patch #16, containing SR-2000, placed over an expansion joint.

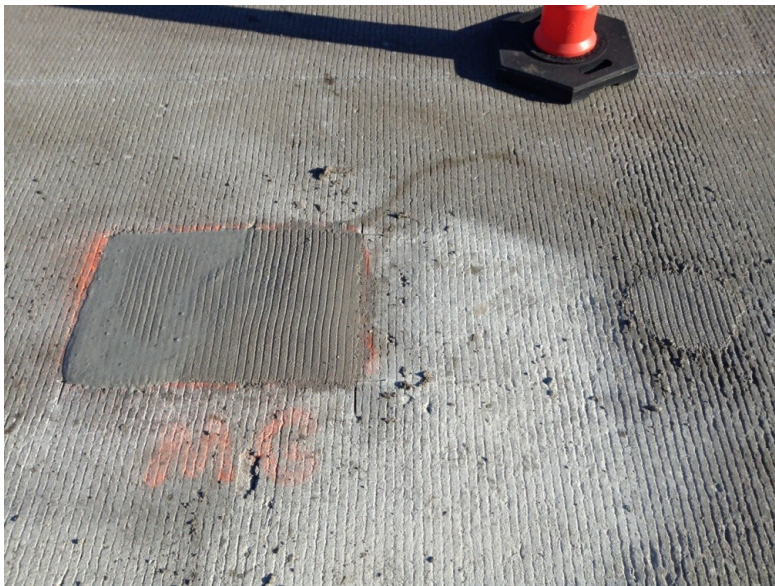
estimated half of a bag and half of a bottle into a 5 gallon (19 liter) bucket that was used to mix the material, which caused consistency differences throughout the installation of the MG Krete patches. Due to this, some of the mixes ended up being denser than others, and some ended up being 'watery.' For some of the smaller patches, this ended up causing an issue with tining the patch after the installation, because part of the patch had too much liquid in it and caused the patch to flow into the tines. This can be seen below in Figure 23, where the left half of patch #6 was wet due to improper mixture proportions. The material had to be left to sit for a while before the left half of the patch was tined. Whether or not this affects the strength, durability, or longevity of the MG Krete patches is unknown at this point, but will be determined throughout the course of this project.

Figure 23: Patch #6, constructed with MG Krete, showing bleeding in the left half of the patch due to improper mixture proportions.

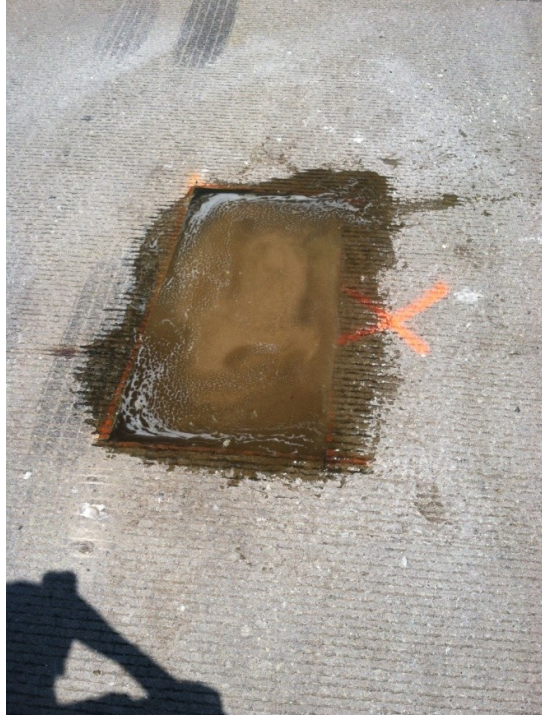
For the majority of the patches that were installed with SR-2000, the surface after the patch was installed was difficult to finish. The patches tended to float a liquid to the top of the patch, so the patch could not be tined effectively. The topping sand was mostly absorbed by the liquid and sank below the top of the patches. Most of the patches that were installed with the SR-2000 ended up being aesthetically ugly, smooth, shiny, and wet looking, even after being traffic ready. Patch #26 can be seen in Figure 24, which shows these issues.

Figure 24: Patch #26, containing SR-2000, bleeding liquid.

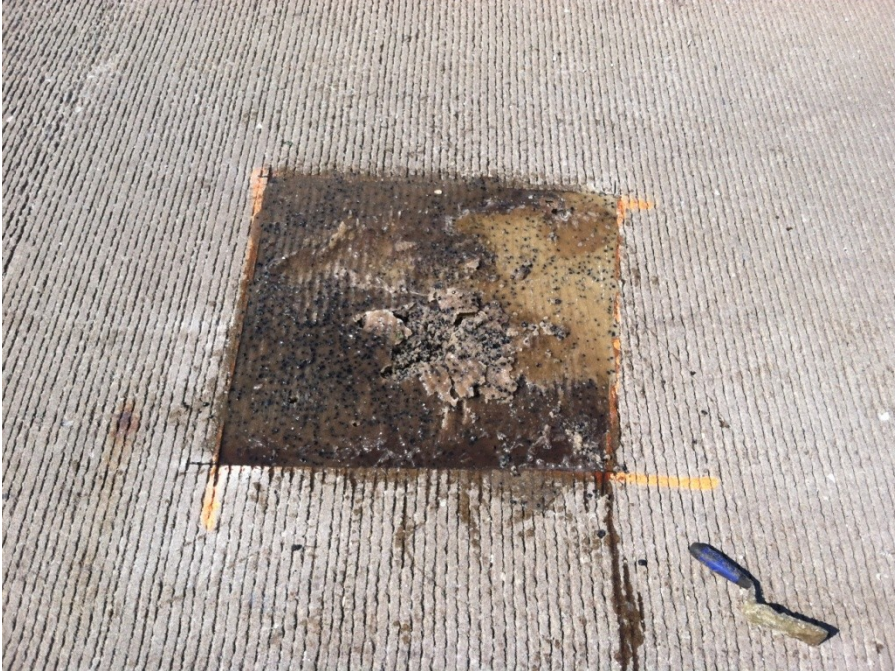
Patch #21, constructed with SR-2000, did not set after it was filled. Over 5 hours after the patch was installed only a thin layer on the top of the material was partially hard. Taking a stick, a hole was easily poked through the top layer of the material. Patch #21 with the material that did not set, before it was refilled, can be seen in Figure 25. The hole was then cleaned out with a shovel and refilled. Likely, the material that was put into the hole the first time did not have enough of the activator liquid added, so the material did not cure. The remnants of the bad batch were difficult to remove.

Figure 25: Patch #21, containing SR-2000, in which the entire patch did not set. The patch was cleared and refilled after the patch did not set over the course of 5 hours.

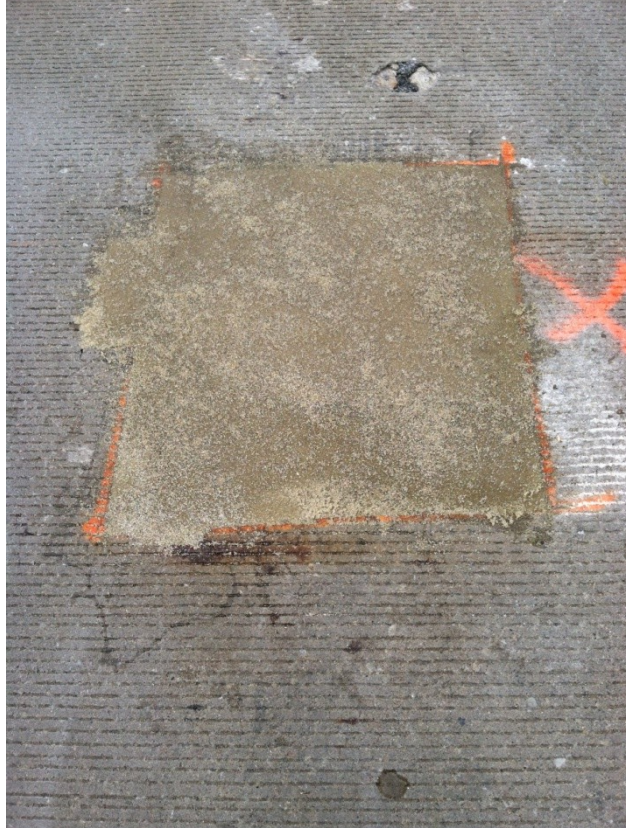
After patch #29 was installed, a spot of delamination was detected in the concrete pavement next to the middle right of the patch. This is a sign of potential spalling occurring next to this patch, which could cause damage to the patch. Patch #24 had what was observed as two loose batches of the SR-2000 product when it was installed. Also, patch #30 had an extension (ear) added onto the originally marked out rectangle, which may in the future lead to a cracking failure. Figure 26 shows the extension to the patch.

Figure 26: Patch #30, containing SR-2000, showing an extension (ear) on the middle left of the patch.

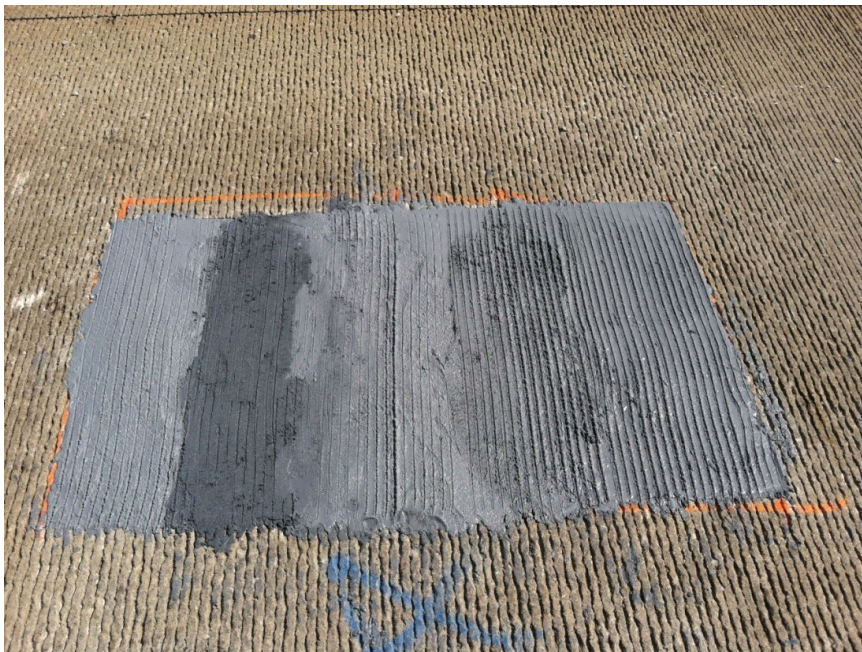
A batch of Delpatch that was mixed for patch #36 came out darker than normal, and it set faster than the average batch of Delpatch. This indicates that either too much of patch B was added to this batch mixture, or too little of part A was added. This was suggested by the fact that part A is a clear liquid, while part B is a black and darker liquid, and that the set time for the project would decrease with a higher than usual part B to part A ratio. The integrity of this patch is likely still strong; however, it is less aesthetically pleasing. A picture of the darker section on patch #36 can be seen in Figure 27.

Figure 27: Patch #36, containing Delpatch, showing a dark spot due to batch completed with improper material measurements.

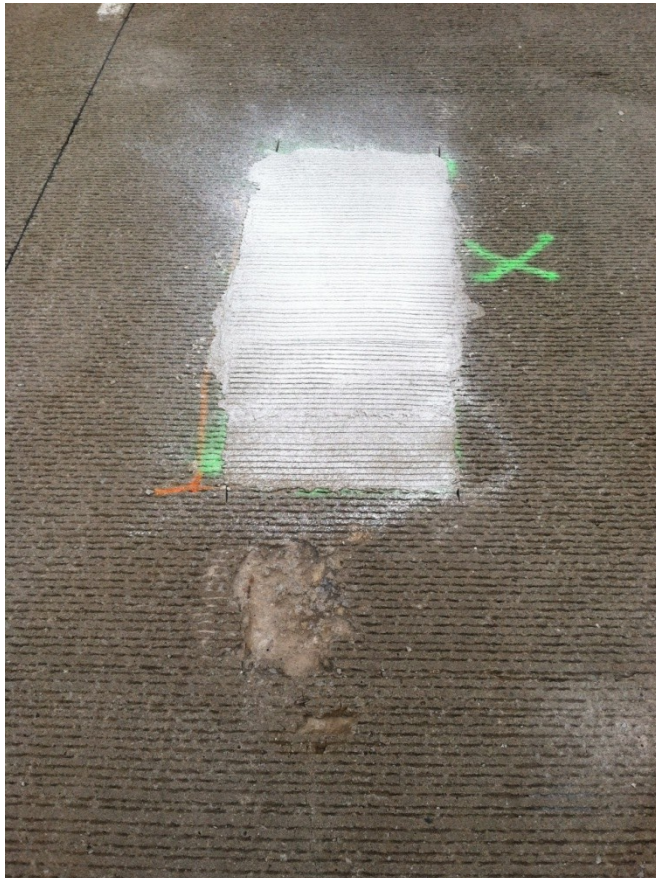
Patches #66 and #67 were installed with soupy batches, relative to the rest of the patches installed. The area between a pothole and Patch #68 detected delamination, and might cause a problem at the front of the patch if the area spalls. This section of delamination can be seen in Figure 28.

Figure 28: Patch #68, containing FastSet DOT Mix, with a pothole in front of it. Delamination was detected between the patch and the pothole after installation.

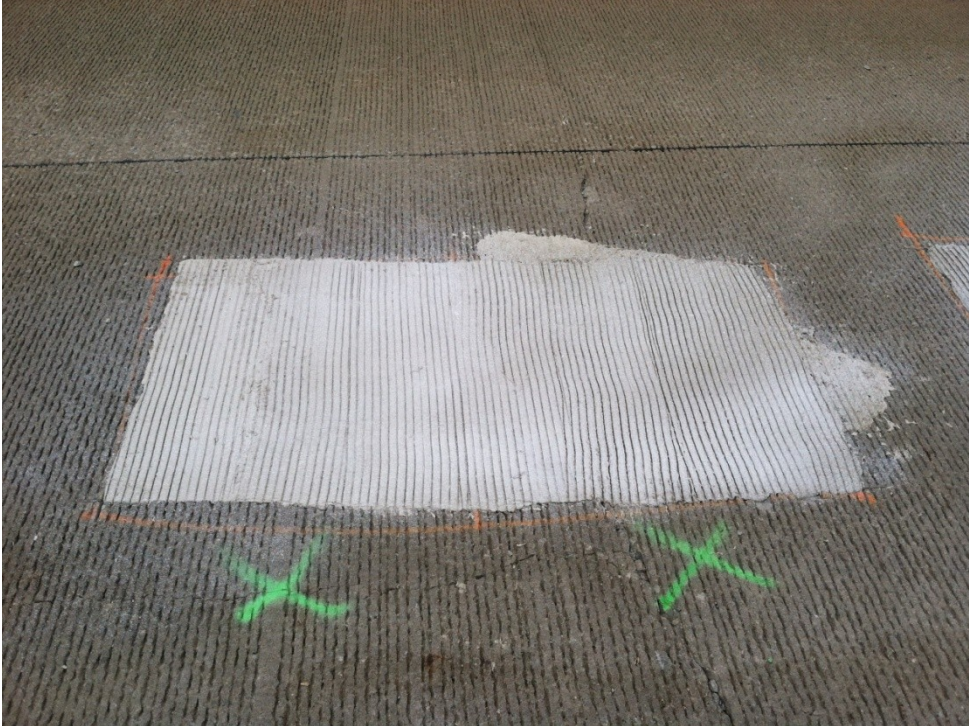
A small crack, as seen in Figure 29, ran through the pavement at the location of patch #64. Whether or not this causes a crack in the patch in the future is unknown. The crack can be seen running from the top right of the slab in the figure, down under the patch

and to the left of the green 'X' on the right. Also, the last batch of FastSet DOT Mix that was added to this hole was loose.

Figure 29: Patch #64, containing FastSet DOT Mix, with a crack running through the concrete slab and under the patch.

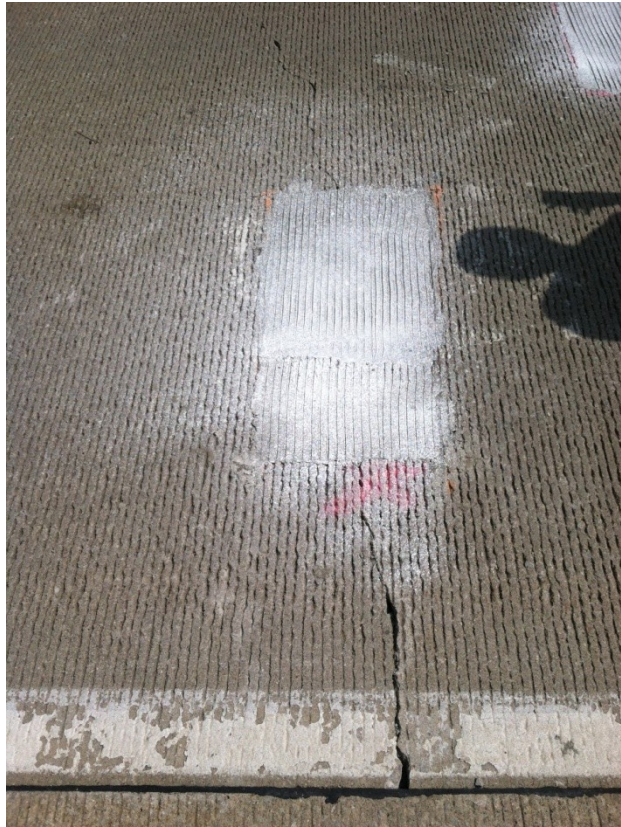
have around one foot (0.3 m) of pavement between them. Lastly, patch #76 had a large crack running through the middle of the hole, spanning the entire width of the slab. This crack can be seen in Figure 30.

Figure 30: Patch #76, containing RepCon 928, with a large slab crack running through the middle of the patch.

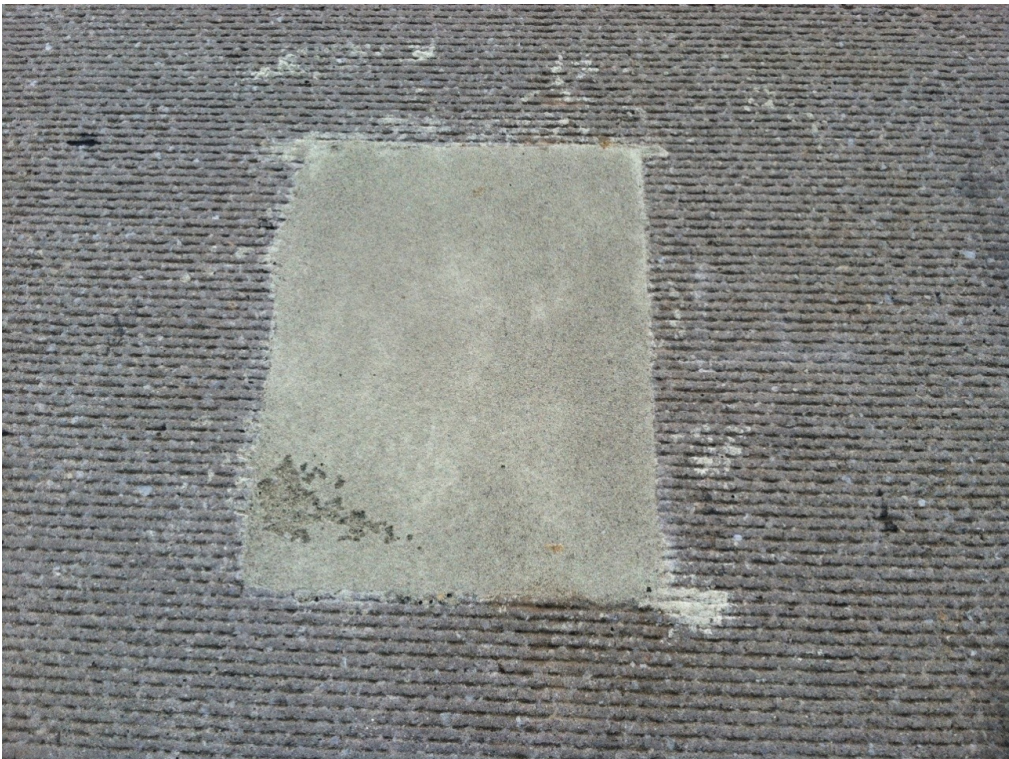
small section at the bottom left of patch #8 shows part of the surface of the patch missing. Figure 31 consists of a picture of patch #8 from the first inspection. The second inspection did not show the spalling area increase much, compared to the first inspection, for all three of the patches that showed spalling. None of the new patches showed spalling during the second inspection.

Figure 31: Patch #8, constructed with Flex Set, showing slight surface spalling on the bottom left of the patch.

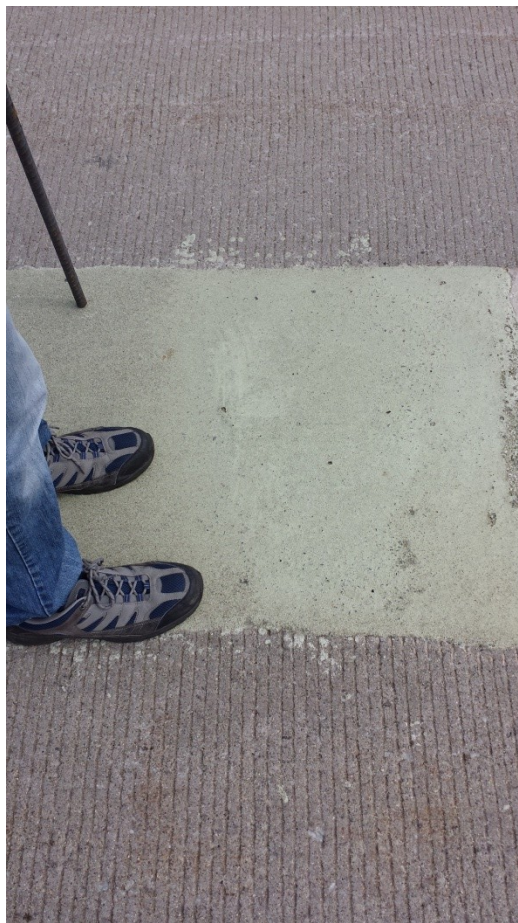
the other Flex Set patches. Figure 32 shows the rebar test being performed on patch #14, with the rebar pointing to the area that failed the rebar test. During the summer installations, in June, the delamination test was performed on patch #14 with the Delam 2000, and no delamination was detected anywhere on the patch. These areas of patches #11 and #14 should be monitored throughout the project; however, delamination, or debonding, does not seem to be present, as of the July inspection, at any of the FlexSet patches. The Delam 2000 was used on all of the Flex Set patches during the second inspection, and all of the patches passed this test.

Figure 32: Performing the rebar test on patch #11, containing Flex Set, with the rebar placed over the area that failed the rebar test.

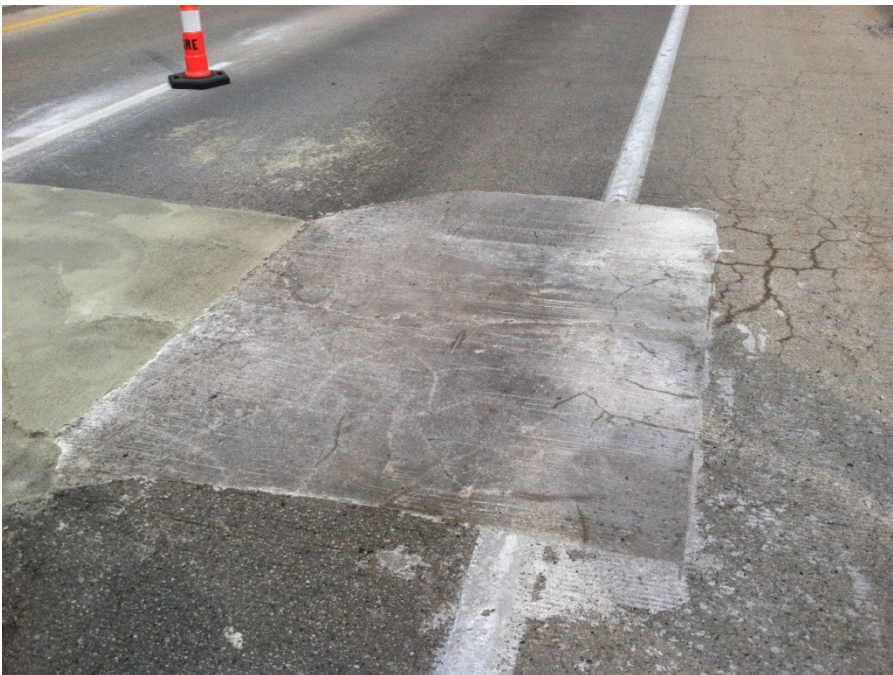
Patch #1, on the bridge deck, had the most of the small surface cracks, which was also expected due to the large size and depth of the patch. Figure 33 shows patch #1 two and a half months after the winter installation, where multiple cracks can be seen on the surface of the patch. Figure 34 shows a crack on patch #1 being measured at 1/32 inches (0.79 mm) wide. The entire patch passed the delamination test.

Figure 33: Patch #1, containing MG Krete, and showing cracking 2.5 months after installation.

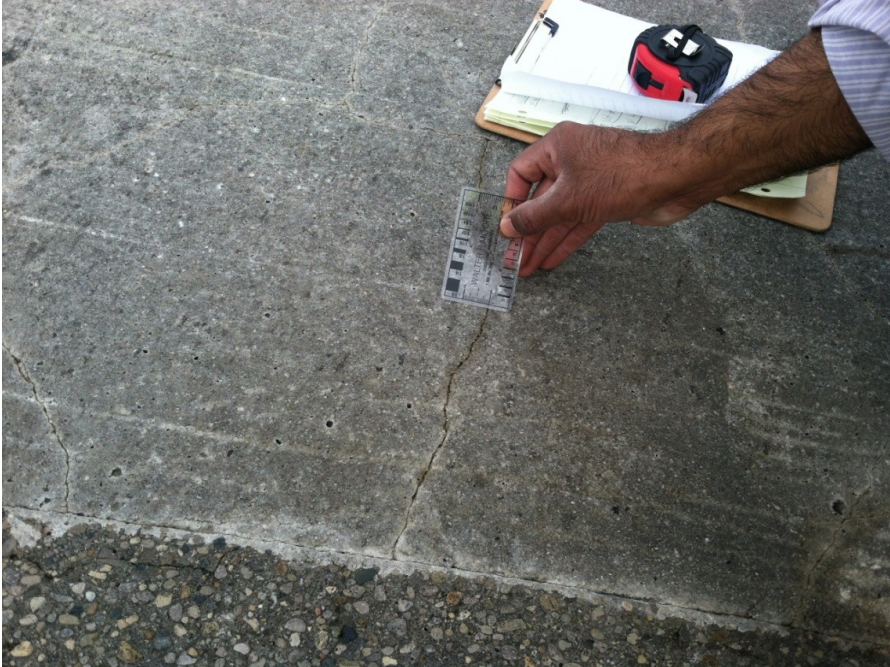
Figure 34: Patch #1, containing MG Krete, and showing a crack that is approximately 1/32 inches (0.79 mm) wide, 2.5 months after installation.

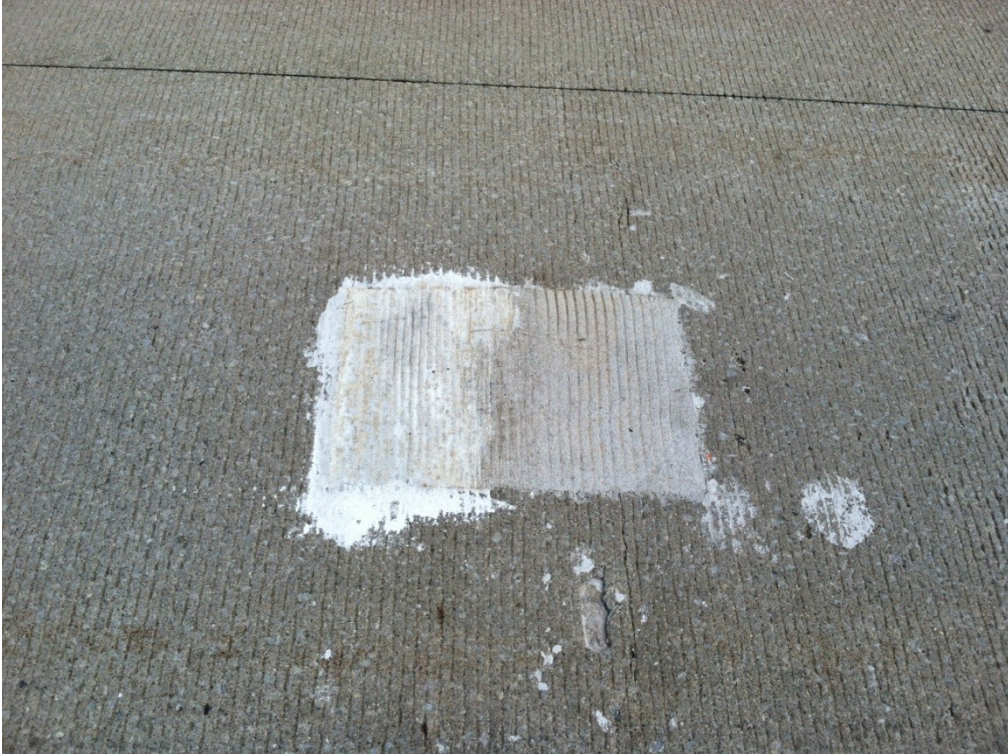
Patch #6, which had improper mixture proportioning at the time of the winter installation, was solid and showed no signs of failure. The west half of patch #6, seen on the left of the patch pictured in Figure 35, shows that the improper proportioning is still visible, but there is no noticeable difference in strength and durability between the two halves of the patch. The delamination test produced the same positive results for both halves of the patch, indicating it was well bonded.

Figure 35: Patch #6, containing MG Krete, with the improper mixture proportioning still visible.

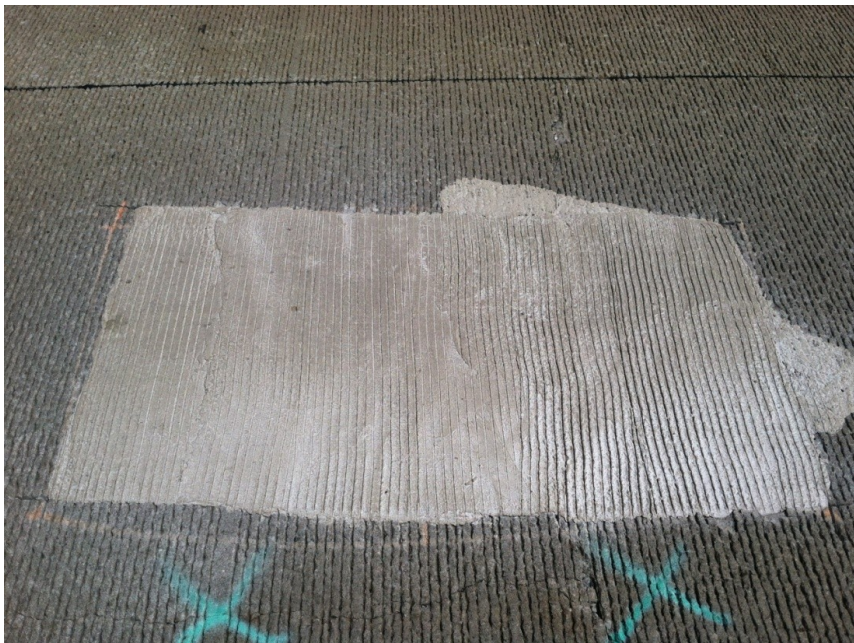
The FastSet DOT Mix installed patches had two patches that had cracks form through them, patches #64 and #65. These cracks were small and expected, and were formed by cracks already present in the concrete pavement in which the patches were placed on. The crack in the pavement around patch #64 can be seen on the right side of the patch in Figure 36, but the crack through the patch following the crack through the pavement is difficult to see as it is not very wide. The FastSet DOT Mix patches also passed the delamination test, and showed no signs that would suggest concern for possible failure.

Figure 36: Patch #64, consisting of FastSet DOT Mix, with a small crack through the patch.
