Ronan Point Apartment Tower Collapse and its Effect on Building Codes

Cynthia Pearson¹ and Norbert Delatte, M.ASCE²

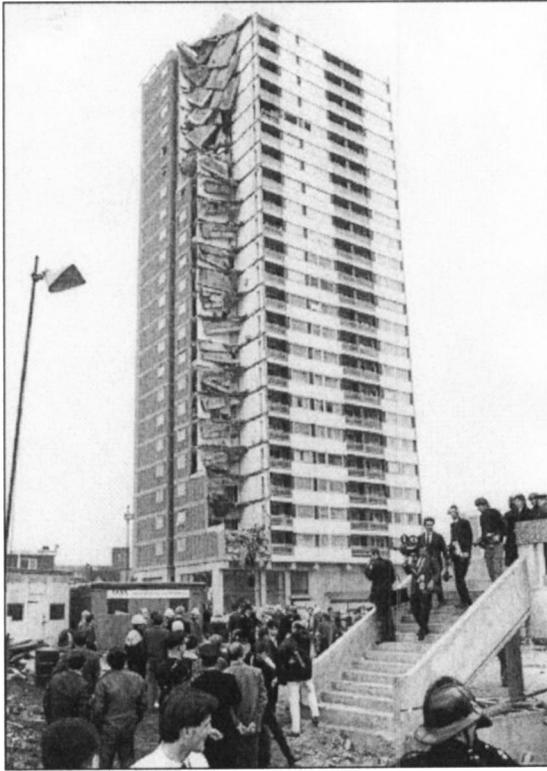
The pressure of the small gas explosion blew out the walls of her apartment, and initiated a partial collapse of the structure that killed four people and injured 17. One of the injured, an 82-year-old woman, subsequently died, but possibly not due to the collapse (Griffiths et al. 1968). The partially collapsed structure is shown in Fig. 1. The floor plan for apartment 90 is provided in Fig. 2.

Fig. 1. Ronan Point after collapse

The collapse was initiated by a gas-stove leak on the 18th floor in apartment 90. The resident struck a match and was knocked unconscious by the resulting explosion. The force of the explosion knocked out the opposite corner walls of the apartment. These walls were the sole support for the walls directly above. This created a chain reaction in which floor 19 collapsed, then floor 20, and so on, propagating upward. The four floors fell onto level 18, which initiated a second phase of the collapse. This

sudden-impact loading on floor 18 caused it to give way, smashing floor 17 and progressing until it reached the ground.

The southeast corner of Ronan Point was rebuilt as a separate section of apartments and then joined to the existing building by means of walkways. Ronan Point was reinforced with blast angles as part of the reconstruction. The blast angles added are shown in Fig. 4, on the right side. Gas was also banned from Ronan Point.

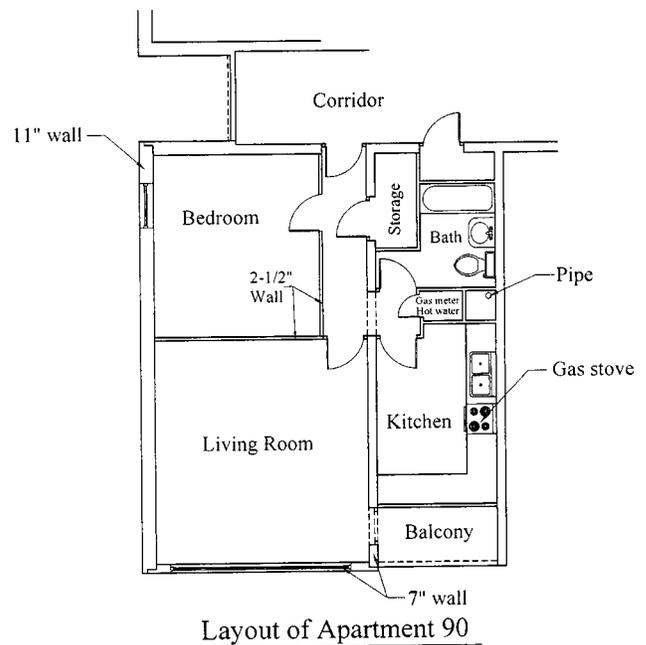
Fig. 2. Floor plan of apartment (based on Bignell [1977] and Levy and Salvadori [1992])

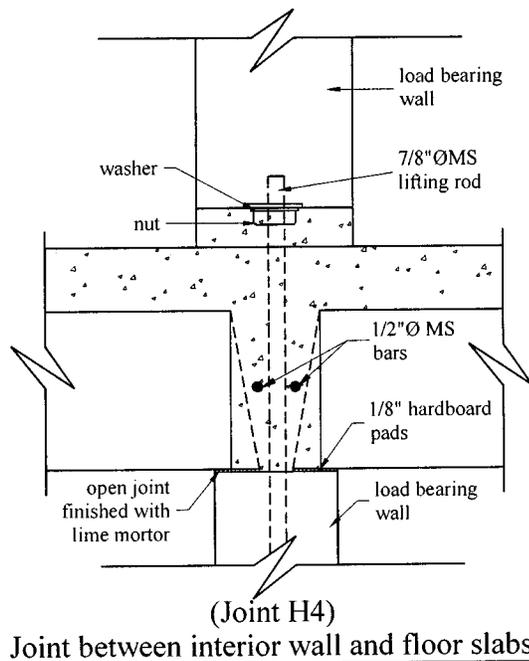
Ronan Point was one of many identical high-rise precast concrete flat-plate structures constructed during this time. In this type of structural system, each floor was supported by the load-bearing walls directly beneath it. Gravity load transfer occurred only through these load-bearing walls. The wall and floor panels fitted together in slots. These joints were then bolted together and filled

with dry-pack mortar to secure the connection. The connections are shown in Figs. 3 and 4.

Fig. 3. Interior joint (based on Wearne [2000], Bignell [1997], and Levy and Salvadori [1992])

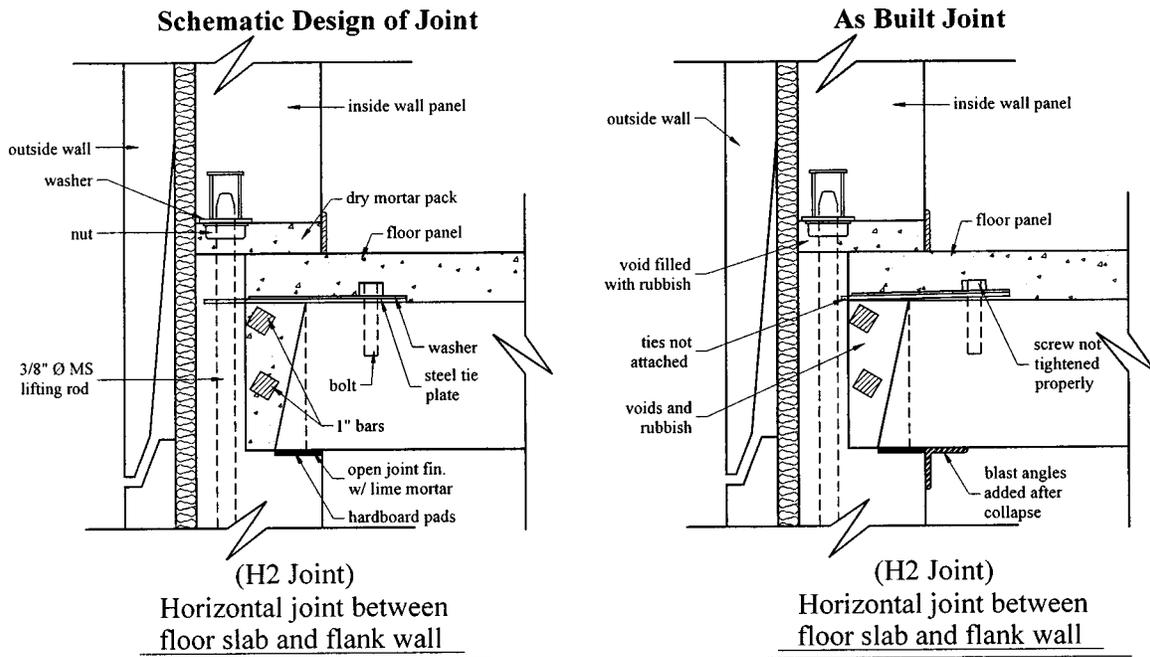
A shocked Webb commented: “I knew we were going to find bad workmanship—what surprised me was the sheer scale of it. Not a single joint was correct. Fixing straps were unattached; leveling nuts were not wound down, causing a significant loading to be transmitted via the bolts; panels were placed on bolts instead of mortar. But the biggest shock of all was the crucial H-2 load-bearing joints between floor and wall panels. Some of the joints had less than fifty percent of the mortar specified” (Wearne 2000). Wearne (2000) provides a complete account of Webb’s work investigating Ronan Point.

Fig. 4. Exterior joints (based on Wearne [2000], Bignell [1997], and Levy and Salvadori [1992])
