Ronan Point Apartment Tower Collapse and its Effect on Building Codes

Cynthia Pearson¹ and Norbert Delatte, M.ASCE²

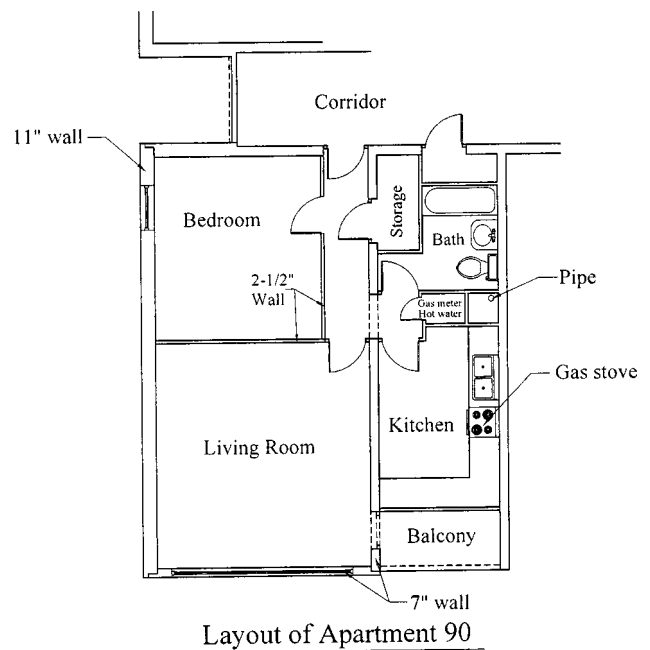
Fig. 2. Floor plan of apartment (based on Bignell [1977] and Levy and Salvadori [1992])
