Developing Improved Bridge Parapet Designs

Lauren A. Hedges
Cleveland State University

submitted in partial fulfillment of requirements for the degree
MASTER OF SCIENCE IN CIVIL ENGINEERING
at the
CLEVELAND STATE UNIVERSITY
May 2014

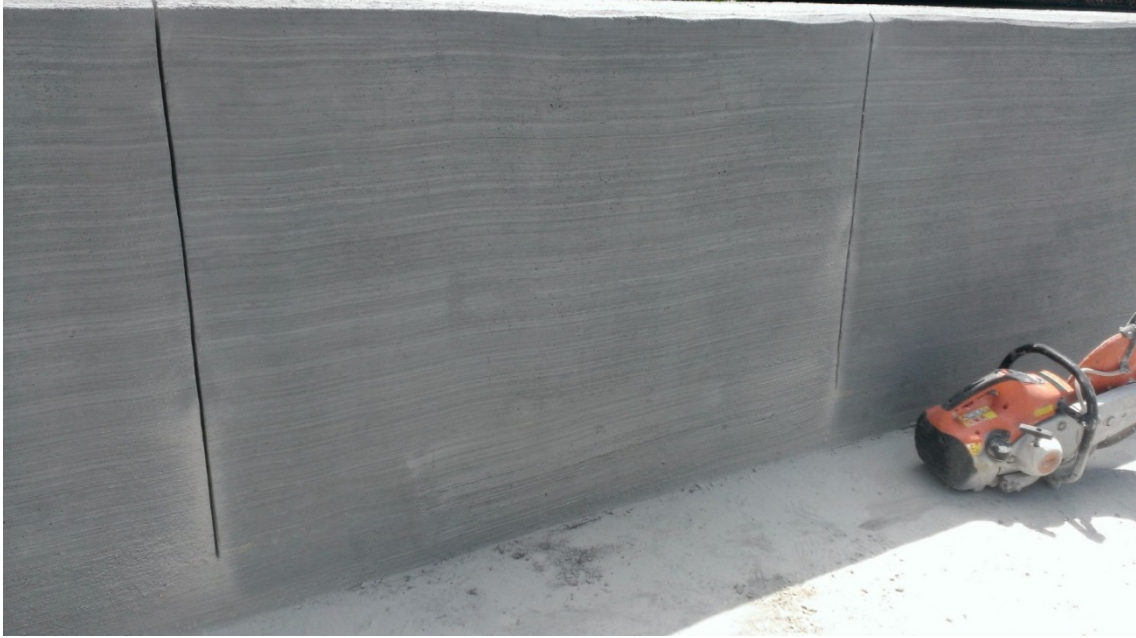
Before starting the curing process, the concrete structure should be properly finished once the formwork is removed. This is an important step in the construction process that can affect the risk of cracking. Plastic shrinkage should be taken into consideration at this time, however, ensuring that the concrete does not dry out. Additionally, extra water or cement paste should not be added to help finish the concrete, (ACI 224R-01, 2001). An example of a properly finished concrete parapet can be seen in Figure 1 below.

Figure 1: Finished Bridge Parapet (Photo Provided by Lauren Hedges)

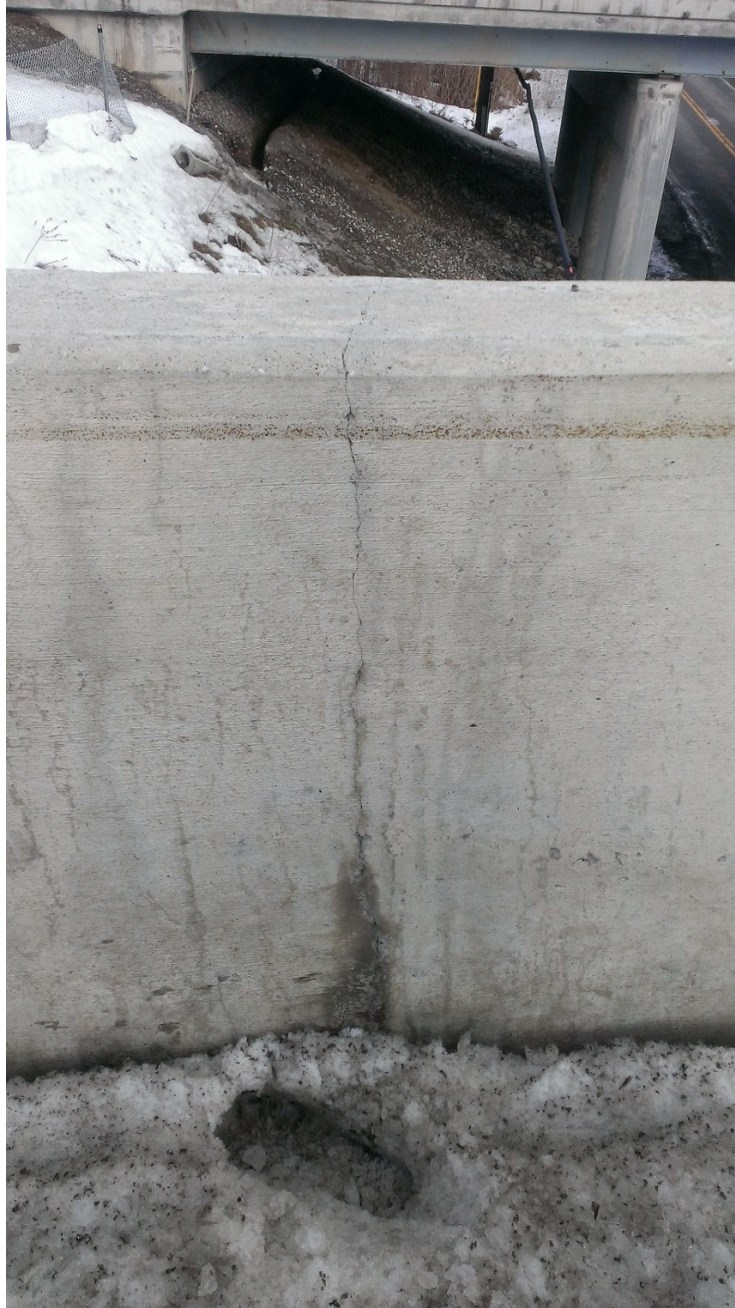
District 12 in ODOT is not the only district to have experienced problems with parapet cracking. Additional information was collected from ODOT District 8, which is located in the Southwest portion of Ohio. According to Brandon Collett, P.E. and structures planning engineer for District 8, many bridge parapets located in their district also suffer from prominent vertical cracking (Brandon Collett, P.E., personal communication, October 21, 2013). An example of the vertical cracking seen in these districts can be seen in Figure 2.

Figure 2: Vertical Parapet Cracking (Photo Provided by Lauren Hedges)

Many of the older bridges with these cracks were seen upon were constructed through the use of slip forming. Slip forming is the construction of a parapet with the use of pulling or lifting a form while concrete is placed. The machine moves at a slow but

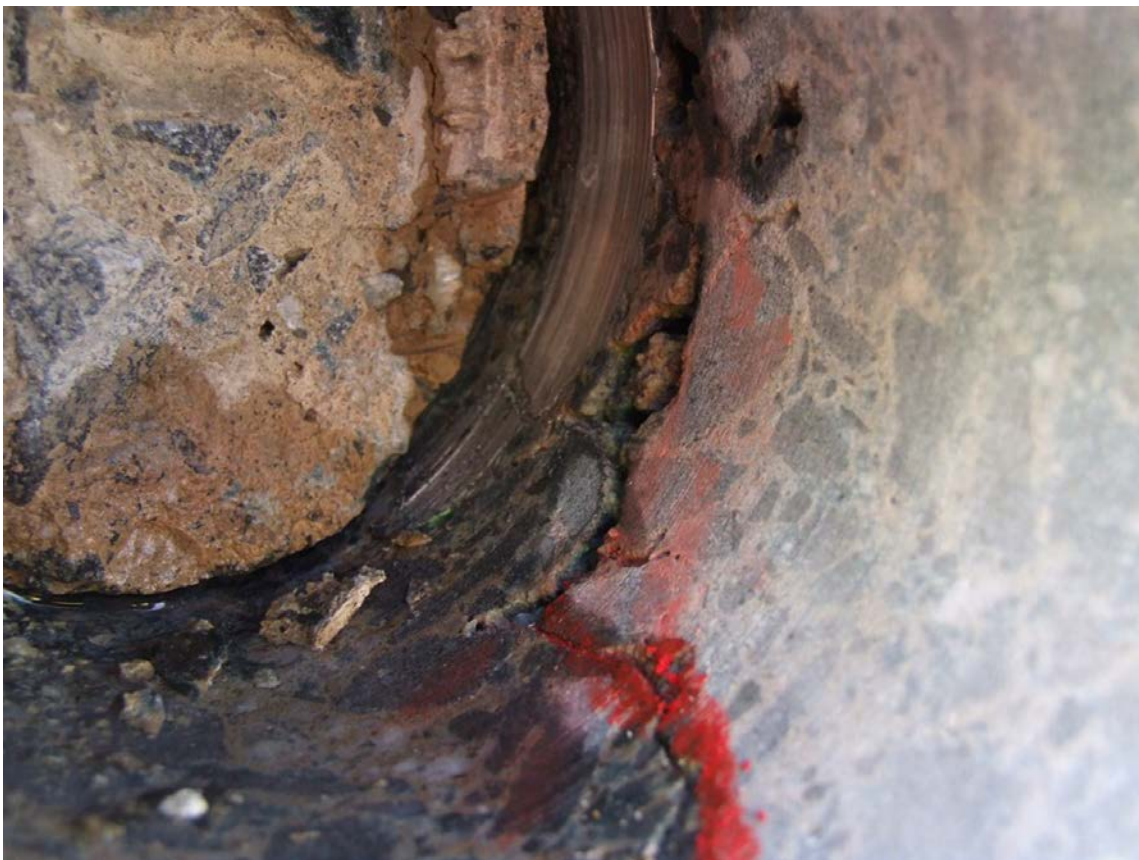
The parapets were also subject to vertical cracks as wide as 0.05 inches (1 mm). Two core samples were taken at the location of where the cracks can be seen. For both cores, concrete voids were present around the vertical rebar, as seen in Figure 3 below. Because the parapets were constructed using the slip forming method, it is thought that the voids may have occurred due to the low slump and poor vibration methods not allowing the concrete to flow around to the underside of the vertical rebar (Saraf, 2013).

Figure 3: I-95 Parapet Concrete Void (Photo Provided by Fawaz K. Saraf, P.E.)

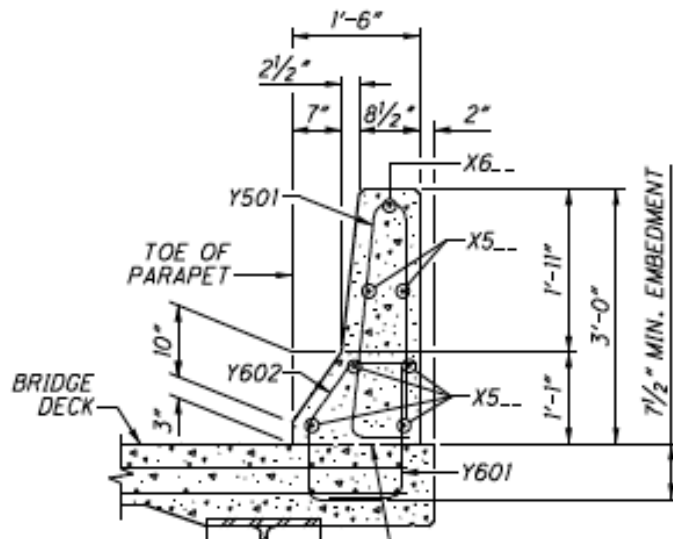
Vertical rebar will run along the backside of the parapet and bend over the top piece of rebar. The vertical rebar should be placed every twelve inches along the length of the parapet. Two additional pieces of rebar will extend into the bridge deck for a minimum of 7 ½” (191 mm) of embedment. All vertical rebar should be #5 (16 mm) in size.

There should be at least 2 ½” (64 mm) of concrete cover on all edges of the parapet. The profile view of ODOT’s bridge parapet can be seen in Figure 4 (ODOT, 2013).

Figure 4: Ohio Department of Transportation Parapet Profile (ODOT, 2013)

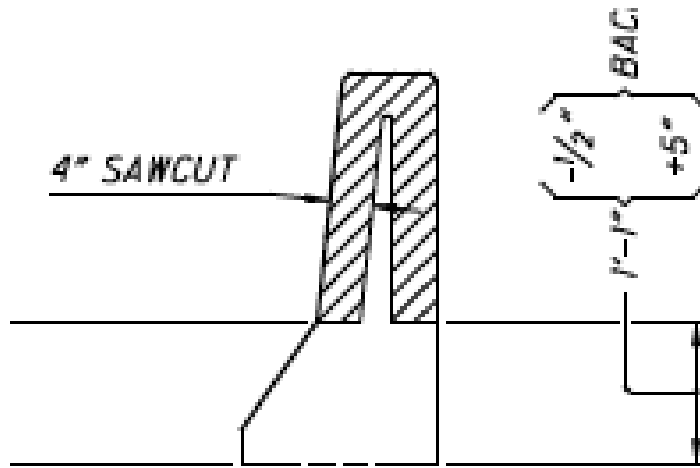
If GFRP is being used, then once the parapet has cured a saw cut of 4” (102 mm) must be performed. Contractors may also choose to do a full depth saw cut, but must stop 1’-1” (330 mm) above the bridge deck. A profile view of the GFRP saw cut perimeter can be seen in Figure 5.

Figure 5: GFRP Saw Cut Perimeter Profile (ODOT, 2013)

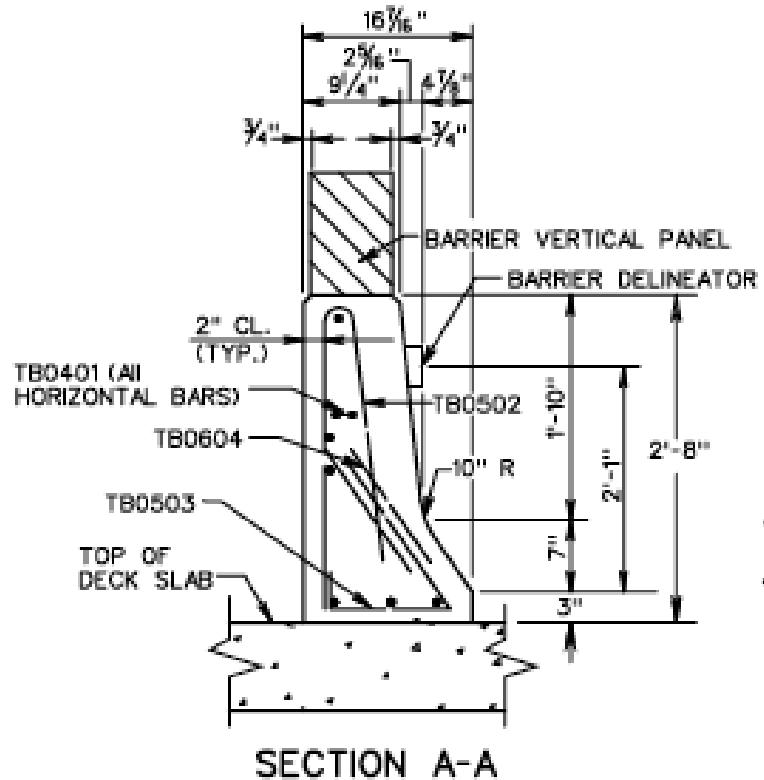
The parapet will also be constructed of vertical #5 (16 mm) rebar that will bend over the horizontal rebar. The vertical rebar will be spaced every 12" (305 mm). All

reinforcement should be reinforcing steel grade 60. There should be a minimum 2" (51 mm) of concrete cover on the flat face of the parapet, as seen in Figure 6 (VDOT, 2008).

Figure 6: Virginia Department of Transportation Parapet Profile (VDOT, 2008)

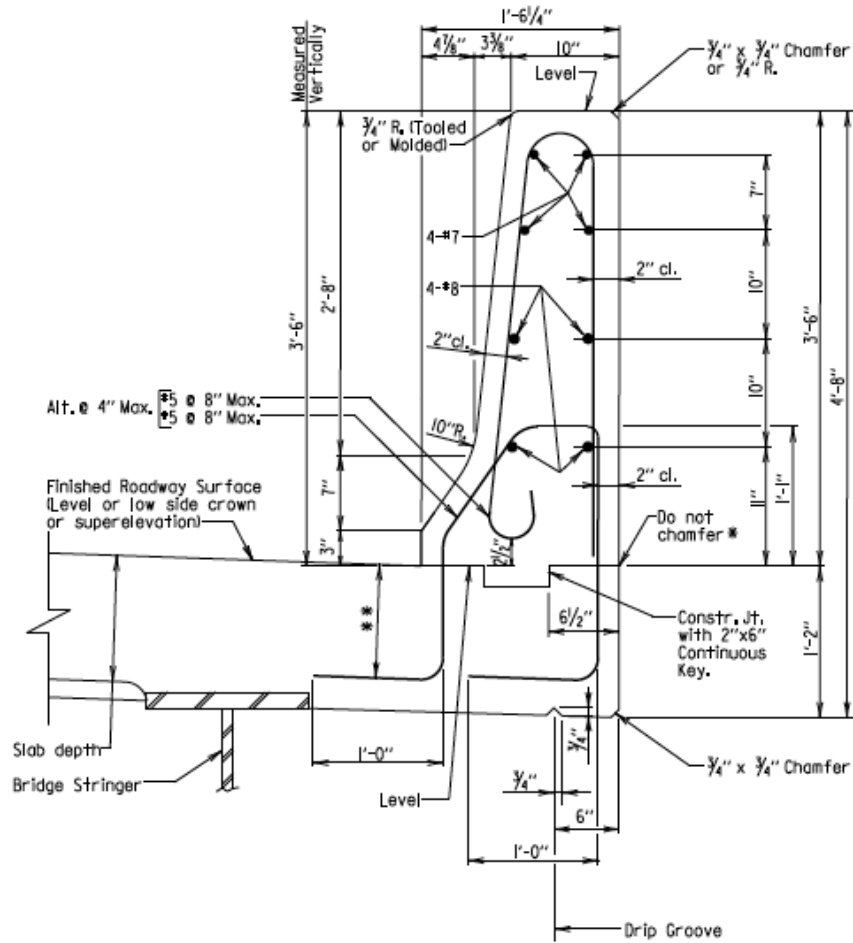
Vertical #5 (16 mm) rebar that bends over all the horizontal rebar is also required and placed at a maximum of 8" (200 mm). Additional vertical #5 (16 mm) rebar is required at the bottom of the parapet, bending over the bottom two pieces of horizontal rebar and extends into the deck slab. This rebar is also placed at a maximum of every 8" (200 mm) and is offset from the other set of vertical rebar by 4" (100 mm). There is two inches (50

mm) of cover on the vertical rebar. The profile view of Maryland's bridge parapet can be seen in Figure 7 (Maryland DOT, 2012).

Figure 7: Maryland Department of Transportation Parapet Profile (Maryland DOT, 2012)

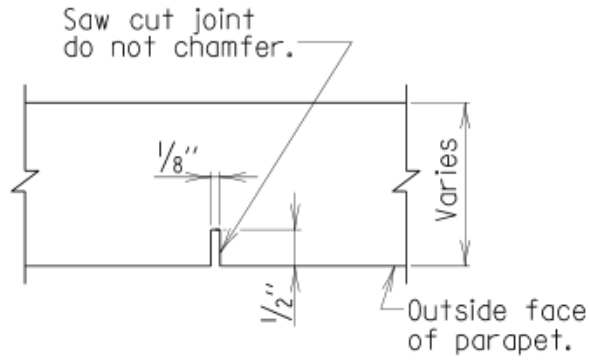
Construction joints are to be spaced 20' (6.1 m) apart. Also, joints are to be placed at the center of each railing panel when railing is used. Joints are to be cut 1/2" (13 mm) deep and 1/8" (3 mm) thick, as seen in Figure 8.

Figure 8: Maryland DOT Joint Cut Depth (Maryland DOT, 2012)

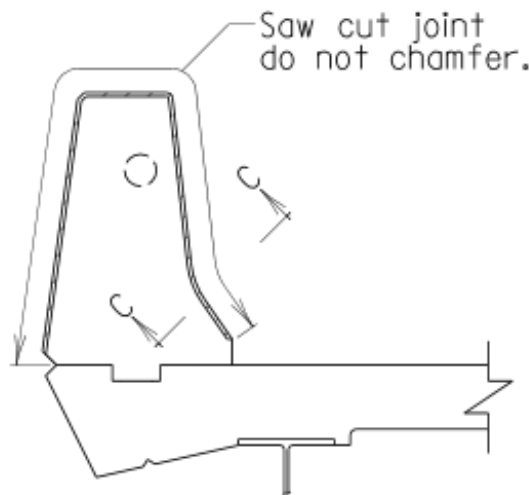
The saw cut control joint should be sawed the same day concrete is poured. The joint should be cut all the way around the parapet, including both front and back faces. An example of the saw cut joint length can be seen in Figure 9 (Maryland DOT, 2012).

Figure 9: Maryland DOT Saw Cut Length (Maryland DOT, 2012)

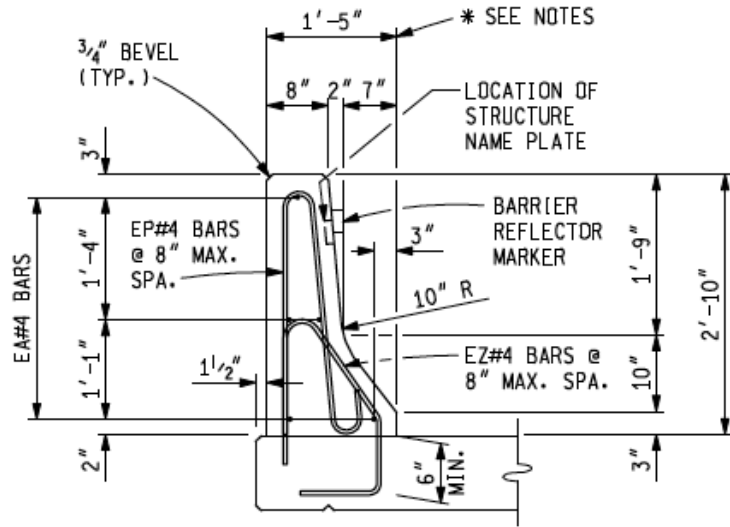
SECTION A-A

The Michigan Department of Transportation specifies that bridge parapets are to be 2'-10" (864 mm) tall. The bottom of the parapet is 1'-5" (432 mm) and tapers to a width of 8" (203 mm) at the top. Five horizontal pieces of #5 (16 mm) rebar are required, which is a total cross-sectional area of 1.55 in² (1,000 mm²). The horizontal pieces require 3" (76 mm) of cover from the edges, and a minimum lap length of 1'-4" (406 mm) to ensure the reinforcing steel is continuous (Michigan DOT, 2013).

The parapet design also specifies that #4 (13 mm) vertical rebar is required to bend around the horizontal rebar. This vertical rebar can be spaced at a maximum of 8" (200 mm). Another piece of vertical rebar is required at the bottom of the parapet, and must extend into the bridge deck a minimum of 6" (152 mm). The profile view of Michigan's bridge parapet can be seen in Figure 10 (Michigan DOT, 2013).

Figure 10: Michigan Department of Transportation Parapet Profile (Michigan DOT, 2013)

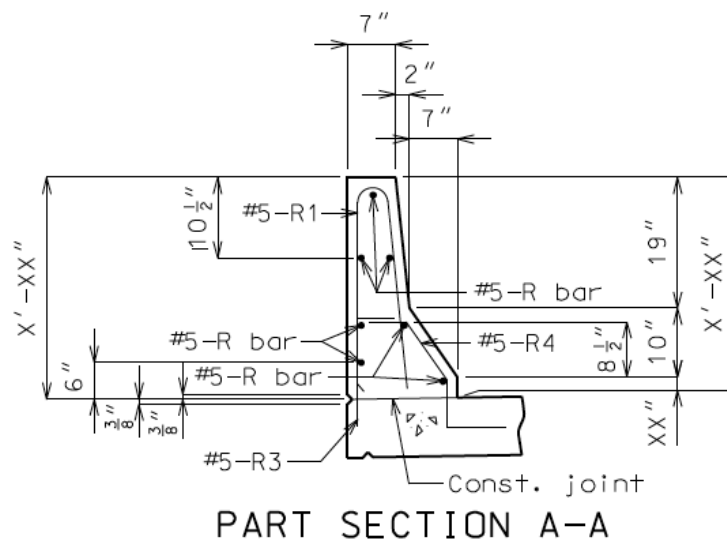
Additionally, there is vertical rebar that bends over the horizontal rebar and extends into the bridge deck. The vertical rebar are also sized #5 (16 mm), and should be spaced at $12''$ (305 mm) and must have $1 \frac{1}{2}''$ (38 mm) of cover. The profile view of Missouri's bridge parapet can be seen in Figure 11 (MODOT, 2012).

Figure 11: Missouri Department of Transportation Parapet Profile (MODOT, 2012)

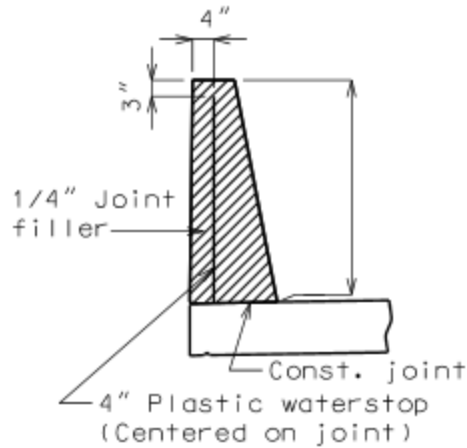
Construction joints are used for parapets throughout Missouri. A joint must be placed above each pier, and an additional joint will be placed on each side of the pier. These additional joints will be spaced $10'$ (3 m) from the pier. Construction joints are cut all the way through the parapet and stop $3''$ (76 mm) above the deck of the bridge. It is also noted that a $\frac{1}{4}''$ (6 mm) joint filler must also be used, as seen below (MODOT, 2012).

Figure 12: MODOT Construction Joint (MODOT, 2012)

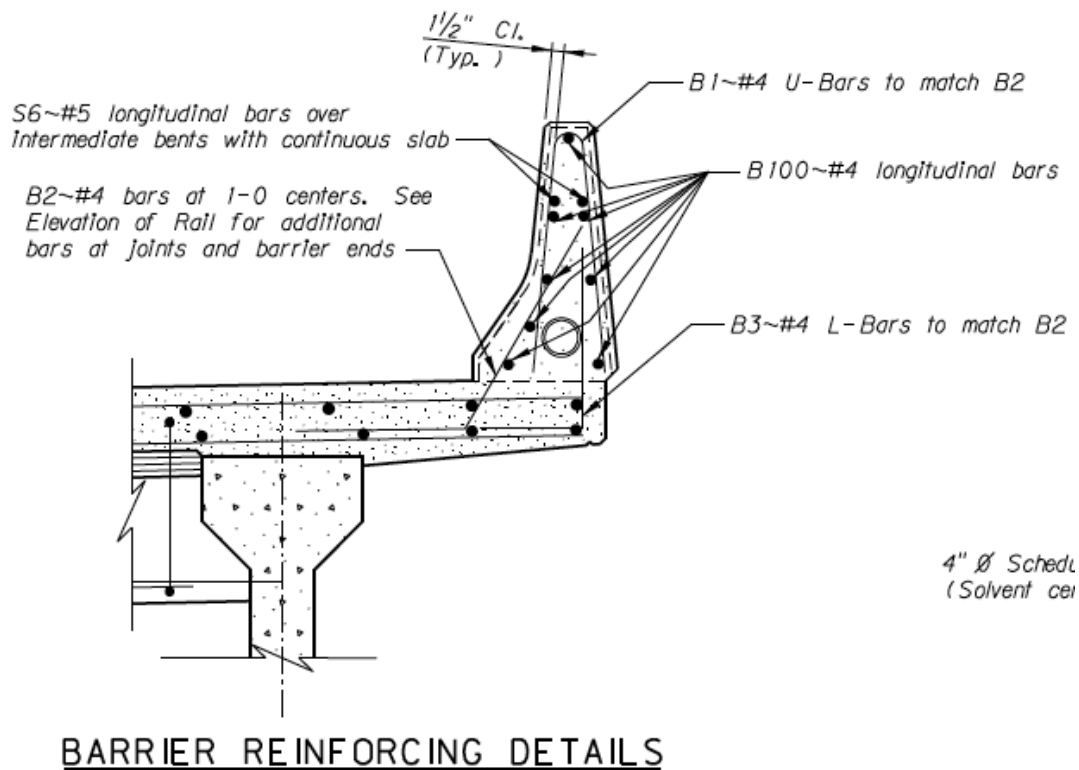
toward the middle of the parapet This amounts to a total cross-sectional rebar area of 2.02 in² (1303 mm²) (MDT, 2012).

The parapet also requires vertical #4 (13 mm) rebar that bends over the horizontal rebar, and an additional piece of vertical #4 (13 mm) rebar that follows the sloped face of the parapet and extends into the bridge deck. A 1 1/2" (38 mm) amount of cover is required for the vertical rebar, and these pieces are spaced at 12" (305 mm). The profile view of Montana's bridge parapet can be seen in Figure 13 (MDT, 2012).

Figure 13: Montana Department of Transportation Parapet Profile (MDT, 2012)

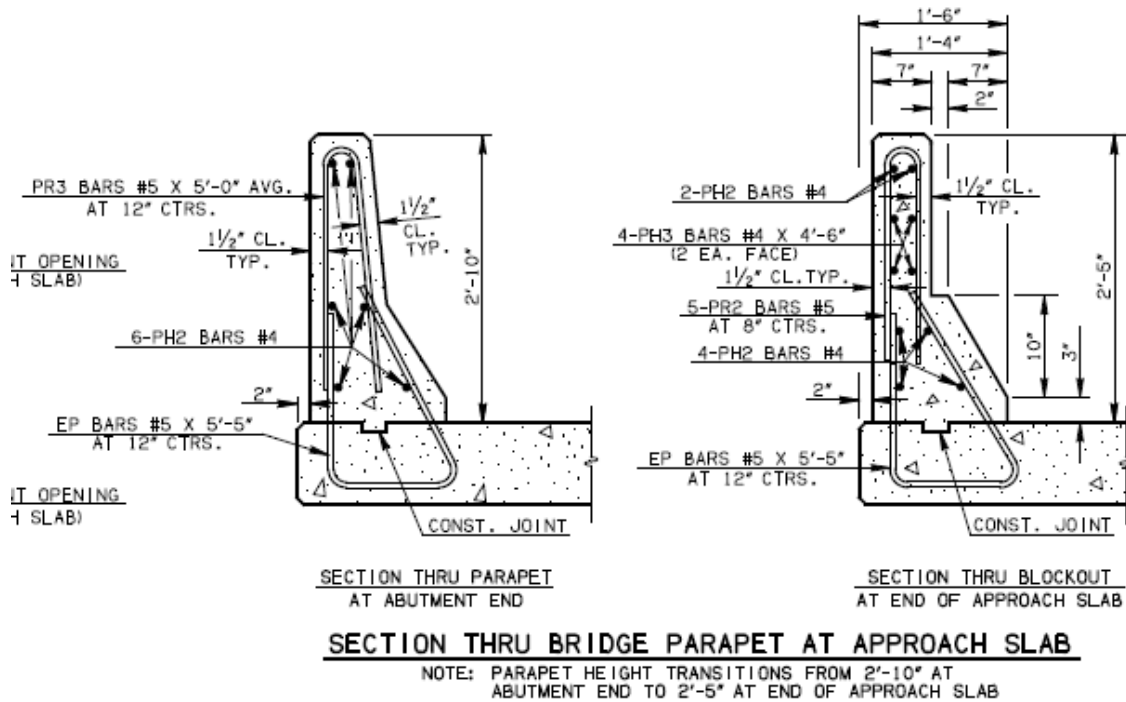
They are reinforced with vertical #5 (16 mm) rebar the bends over the top of the horizontal rebar. Also, they have additional #5 vertical rebar the bends below the horizontal rebar and extends into the bridge deck. The vertical rebar has a 1.5" (38 mm) cover on both vertical and sloped faces of the parapet, and is spaced at 12" (305 mm) on center. The profile view of Oklahoma's bridge parapet can be seen in Figure 14 (OKDOT, 2005).

Figure 14: Oklahoma Department of Transportation Parapet Profile (OKDOT, 2005)

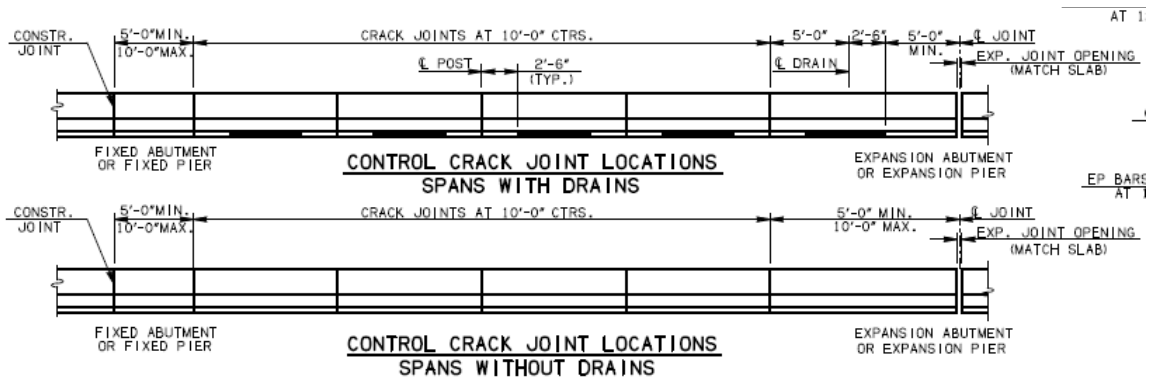
Construction joints consist of a 1/4" (6 mm) thick preformed expansion material. Crack control joints should have 3/4" (19 mm) chamfers or be 3/4" (19 mm) deep saw cut. If the parapet has drain openings, then the crack control joint must be placed in the center of the 5' (1.5 m) solid parapet between drain openings. If there are no drain openings, then the crack control joint must be placed at 10' (3 m) spacing. The layout of crack control joints can be seen in Figure 15 (OKDOT, 2005).

Figure 15: Oklahoma Department of Transportation Control Joints (OKDOT, 2005)

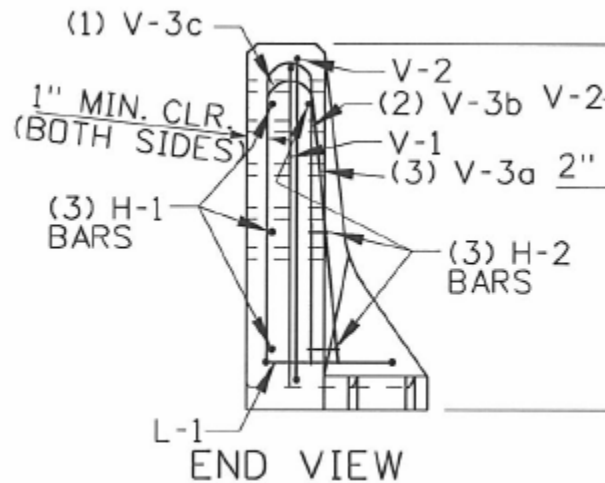
sloped sides. The vertical rebar is spaced at 10 5/8" (270 mm). The profile view of Idaho's bridge parapet can be seen in Figure 16 (ITD, 2010).

Figure 16: Idaho Department of Transportation Parapet Profile (ITD, 2010)

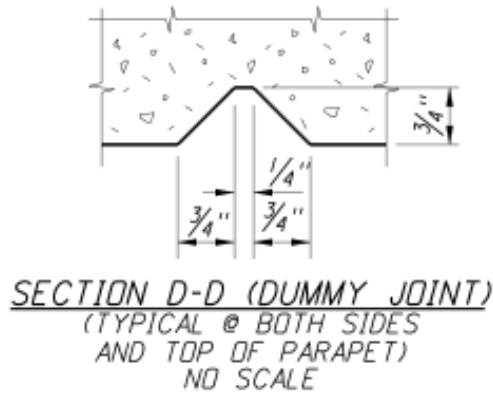
Construction joints are placed above each pier, and then spaced evenly throughout the remaining length of the parapet. The construction joints can be spaced no less than 6' (1.8 m) and no more than 12' (3.7 m) apart. The joints will be 3/4" (19 mm) deep and chamfered. The construction joint, referred to as a dummy joint, can be seen in Figure 17 (ITD, 2010).

Figure 17: IDT Dummy Joint (IDT, 2010)

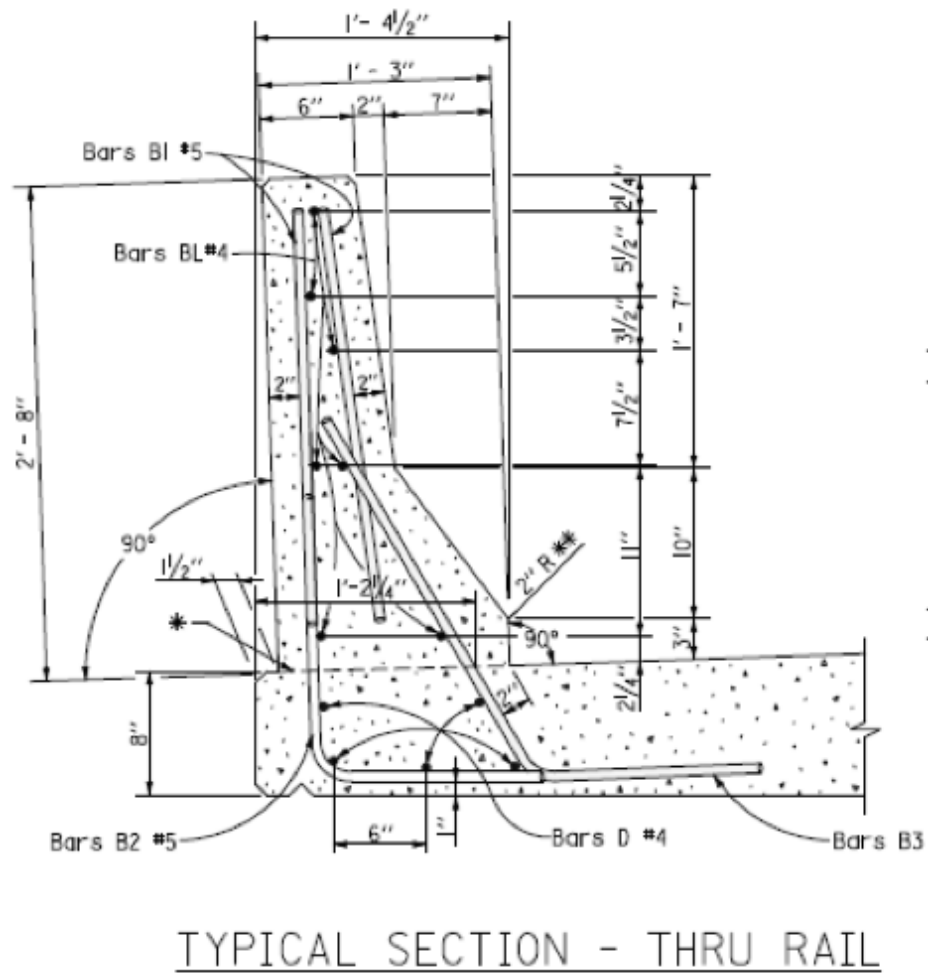
All vertical rebar is spaced at 10" (254 mm) on center. All steel shall be specified on shop drawings. The profile view of Alabama's bridge parapet can be seen in Figure 18 (ALDOT, 2008).

Figure 18: Alabama Department of Transportation Parapet Profile (ALDOT, 2008)

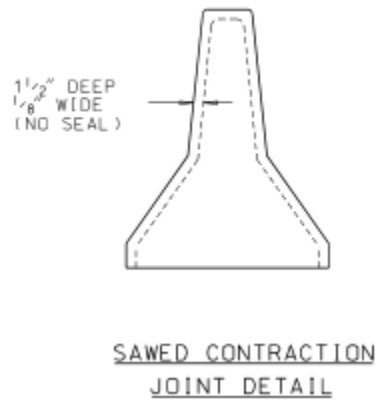
An example of the construction joint on a different type of ALDOT concrete barrier can be seen in Figure 19 (ALDOT, 2008).

Figure 19: ALDOT Construction Joint (ALDOT, 2008)

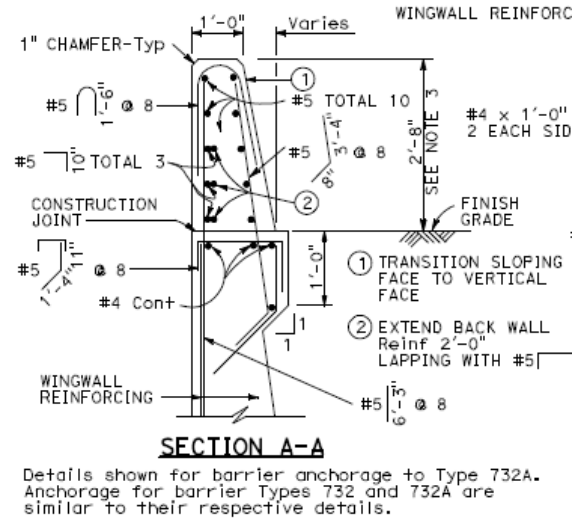
The parapet will also be reinforced with vertical #5 (16 mm) rebar on both faces, and another piece of #5 (16 mm) rebar that will be bent over the top of the horizontal rebar. There will be 1" (25 mm) cover except when noted otherwise. The vertical rebar will be spaced at 8" (203 mm) on center. The profile view of California's bridge parapet can be seen in Figure 20 (Caltrans, 2010).

Figure 20: California Department of Transportation Parapet Profile (Caltrans, 2010)

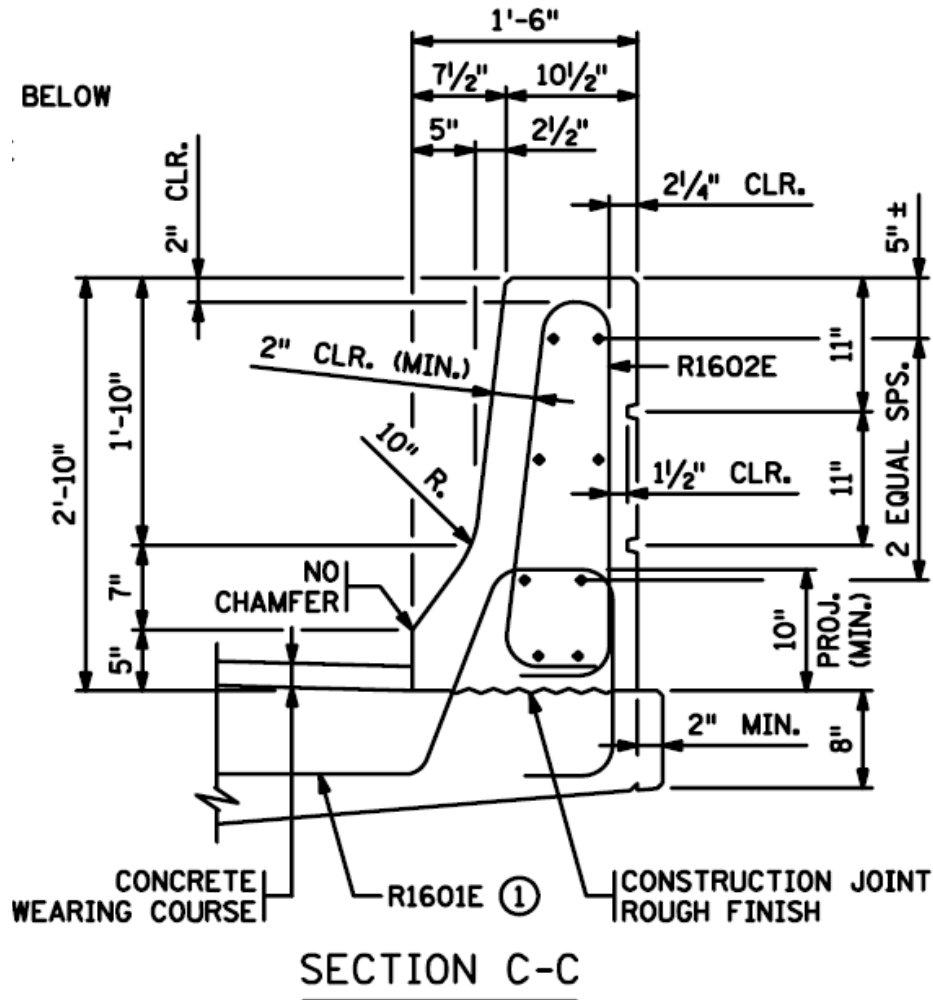
The vertical rebar are spaced every 8" (203 mm). There are 2.25" (57 mm) of cover on the vertical face of the parapet and a minimum of 2" (51 mm) cover on the sloped face. The strength of concrete and rebar used are determined from project drawings. The profile view of Minnesota's bridge parapet can be seen in Figure 21 (MNDOT, 2006).

Figure 21: Minnesota Department of Transportation Parapet Profile (MNDOT, 2006)

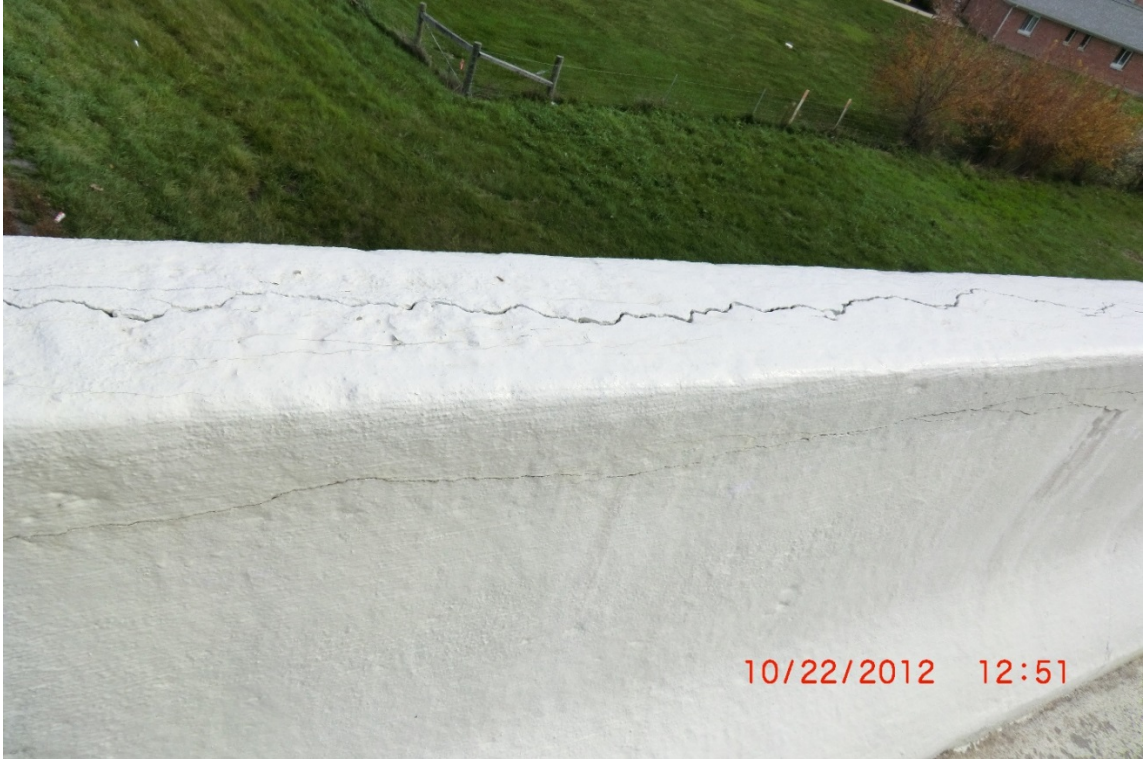
Although it is not considered premature, the replacement of the parapets will need to be done before the bridge deck needs to be repaired. An official estimate for this work has not yet been calculated, but Rod Maas, PE in District 1 has a rough estimate of \$225,000 (Rod Maas, personal communication, March 4, 2014). This is roughly \$363 per linear foot of parapet (\$1,190/m). A photograph of the cracking seen in this parapet can be seen in Figure 23.

Figure 23: Bridge Number ALL-75-1836 Cracking (Photo Provided by Rod Maas)

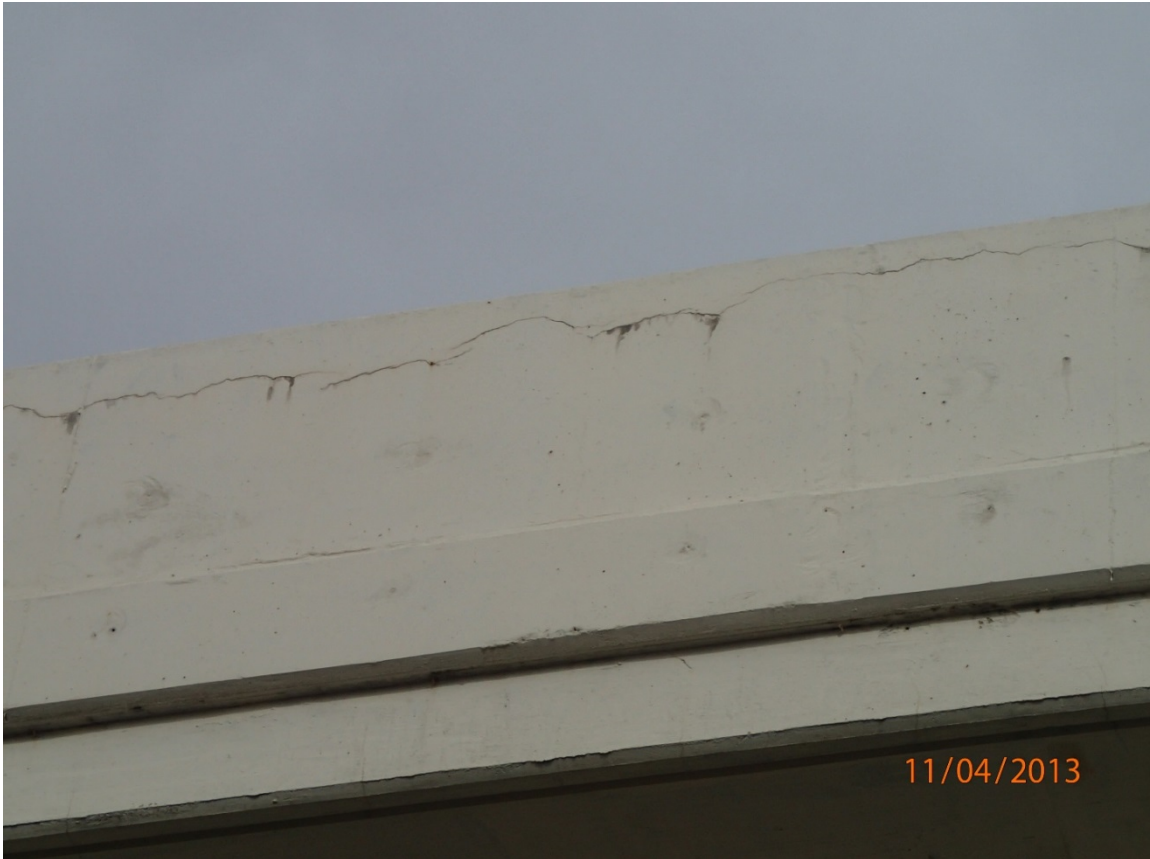
An official estimate for the work needed has not yet been calculated, but Rod Maas, PE in District 1 has a rough estimate of \$150,000 (Rod Maas, personal communication, March 4, 2014). This is roughly \$428 per linear foot of parapet (\$1,400/m). A photograph of the cracking seen on this parapet can be seen in Figure 24.

Figure 24: Bridge Number ALL-696-0086 Cracking (Photo Provided by Rod Maas)

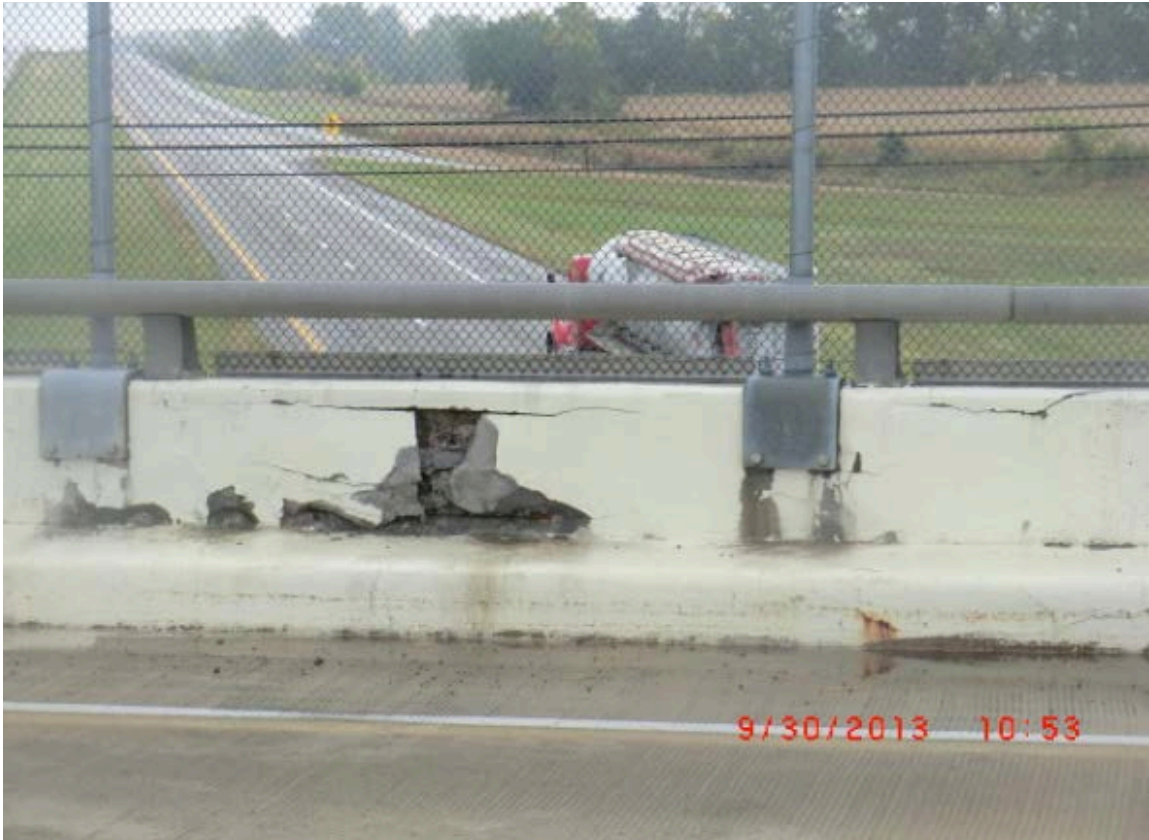
Since 2009, the parapets have begun to deteriorate again and will need more patching done. The patch work is planned for the spring construction season of 2014. A photograph of the parapet can be seen in Figure 25.

Figure 25: Bridge Number ALL-65-1322 Cracking (Photo Provided by Steve Reichenbach)

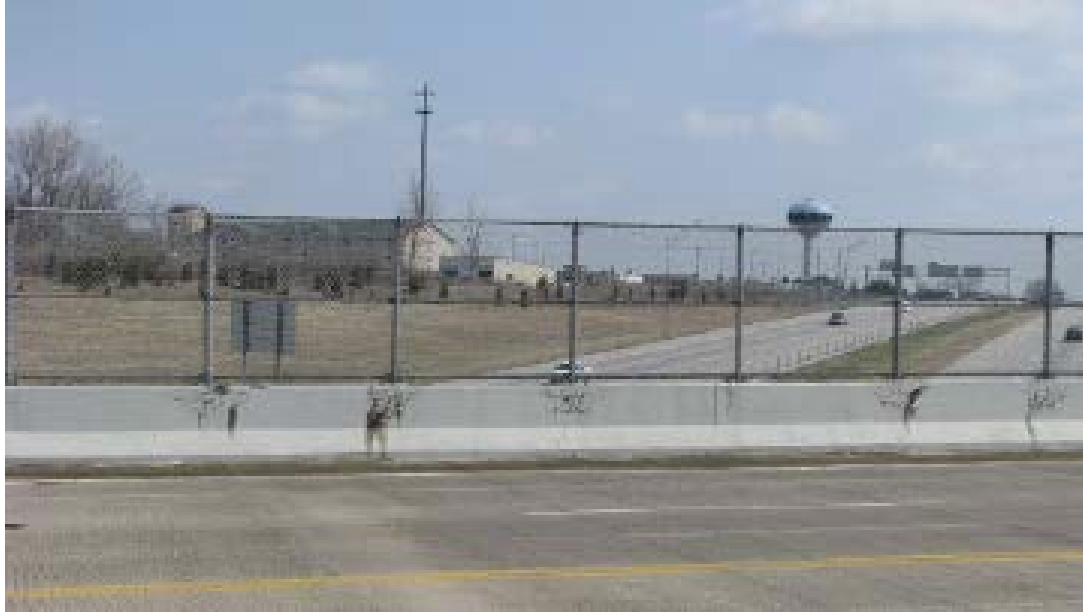
The total cost of repairs to the two parapets was \$218,852. This cost included the repair of the transition sections and purchase and installation of new VPF. The cost is approximately \$420 per linear foot of parapet (\$1,380/m).

Figure 26: Bridge Number GRE-675-0895 Cracking (Photo Provided by Brandon Collett, PE)

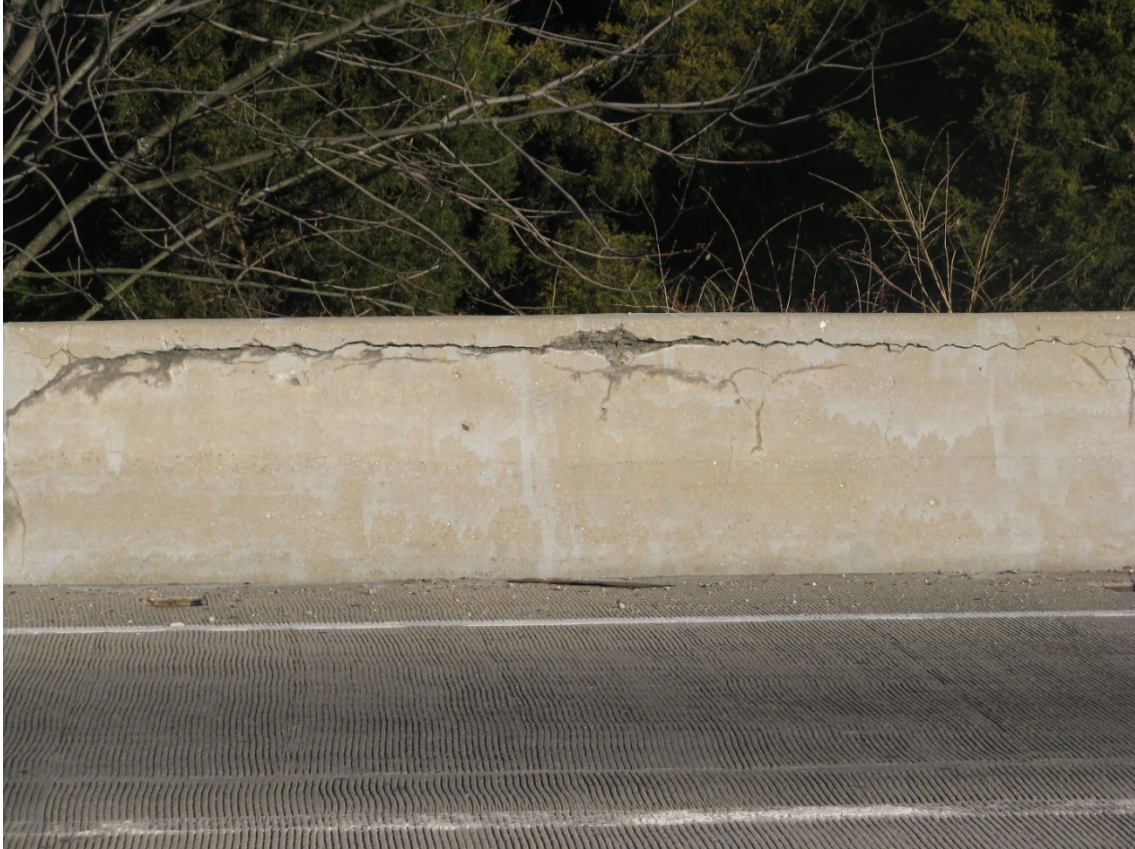
The top foot and a half of the selected sections needed to be repaired. Other work that was performed at the same time included barrier replacement and zone painting. The total cost of these repairs was \$17,000, which is \$60 per linear foot of parapet (\$200/m).

Figure 27: Bridge Number HAM-74-1116L Cracking (Photo Provided by Brandon Collett, PE)

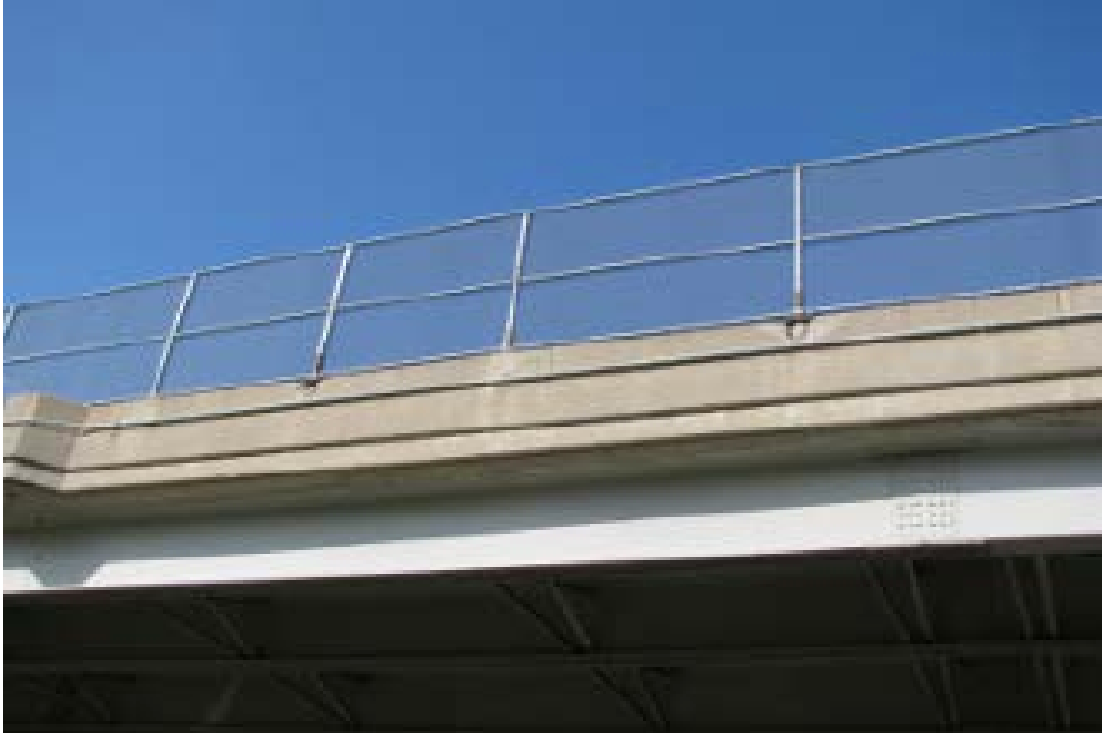
This bridge repair occurred in Greene County. The bridge is an overpass on North Fairfield Road that crosses over I-675 and has a total length of 277 feet (84 m). Due to extensive concrete deterioration and cracking caused by VPF, multiple patches were needed along the length of the parapet. A photograph of the deterioration can be seen in Figure 28. The total cost of these patches was \$13,600, which is \$50 per linear foot of parapet (\$910/m).

Figure 28: Bridge Number GRE-675-1034 Cracking (Photo Provided by Brandon Collett, PE)

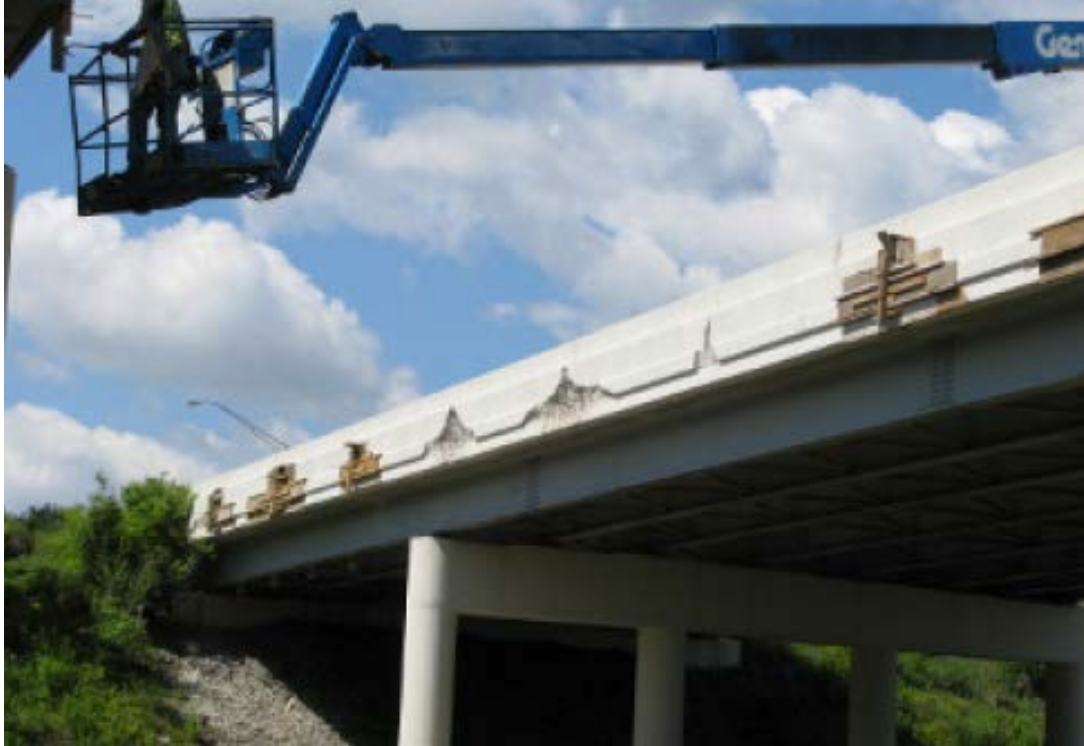
This bridge parapet repair occurred in Greene County and has a total length of 244 feet (74 m). The cost of repairs included in this project included the removal of loose concrete from the parapets, various deep patches, and applying an epoxy sealer. A photograph of the cracking and repairs being done can be seen in Figure 29. The total cost of these patches was \$117,000, which is \$240 per linear foot of parapet (\$790/m).

Figure 29: Bridge Number GRE-42-0789 (Photo Provided by Brandon Collett, PE)

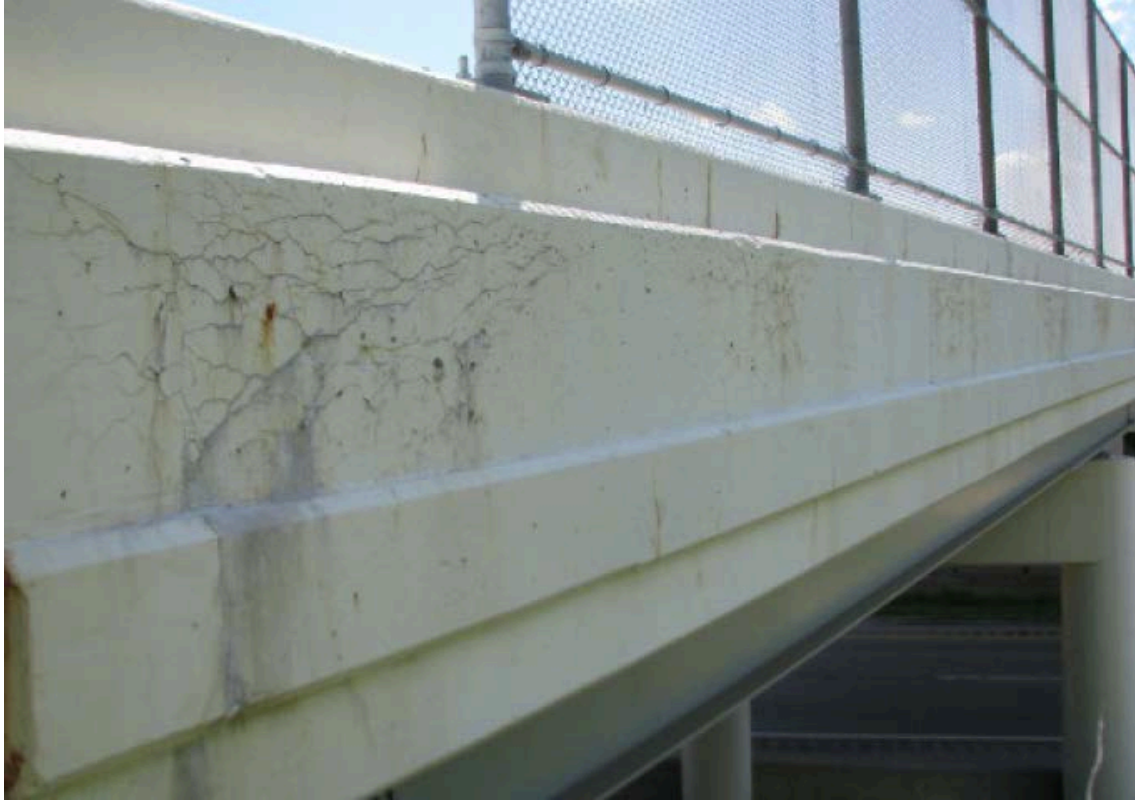
This bridge parapet repair will occur in Greene County with a total length of 277 feet (84 m). The repairs needed for this bridge not only include the replacement of the parapet, but also an overlay of the bridge deck and possible replacement of the VPF. A photograph of the cracking can be seen in Figure 30. The estimated total cost of these repairs is \$200,000, which is \$361 per linear foot of parapet (\$1180/m).

Figure 30: Bridge Number GRE-380-0671 Cracking (Photo Provided by Brandon Collett, PE)
