Agricultural Product Loads and Warehouse Failures

Abstract: Two manufactured metal building warehouses loaded with agricultural products failed in service. Inspection revealed considerable damage to the structure and the foundation. The building owner filed suit against the building supplier, the building erector, and the soils testing laboratory whose engineer had designed the foundation. The agricultural product imposed substantial outward lateral pressures on the walls of the structures. Review of the available design documents indicated that these loads had not been accounted for in design. A structural analysis revealed that elements of the structure were underdesigned for the agricultural product loads. In addition, the foundation did not have any slab reinforcement to resist the loads. To prevent similar failures, these loads must be accounted for in design. The steel structure design and foundation design were both deficient. A contributing factor was the lack of communication between the designer of the structure and the designer of the foundation, due to the lack of a single engineer of record to take responsibility for the buildings.

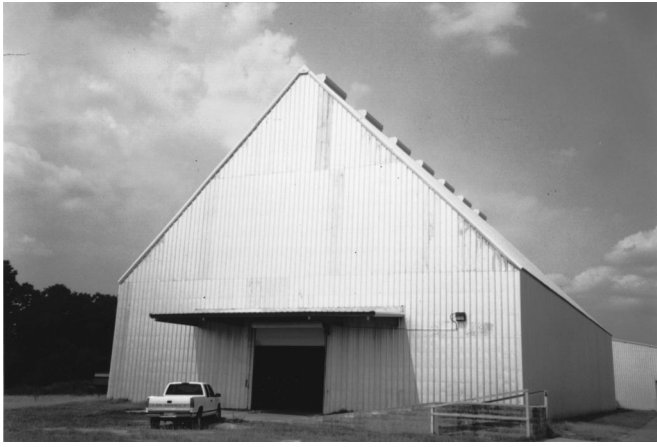
The author first inspected the two warehouses in August 1999. Both warehouses were empty. Each warehouse was 24.4 by 42.7 m (80 by 140 ft) in plan. The side warehouse walls were just over 7.26 m (23 ft 10 in.) high, with the roof rising at a 45° angle to a peak 18.3 m (60 ft) high. One of the warehouses is shown in Fig. 1. The auger, intended to move the product from the loading end to the door, was at the peak of the roof.

Fig. 1. Exterior view of warehouse
