## Another Look at the L'Ambiance Plaza Collapse

Martin, R., and Delatte, N. (2000). "Another Look at the L'Ambiance Plaza Collapse."  
J.Perform.Constr.Facil., 14(4), 160-165.

# ANOTHER LOOK AT THE L'AMBIANCE PLAZA COLLAPSE

By Rachel Martin<sup>1</sup> and Norbert J. Delatte,<sup>2</sup> Member, ASCE

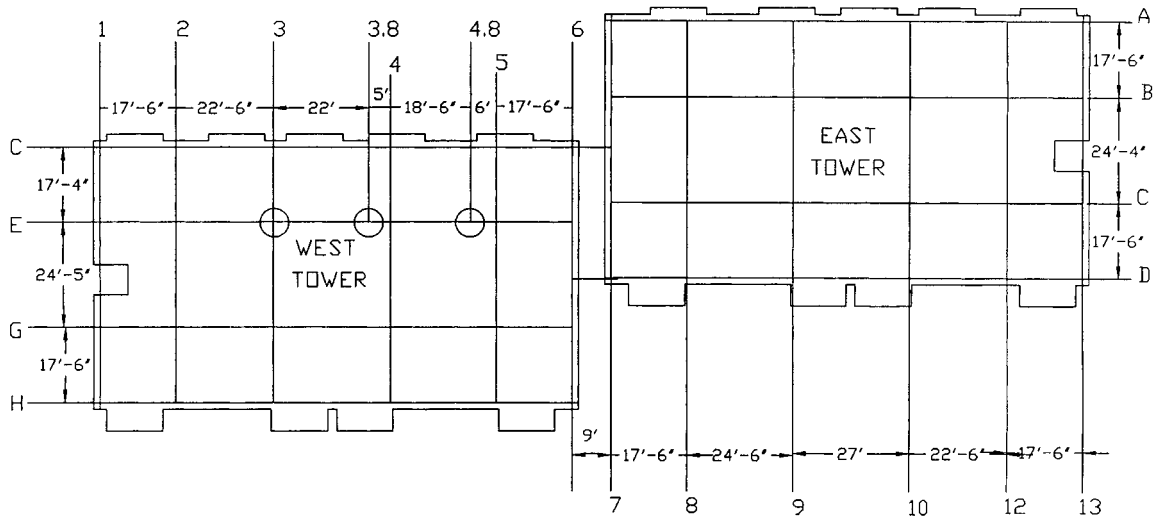
FIG. 1. Floor Plan of L'Ambiance Plaza

L'Ambiance Plaza was planned to be a 16-story building with 13 apartment levels topping three parking levels. It consisted of two offset rectangular towers,  $19.2 \times 34.1$  m ( $63 \times 112$  ft) each, connected by an elevator (Fig. 1). Posttensioned concrete slabs 178-mm (7-in.) thick and steel columns comprised its structural frame (Cuoco et al. 1992). Posttensioning overcomes the tensile weakness of concrete slabs by placing high strength steel wires along their length or width before the concrete is poured. After the concrete hardens, hydraulic jacks pull and anchor the wires compressing the concrete (Levy and Salvadori 1992).
