## Investigating Performance of Bonded Concrete Overlays

# INVESTIGATING PERFORMANCE OF BONDED CONCRETE OVERLAYS

By Norbert J. Delatte Jr.,<sup>1</sup> Member, ASCE, David W. Fowler,<sup>2</sup> Fellow, ASCE,  
B. Frank McCullough,<sup>3</sup> Member, ASCE, and Stefan F. Gräter<sup>4</sup>

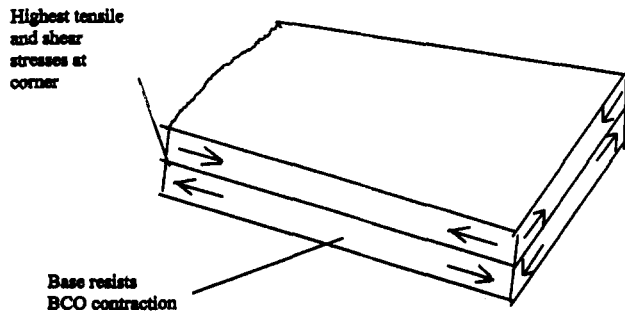
At the interface between the BCO and the base slab, normal and shear stresses develop. Compressive normal stresses may be neglected. As the BCO contracts relative to the base slab due to shrinkage and temperature differentials, tensile and shear stresses develop. These stresses are highest at boundaries and corners (Fig. 1).

**FIG. 1. Interface Stresses from BCO Contraction Relative to Base Slab**

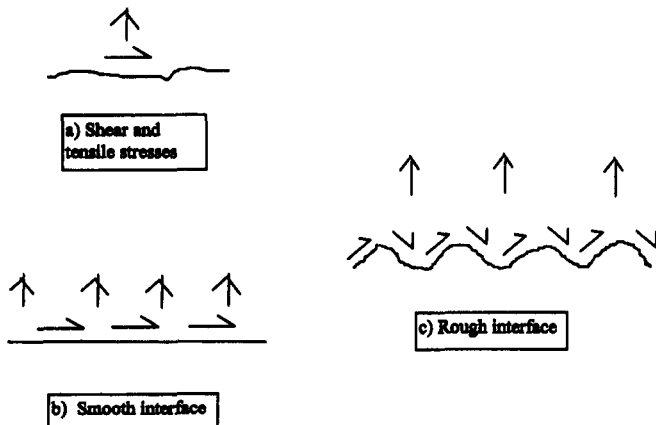
Whereas adhesion develops as the concrete cures, the contribution of interlock does not change. However, improved surface roughness, in addition to improving interlock, also enhances adhesion. With a rougher surface, more area is available for the paste to adhere (Fig. 2). Interlock considerably increases the shear capacity of the interface bond.

**FIG. 2. Effect of Surface Roughness on Bond**

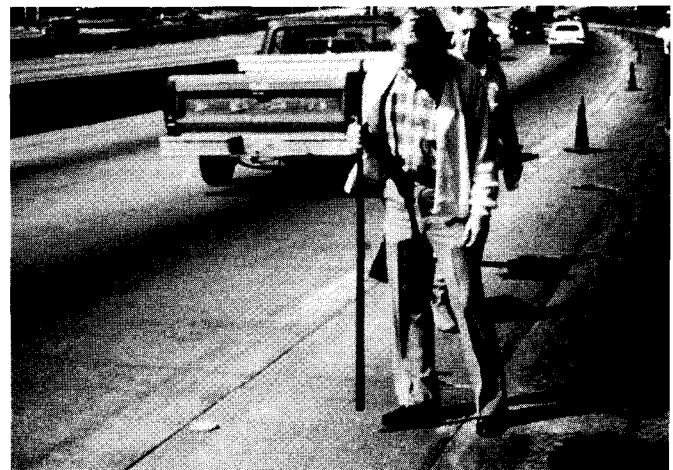
**FIG. 7. Rebar Sounding**

is dropped on the overlay from a height of 100 to 300 mm (Fig. 7). Rebar dropped on the overlay over a delamination sounds "hollow" compared to a sounding made in the interior of the slab, where the BCO is presumably well bonded. Also, it is possible for the operator to feel vibrations in his feet when the rebar is dropped over a delamination. This method is subjective and dependent upon the skill of the operator. Cores were also drilled through the BCO to locate delaminations. The impact (Schmidt) hammer was unable to detect delaminations.
