INSTALLATION AND FIELD TESTING OF HIGH PERFORMANCE REPAIR
MATERIALS FOR PAVEMENTS AND BRIDGE DECKS

ANDREW LESAK

This study was sponsored by the Ohio Department of Transportation (ODOT), under a research contract titled “Evaluation of High Performance Pavement and Bridge Deck Wearing Surface Repair Materials”, State Job number 124816, Agreement number 25969. The research was also supported by Civil and Environmental Engineering Department, Washkewicz College of Engineering, and the College of Graduate Studies at Cleveland State University.

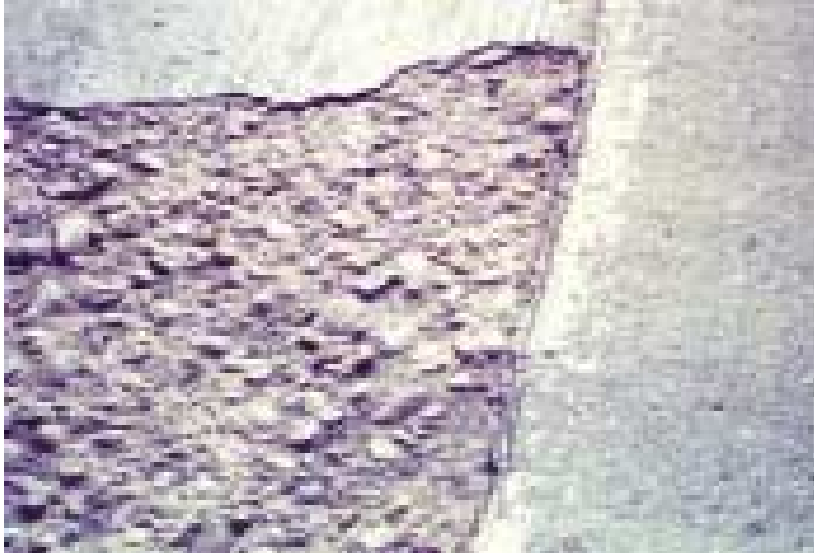
The FHWA Distress Manual was used throughout the visual inspection process to document the types of distress that may be found. Some of the possible types of distress include spalling, scaling, and patch deterioration. Figure 1 shows scaling on concrete, in which the surface of the concrete is deteriorating. Spalling, similar to scaling, is the chipping or breaking of the surface of the concrete (Miller & William, 2003).

Figure 1: Scaling on concrete (Miller & William, 2003).

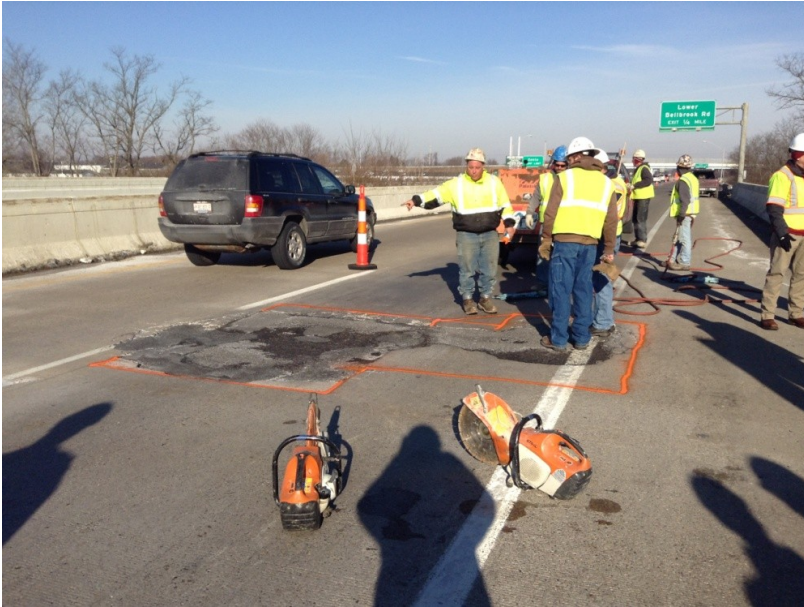
To begin the patching process, the proposed patch areas were first outlined with spray paint, as seen below in Figure 9. The outlining was done well before the patch installation started.

Figure 9: Outlining the proposed patch areas with spray paint.

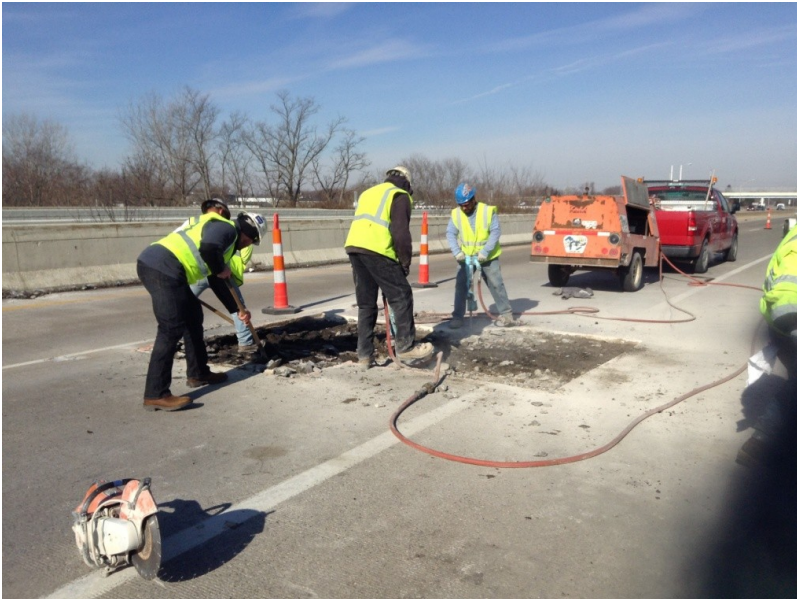
The patch perimeter was then cut with a concrete saw. The pavement was then removed with jackhammers, as seen in Figure 10, below. An air compressor was used to blow out all of the loose debris, dust, and dirt from the hole in order for the patching material to have a clean surface to bond with. While the holes were being cleared of debris, a torch was occasionally used for the holes that had moisture in them, in order to make sure that the holes were dry upon installation. The torch was primarily used for the bridge deck, as seen in Figure 11 on the following page, due to the amount of moisture trapped within the bridge deck. The locations that were not on a bridge deck

Figure 10: Removing the pavement with jackhammers.

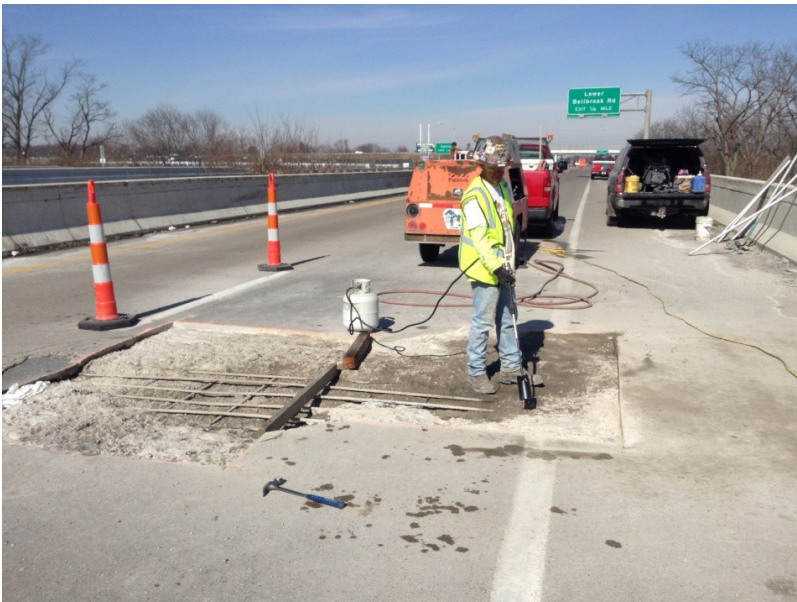
Figure 11: Drying the hole with a torch.

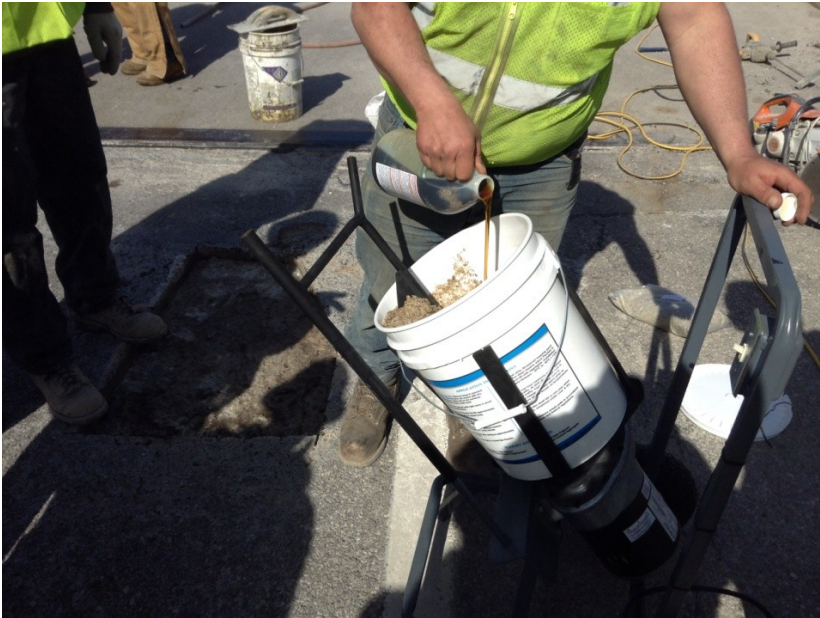
Figure 12: Mixing Flex Set patching material.

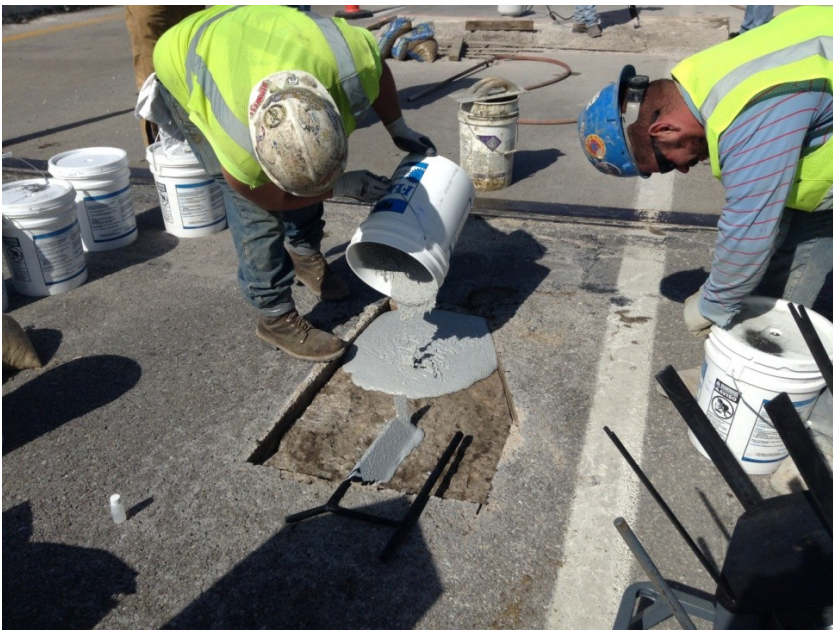
Figure 13: Filling hole with Flex Set patching material.

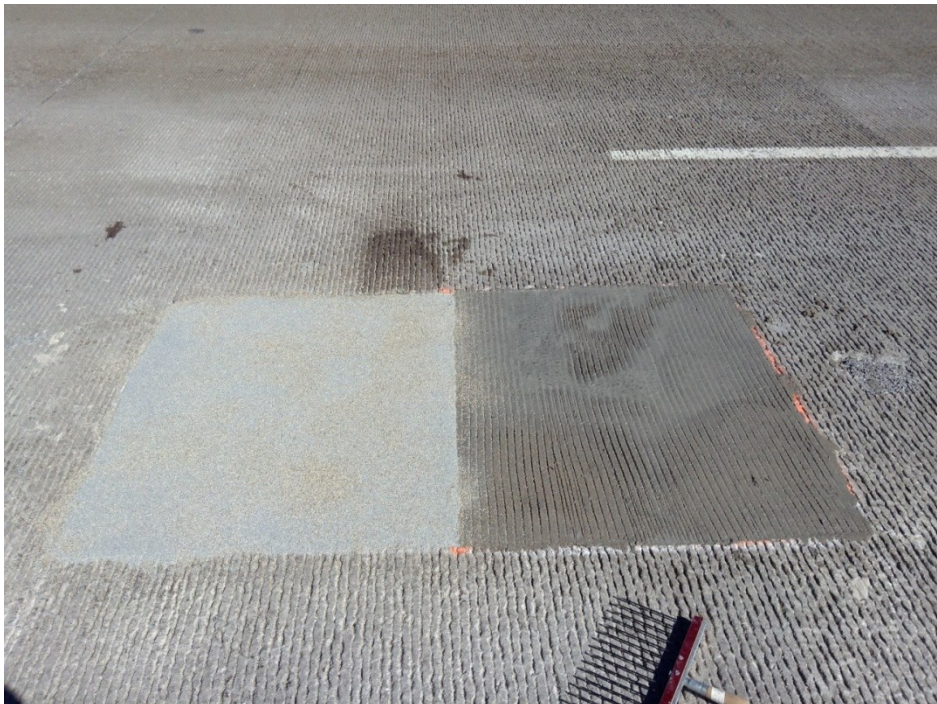
and #2 on the bridge deck, patches #9 and #10, and patches #11 and #12 together. Patches #9 and #10, side-by-side, can be seen in Figure 14. For all of the side-by-side patches, the MG Krete was installed first, since the MG Krete had significantly lower slump. A thin piece of wood was placed temporarily at the halfway point of the hole, to help keep the MG Krete in its half of the hole. Once the MG Krete was solid enough, the FlexSet was then installed. The FlexSet was installed last because it is self-leveling.

Figure 14: Patches #9 (left) and #10 (right), containing FlexSet and MG Krete, respectively.

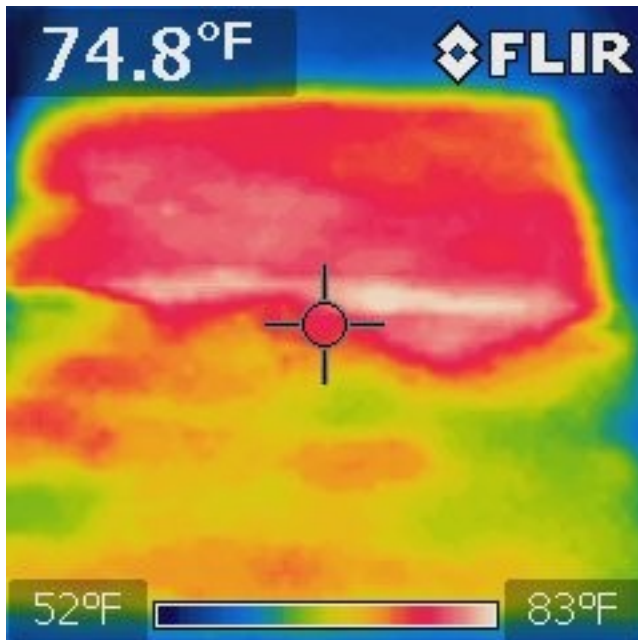
A picture from the infrared camera of patch #11, containing FlexSet, can be seen in Figure 16. The heat distribution of the FlexSet tended to be even throughout the patch, as can be seen in the figure. The top half of the patch shows slightly more heat, likely because it was installed before the bottom half of the patch, thus having more curing time. The differences of the temperature noticed in the figure throughout the patch are minimal.

Figure 16: Infrared camera picture of patch #11, containing FlexSet, showing the temperature variation throughout the patch.

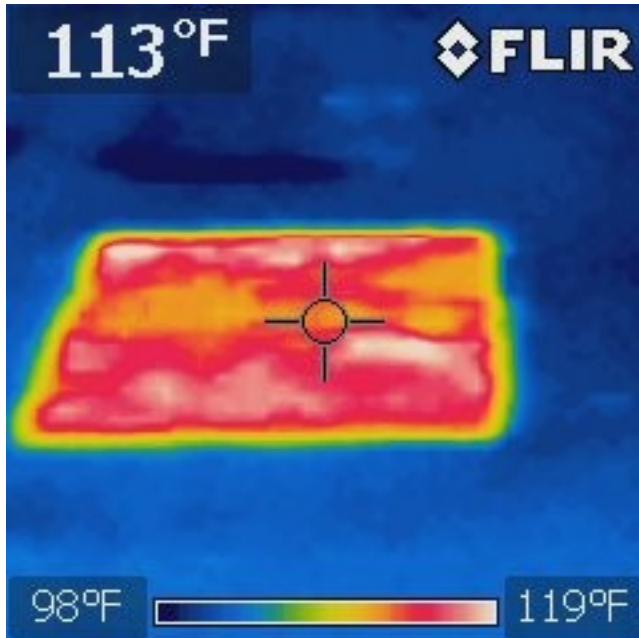
Similar to the FlexSet patches, the SR-2000 product had an even heat distribution throughout the patches, as seen in Figure 18. Figure 19 shows patch #34, containing the Delpatch product, with a fairly even heat distribution throughout the patch. This patch was nearly 7 feet (2.1 m) long, which would make the installation of the product take

Figure 18: Infrared camera picture of patch #22, containing SR-2000, showing the temperature variation throughout the patch.

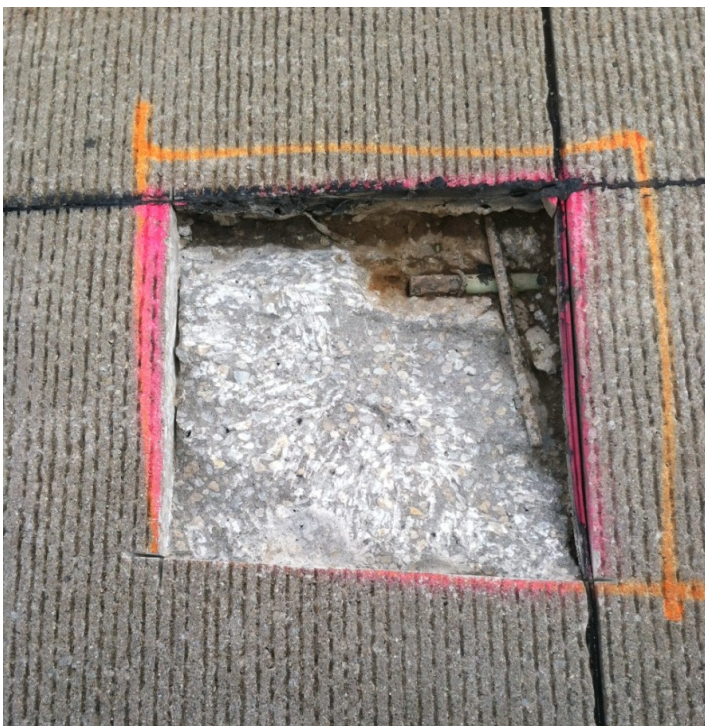
Five of the patches for this project were installed on original expansion joints. Two of these patches were at the corner of concrete pavement slabs, as seen in Figure 20 and Figure 21. The material used for patch #5, on the first expansion joint, was chosen to be Flex Set due to its promoted flexibility. The material used for patch #75 was RepCon 928, which is a polymer modified material. Patch #75 is on an expansion joint, in Figure 21, and it can be seen that there is a tie-bar and dowel that seems to be located too close together to the expansion joint. With the obvious future expansion of the expansion joints, it will be interesting to see the performance of these patches over the course of this project. It can also be seen in Figure 20 that the upper left corner of the patch hole, at the expansion joint, is visibly damp. This was not flame dried, and should be monitored throughout the project.

Figure 21: Patch #75, placed at an expansion joint.

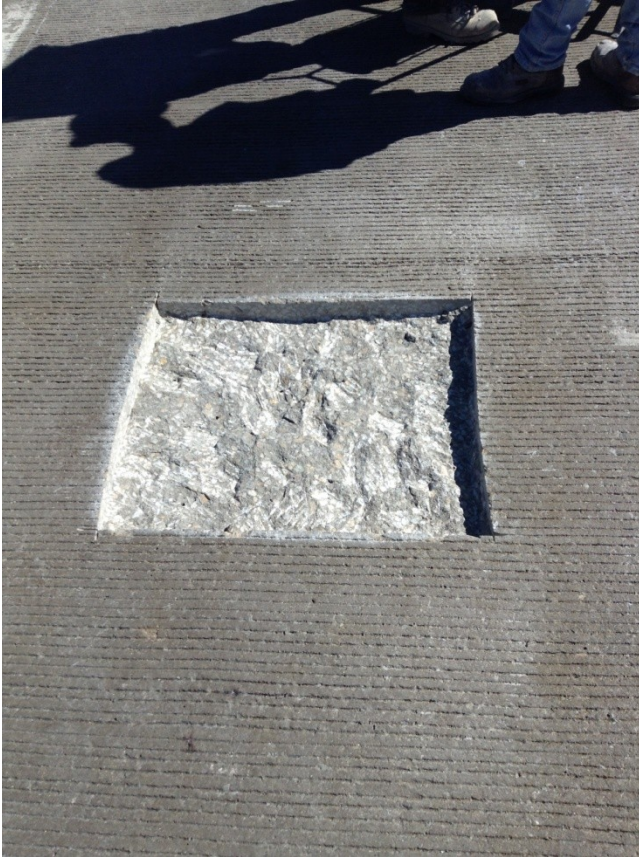
In order for the installation of the patches to go smoothly, and for the products installed to have the best chance to succeed, there were a few factors regarding the patching process that should be noted. It is important to know that the cutting, jackhammer drilling, and properly cleaning the holes will be more time consuming than the time spent installing any of the products used during this project. It is essential to the longevity of the patch being installed that the hole is made in a rectangular shape with smooth-cut edges, and that the hole is cleaned of all dirt and debris before installation of a patching product. Figure 37 shows the hole where patch #14 was installed, properly prepared before installation. Simply placing a product in a pothole with loose debris in it and tapered edges will lead to early patch failure.

Figure 37: An example of a clean, smooth-cut hole, where patch #14 was installed.
