Damage Assessment of Aerospace Structural Components by Impedance Based Health Monitoring

Gyekenyesi, A., Martin, R.E., Sawicki, J.T., Baaklini, G.Y., Damage Assessment of Aerospace Structural Components by Impedance Based Health Monitoring, NASA/TM Publication, 2005-213579, April 2005.

This paper addresses recent efforts at the NASA Glenn Research Center at Lewis Field relating to the set-up and assessment of electro-mechanical (E/M) impedance based structural health monitoring. The overall aim is the application of the impedance based technique to aeronautic and space based structural components. As initial steps, a laboratory was created, software written, and experiments conducted on aluminum plates in undamaged and damaged states. A simulated crack, in the form of a narrow notch at various locations, was analyzed using piezoelectric-ceramic (PZT: lead, zirconate, titarate) patches as impedance measuring transducers. Descriptions of the impedance quantifying hardware and software are provided as well as experimental results. In summary, an impedance based health monitoring system was assembled and tested. The preliminary data showed that the impedance based technique was succ

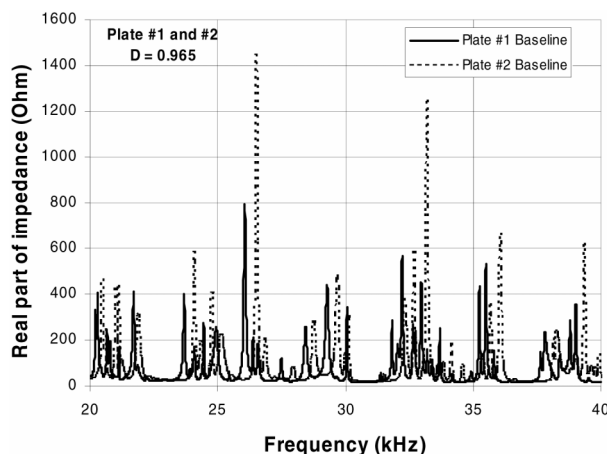
Next, a comparison was made between the baseline of plate 1 and the baseline of plate 2. Figure 5 shows the E/M impedance plots as well as indicating the damage parameter value based on the correlation of the two plates (eq. (3)). Each of the impedance plots was an average of 15 repetitions. The damage metric ($D = 0.965$) indicated that there was much discrepancy between the two baseline measurements. As stated earlier, the large specimen to specimen variations dictate that the method be utilized as a comparison of baseline and subsequent measurements within the same specimen. Similar observations were made by Winston et al. 2001.

Figure 5.—Comparison of undamaged plates 1 and 2 (20 to 40 kHz). Damage metric, D , was 0.965 indicating a lack of correlation between the two plates.

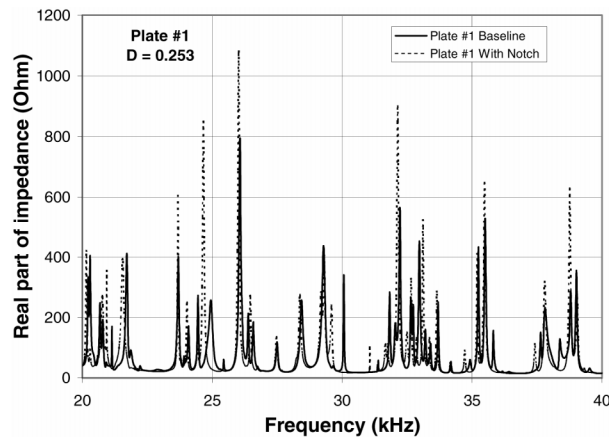
Figure 6 shows the results of comparing the baseline and the notched (i.e., damaged) cases for plate 1. The presence of the notch did modify the frequency response function. This was indicated by the shifting of the resonant frequencies and by the appearance of new resonances. The calculated correlation coefficient for this case was $\rho = 0.497$, and the damage metric was $D = 0.253$ based on eq. (3). Next, figure 7 shows the results for plate 2 comparing the undamaged baseline with the damaged case, again, calculated using 15 repetitions for each plot. The correlation coefficient for plate 2 was $\rho = 0.365$, and the damage metric was $D = 0.403$. Note that plate 2 before-and-after notch comparisons showed a larger damage metric as compared to the plate 1 case, even though the plate 2 notch was located farther from the PZT patch. At this point there is no explanation for this behavior, although, the uniqueness of the plate to plate behaviors probably plays a part. Furthermore, the changes in the E/M impedance could also be influenced by the notch location as it relates to the plate's vibration displacement response and node locations. Further research needs to be conducted concerning these results.

Figure 6.—Averaged E/M impedance results for plate 1 with and without a notch.

This study was conducted in order to establish an impedance based structural health monitoring laboratory, which included both the acquisition of hardware and the development of software, as well as conducting preliminary experiments on aluminum plates in undamaged and damaged states. In addition, a methodology was developed that defined the frequency range utilized for the E/M impedance measurements. This was based on finding frequency ranges that offered the best repeatability (i.e., lowest noise) as expressed by either a high correlation or low damage value. Next, simulated cracks, in the form of narrow notches, were analyzed using PZT patches as impedance measuring transducers. Conclusions from the experiments on the two aluminum plates were as follows: The assessment of the impedance behavior regarding the two undamaged plates indicated that variations between specimens overrode changes due to damage. Therefore, it was shown that the impedance method was best utilized as a comparison of baseline and subsequent measurements concerning the same specimen. Next, the E/M impedance measurements were able to recognize the changes between the undamaged and damaged (i.e., notched) cases for each plate, although, larger changes were observed for plate 2 even though the notch was located farther from the PZT patch as compared to plate 1. This may have been due the uniqueness of the plate to plate behaviors, as well as the influence of notch and patch locations as it relates to the plate's displacement response and node locations. Further research is needed regarding this observation.
