# **Damage Assessment of Aerospace Structural Components by Impedance Based Health Monitoring**

## **Abstract**

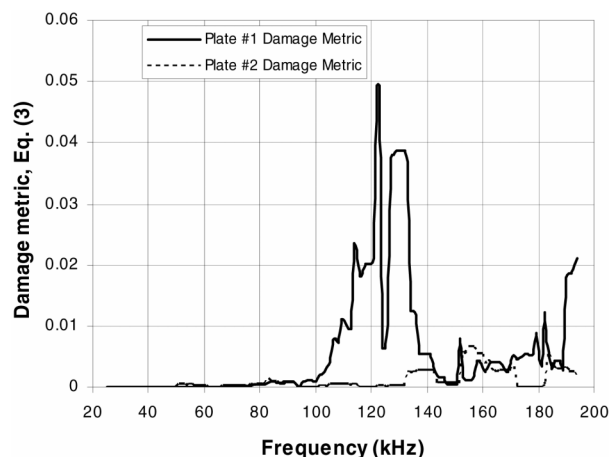
Figure 4.—Windowed correlation coefficient (20 to 200 kHz, 10 kHz window, 1 kHz step) for two uncracked plates.

Figure 4 shows a plot of the damage metric versus the central frequency for the windowed region regarding the undamaged plates. As mentioned above, this procedure was done in order to search for frequency regions that offered good repeatability under constant conditions (i.e., undamaged case). It can be seen from this plot that the damage metric was consistently valued at zero from 20 kHz to approximately 45 kHz, meaning that the two plots correlate well in that frequency range. The damage metric, in regions of good repeatability, should be close to zero, since the material state was maintained (zero damage in this case). Beyond 45 kHz, however, there was a noticeable inconsistency regarding the damage parameter. Based on these results, a frequency range of 20 to 40 kHz was chosen for subsequent E/M impedance measurements.

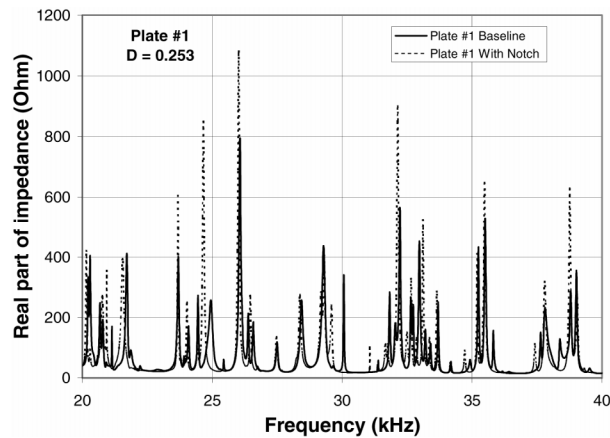
Figure 6.—Averaged E/M impedance results for plate 1 with and without a notch.

Figure 6 shows the results of comparing the baseline and the notched (i.e., damaged) cases for plate 1. The presence of the notch did modify the frequency response function. This was indicated by the shifting of the resonant frequencies and by the appearance of new resonances. The calculated correlation coefficient for this case was  $\rho = 0.497$ , and the damage metric was  $D = 0.253$  based on eq. (3). Next, figure 7 shows the results for plate 2 comparing the undamaged baseline with the damaged case, again, calculated using 15 repetitions for each plot. The correlation coefficient for plate 2 was  $\rho = 0.365$ , and the damage metric was  $D = 0.403$ . Note that plate 2 before-and-after notch comparisons showed a larger damage metric as compared to the plate 1 case, even though the plate 2 notch was located farther from the PZT patch. At this point there is no explanation for this behavior, although, the uniqueness of the plate to plate behaviors probably plays a part. Furthermore, the changes in the E/M impedance could also be influenced by the notch location as it relates to the plate's vibration displacement response and node locations. Further research needs to be conducted concerning these results.
