Measuring the Environmental Impact of Embedded/Bankfull Culverts

MEASURING THE ENVIRONMENTAL IMPACT OF EMBEDDED/BANKFULL
CULVERTS

MASTER OF SCIENCE IN CIVIL ENGINEERING

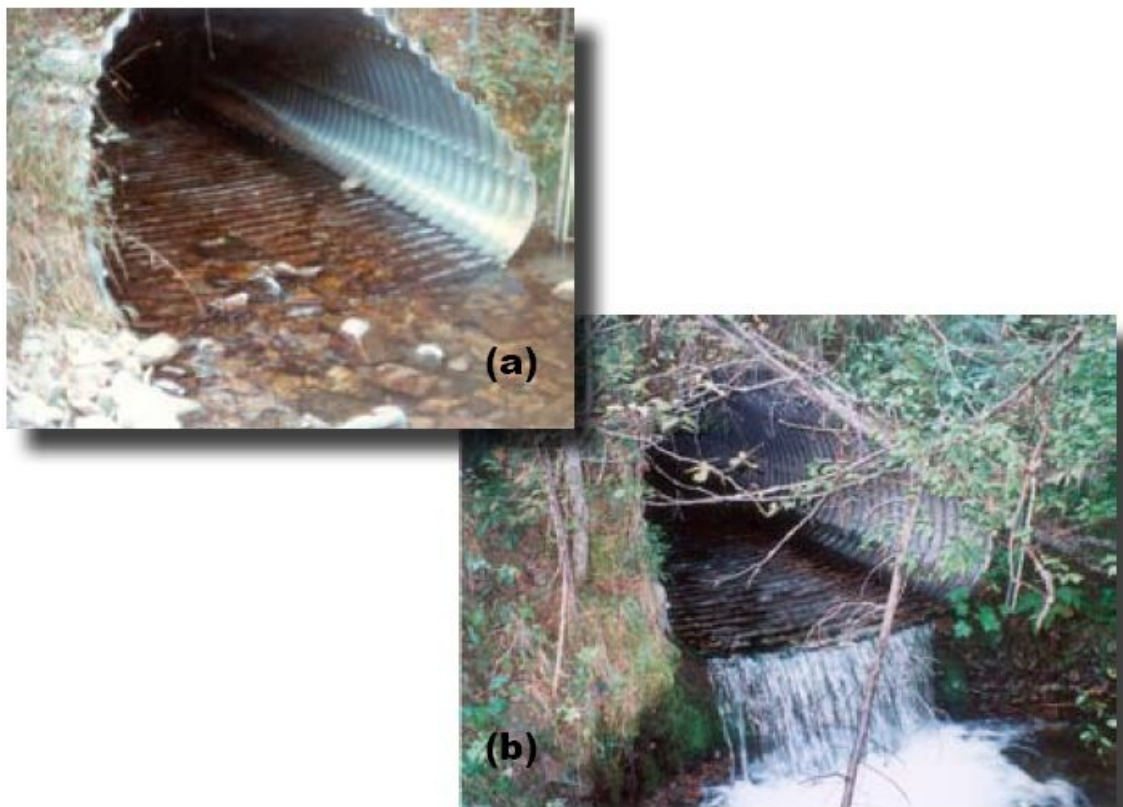
Figure 1.1 Perching of a Culvert as a Result of Long-Term Scouring (Forest Service Stream Simulation Working Group, 2008)

a) Culvert installed in 1979 b) Culvert in 1998. Perching caused by scouring

The erosion of the downstream caused by a culvert is scouring. The continued scouring of a culvert can erode the stream to an elevation where the culvert invert is “perched” above the downstream tailwater. The perching of a culvert can obstruct the passage of aquatic organisms in a stream (Bouska & Paukert, 2009). Figure 1.1 shows a culvert installed in 1979 and in 1998 showing the result of scouring over a 19 year period.

As stated in Chapter 1, increased water velocities exiting the culvert can scour the channel bottom downstream of the culvert causing the culvert to become perched. It was observed that of the 63 culverts sampled, 12 of them were perched. In most instances, the perching is a few inches but in the case 7A, the culvert outlet is perched four feet above the downstream water surface level. Therefore, though most instances of perching can be attributed to scouring, the extreme height of the perch of 7A leads one to suspect the culvert was installed at this height.

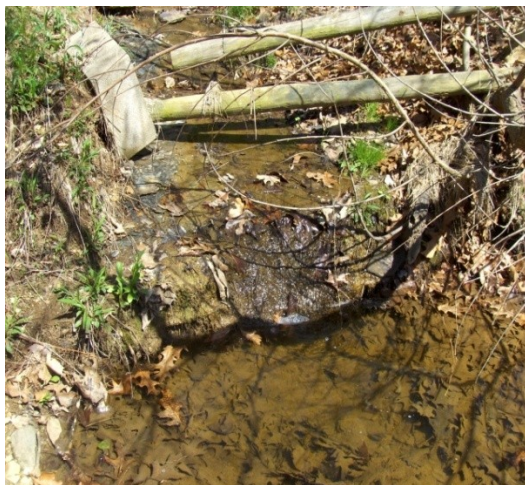
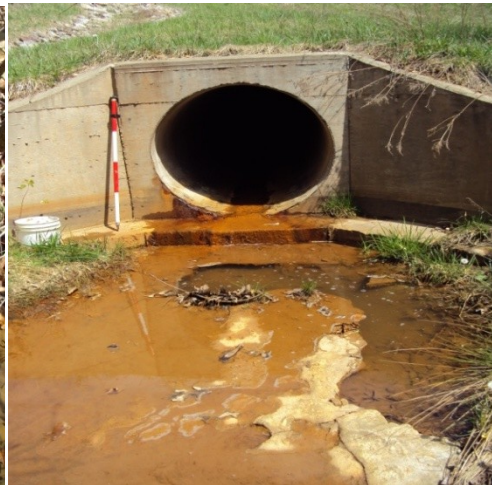
Figure 4.4 Change in Watercolor in Culvert 2E

Water upstream of culvert 2E

Water exiting culvert 2E

Some unique installation methods were observed at the culvert sites in Athens. In culverts 2A, 2B, and 2D the culverts were installed with a concrete bottom. Hence, at these culverts sediments appear to be washing through the culvert and there is no deposition occurring in the culvert. Figure 4.3 shows the installation of culvert 2A. In culverts 3A, 3B, 3C, and 3D there was a concrete pad placed at the outlet of the culvert, raised above the bottom of the culvert. In the culverts lined with concrete, there were no sediments present inside the culvert. Of all the culverts surveyed in Athens County, the only culvert with sediment present inside the culvert was culvert 3B. Perching has occurred at many of the culverts in Athens County. Culverts 2A, 2B, 2C, 2D, 2E, 3A, 3C, and 3D are all perched. For culverts 3A, 3C, and 3D it appears perching has occurred due to the concrete pad that is placed at the outlet. Finally, one other observation was made at the culvert 2E. as shown in Figure 4.4, water entering the culvert was clear, however the water exiting had a red-brown color. This was the only culvert surveyed in this entire study where there was a change in watercolor through the reach of the culvert.

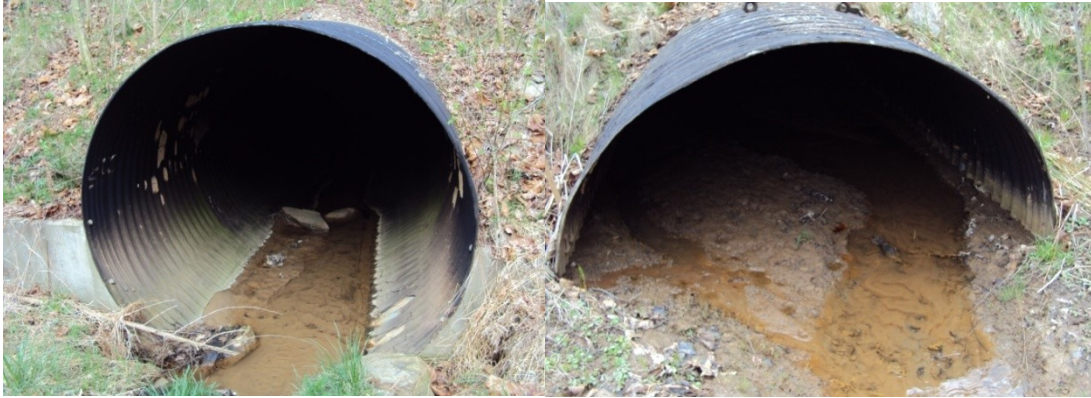
Culvert 5F Inlet

Culvert 5F Outlet

Upon field inspection, there was one less culvert installed than what appears on the plans. This culvert was is 6F. The culvert location would have been very close to the culvert 6E. However, the location of the culvert is an area where there is no stream and it appears the function of the culvert would have been to drain field run-off. Because there is no culvert 6F, there is no data presented. The culverts in Meigs County showed much variation in terms of how they are operating in the field. At culvert 5A some scouring is occurring at the inlet. Fine particles are being washed and only the rocks are remaining. Culverts 5C and 5B have no embedment at the inlet but the outlet is significantly embedded. At 5D, there were low amounts of sediment particles in the stream. The streambed is comprised mostly of rock. Because of this, there was no embedment of the culvert. No sample was taken downstream of the culvert because there is another culvert immediately downstream and the stream does not re-establish itself after the culvert. Culvert 5E is not embedded at the inlet of the culvert, but is embedded at the outlet of the culvert. 5F has some embedment at the inlet, but is embedded 50% at the outlet. Of all the culverts surveyed, in this author's opinion, this culvert's field dimensions match closest to the design principles of an EBC. At the outlet, this culvert was embedded deep enough so the stream could pass through the culvert but formed a channel through the embedment where the water made little contact with the culvert itself. Figure 4.5 shows the inlet and outlet of culvert 5F.
